Alaska Department Environmental Conservation (ADEC) Solid Waste Program (Doug Huntman and Rebecca Colvin) conducted a Coastal Impact Assistance Program (CIAP), Waste Erosion Assessment and Review (WEAR) site visit for Kasigluk, August 29th, 2012. Annie Andrew and Cauline Nicholai, IGAP Coordinators, helped coordinate our visit. The following narrative is a brief description of our findings during our August inspection.

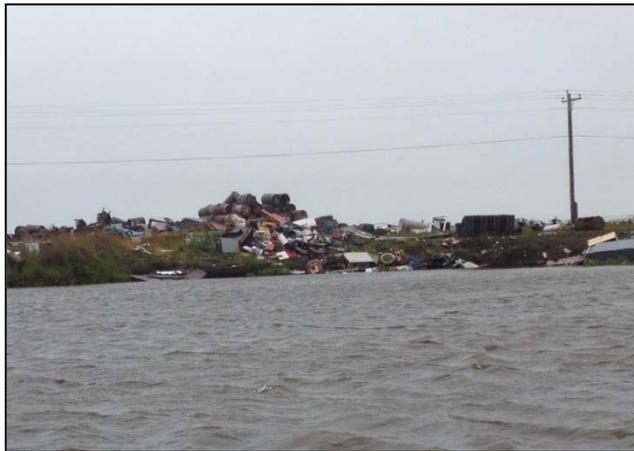
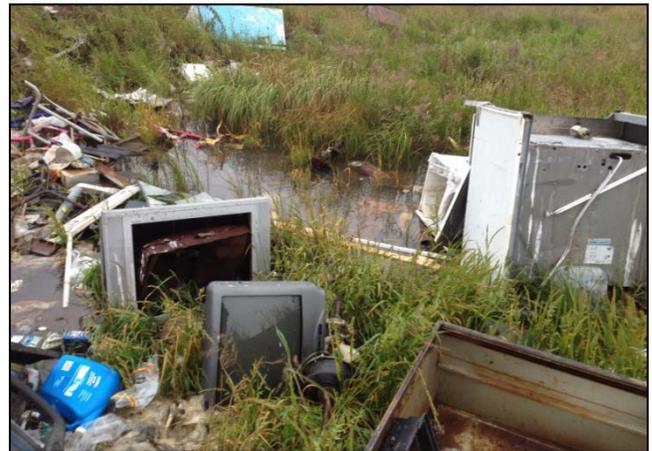
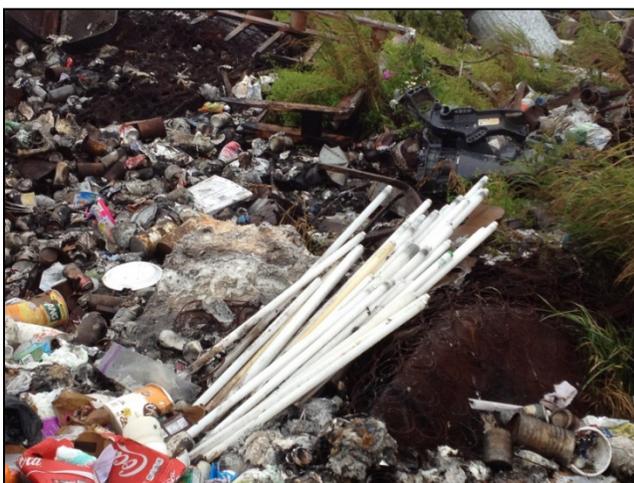
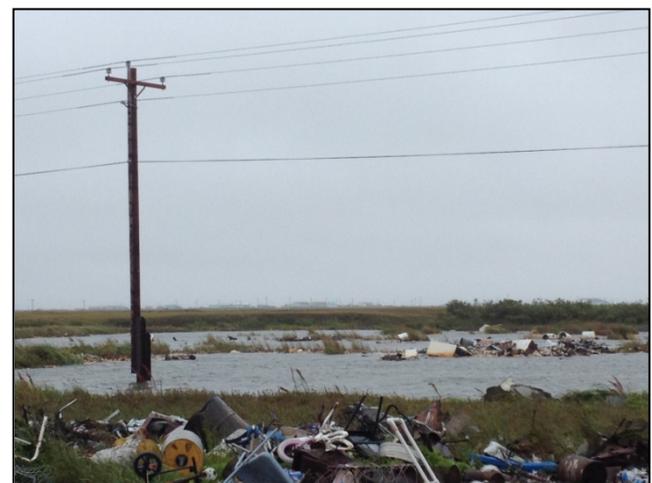
- **Landfill, 60.893745/-162.498668 (Active)** – The landfill is a 2.5 acre self-haul landfill located more than half a mile from the nearest structure. The site is only accessible by boat in the summer and snow machine in the winter. The landfill is owned and operated by the Native Village of Kasigluk and located on discontinuous permafrost. The site includes a large tundra pond which is used for winter disposal of trash. The landfill accepts municipal wastes, but does not prohibit any special wastes or hazardous wastes. The landfill's operations are very basic: there is no cover material, no heavy equipment for consolidation or compaction, and there is open burning. There was a large amount of contractor waste in the landfill at the time of the inspection. The landfill is located right on the banks of a large pond that feeds into the Johnson River and the entrance to the landfill was observed to be eroding. Locals reported the erosion rate to be less than a foot per year. The entire site is situated at a very low elevation and floods in the spring and fall.

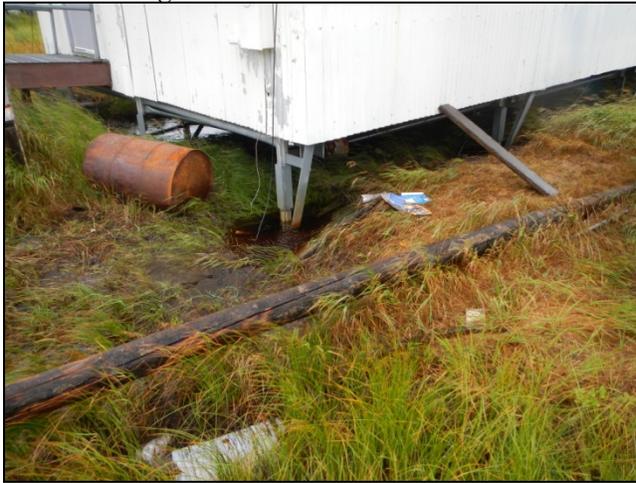
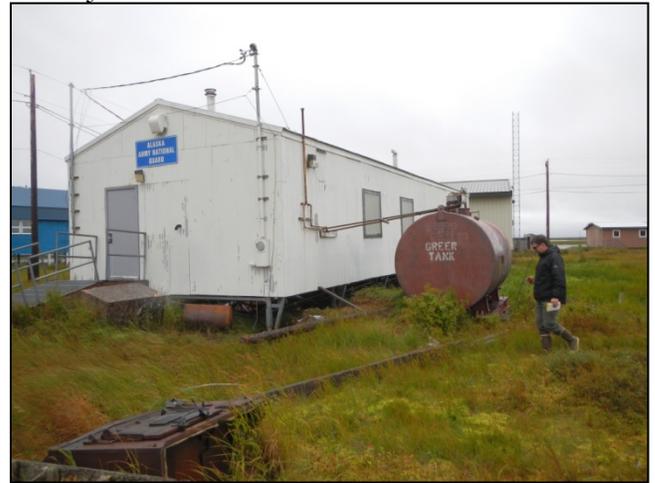
- **AKARNG Kasigluk FSA, 60.894139/-162.519949 (Active)** – This Alaska Army National Guard (AKARNG) site is an active Contaminated Site (File ID 2420.38.001). It was the site of petroleum spill from a heating oil system in 1990. Approximately 28 cubic yards of polluted soil were removed and treated offsite in 2008. Work is ongoing for this site by the Contaminated Sites Program. The site is located over 270 feet from the Johnson River.

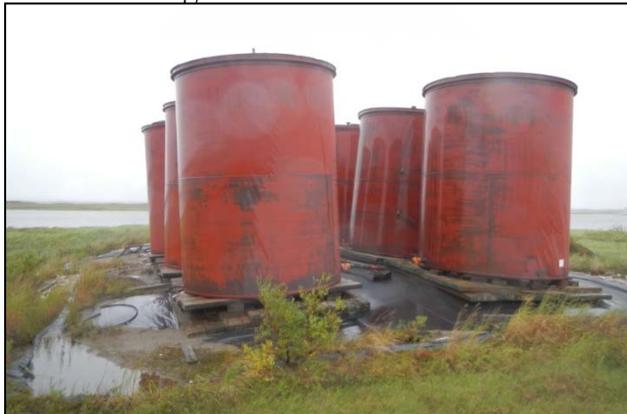
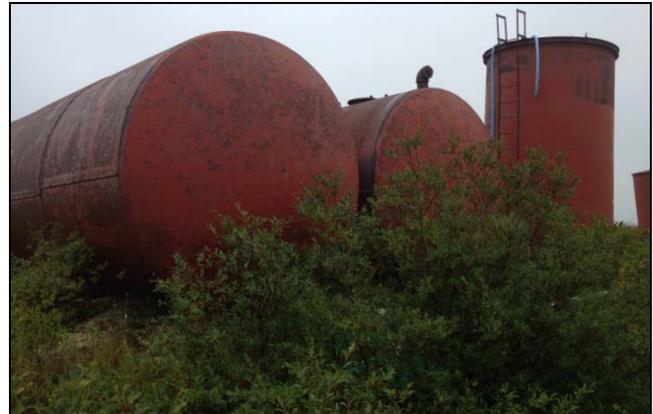
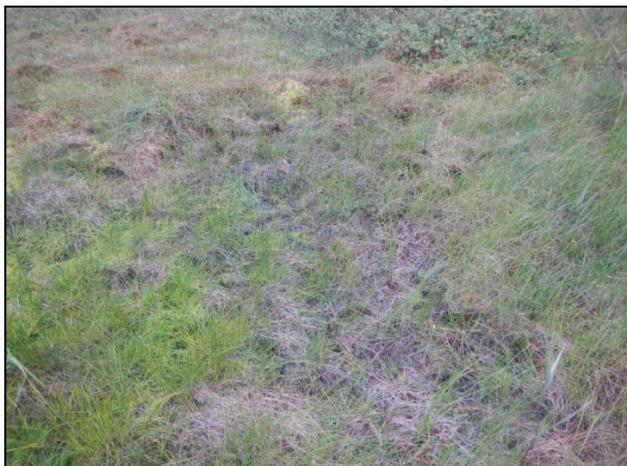
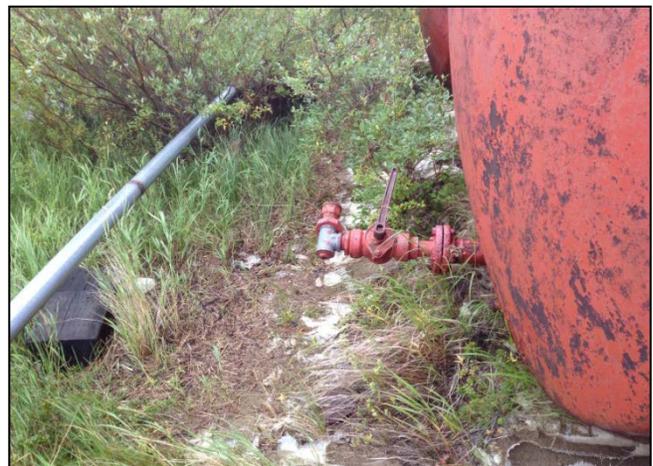
- **Marina Tank Site, 60.886780/-162.518715 (Abandoned)** – There are seven vertical and two horizontal fuel tanks at this site. The fuel from the tanks appears to have been removed; however, the tanks were not cleaned. The horizontal tanks are 45 feet from the bank and the vertical tanks are about 80 feet from the bank. The area is very marshy with a silty soil. The vertical tanks have rudimentary secondary containment. There was some disturbed soil from spills over the years observed in various spots around the tanks. The bank is eroding from the Johnson River at a rate of less than foot a year per local knowledge. The area is also susceptible to flooding.

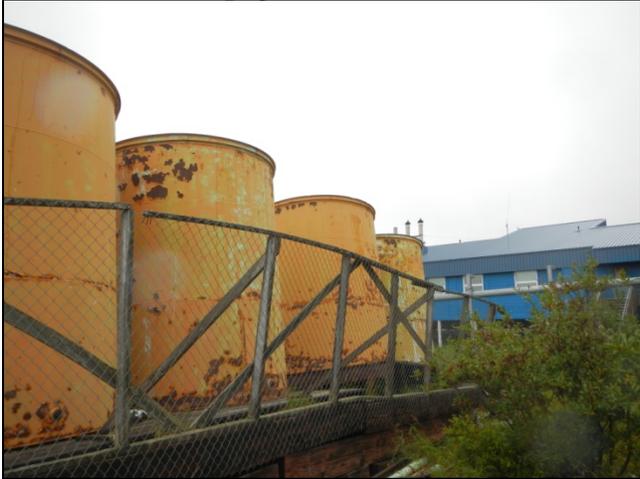
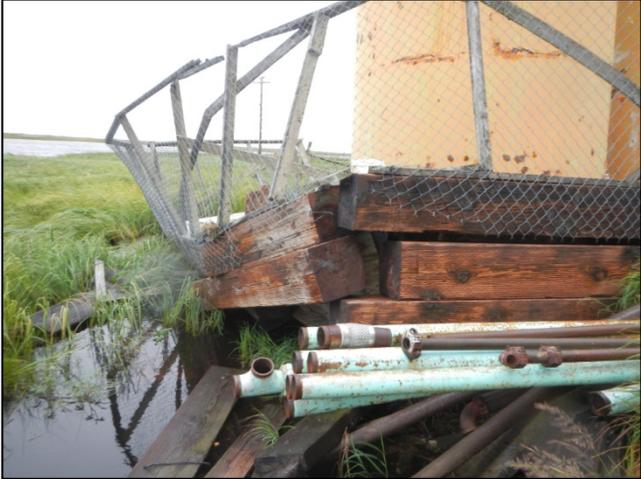
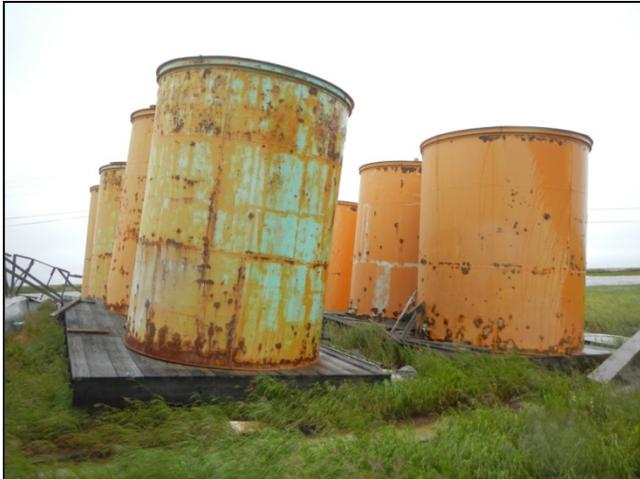
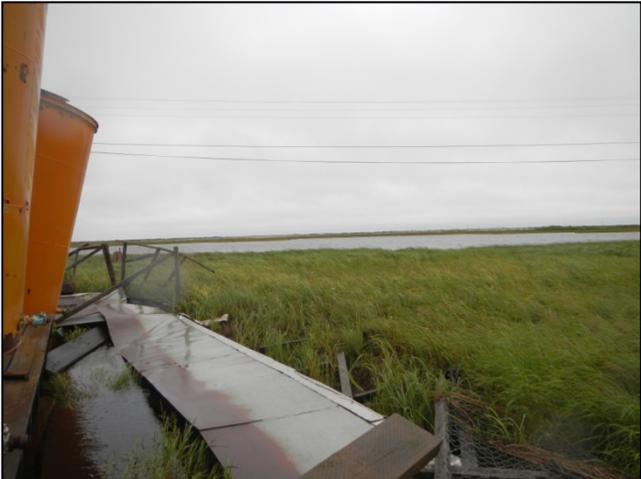
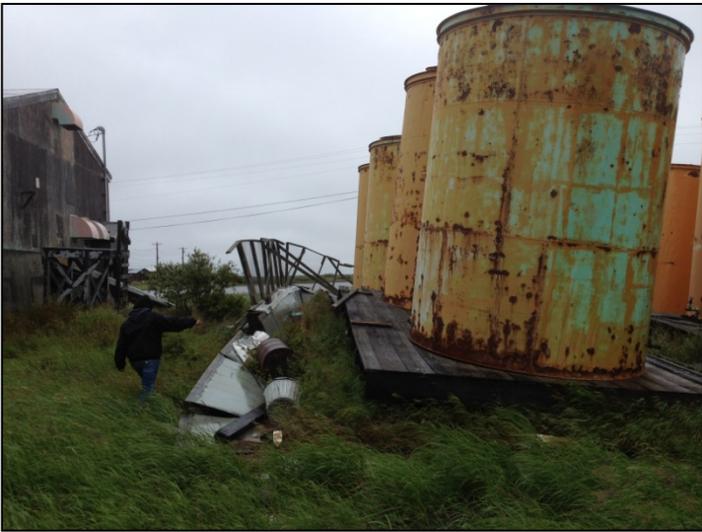
➤ **Old BIA School Tank Farm, 60.894815/-162.519193 (Active)** – This is an active Brownfield Site under the Contaminated Sites Program (File ID 2420.57.001; 2420.38.003). It is adjacent to the Akiuk Memorial School, situated on Alaska State-owned land. At the time of inspection, there were seven vertical fuel tanks which have since been removed on January 1, 2013. There was stressed vegetation and contaminated soil noted within and around the containment area due to petroleum spills. The tanks were shipped to Bethel for disposal, and the platforms and piping are scheduled to be removed later in 2013. Further work is planned for the site to determine the extent of petroleum contamination remaining. The site is situated less than 100 feet from a large pond.

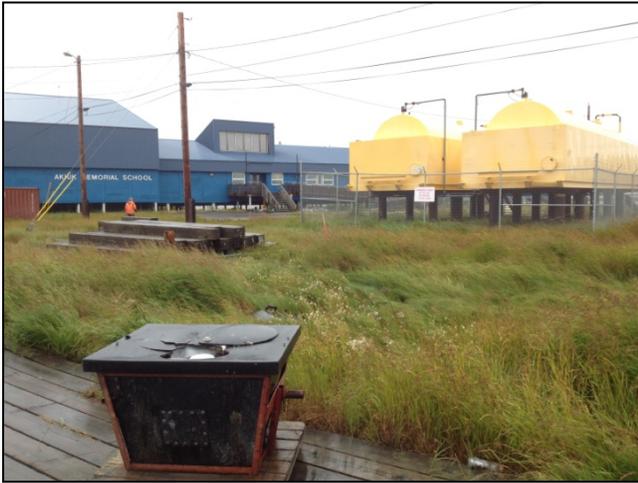
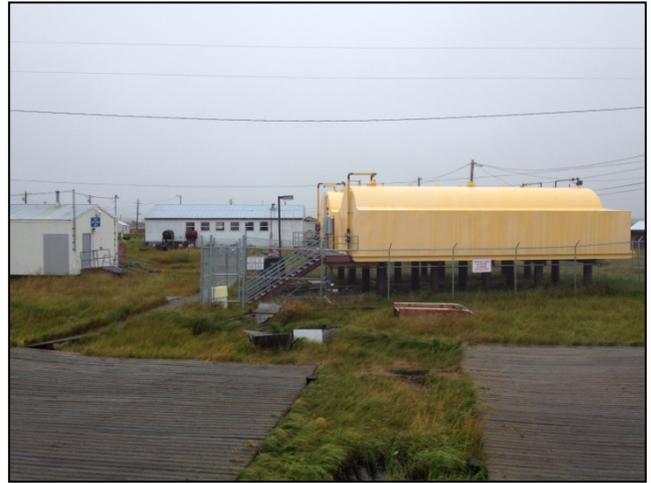
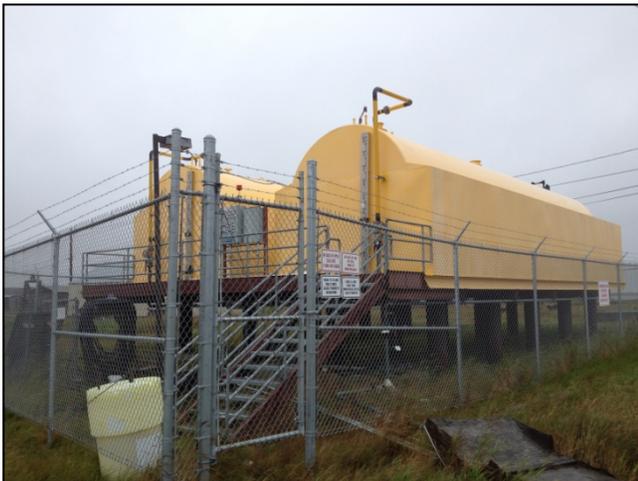
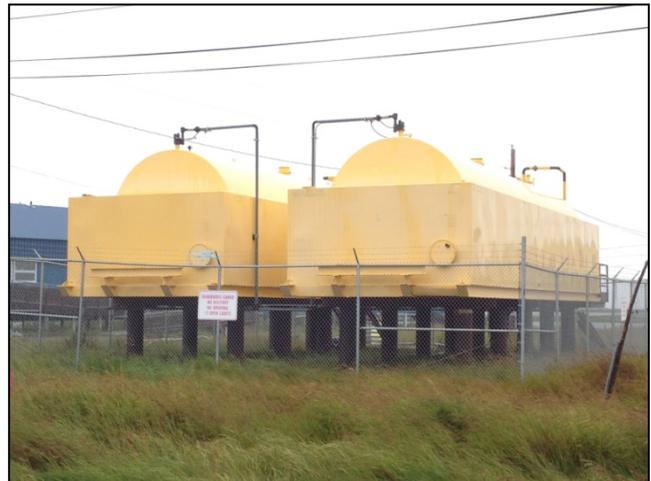
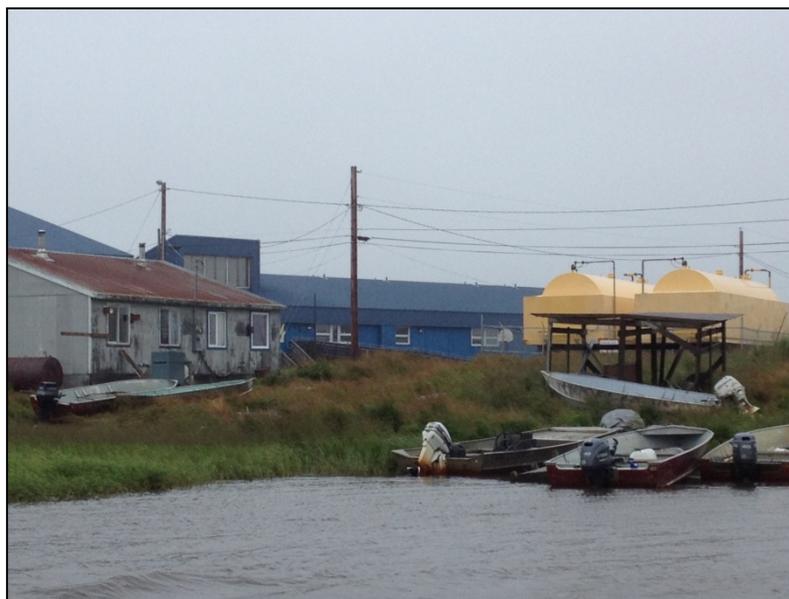
- **School Tanks, 60.894400/-162.520121 (Active)** – This site holds two horizontal 15,000 gallon fuel tanks used by the Akiuk Memorial School. The tanks are elevated four feet on wooden pilings and each tank has built-in secondary containment. There was no evidence of spills. The tanks are approximately 160 feet from the banks of the Johnson River and a popular boat landing. The river bank in this area had a lot of grasses along the bank helping to protect the shore from erosion.
