Alaska Department of Environmental Conservation (ADEC) Solid Waste Program (Stephen Price and David Carlson) conducted a Coastal Impact Assistance Program (CIAP), Waste Erosion Assessment and Review (WEAR) site visit for Nunam Iqua on July 9th, 2014. The following narrative is a brief description of our findings during the July inspection.

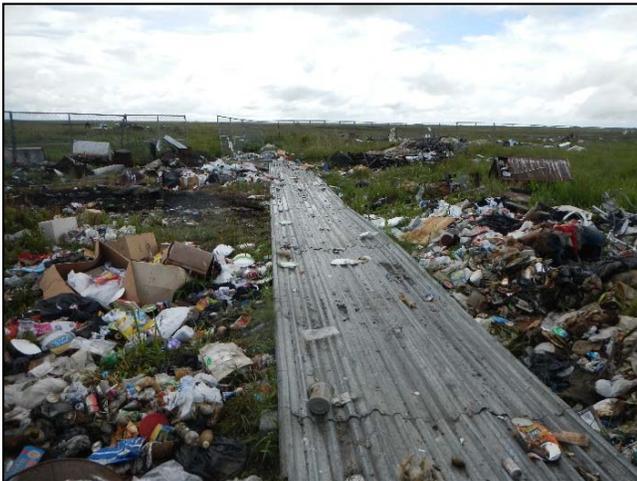
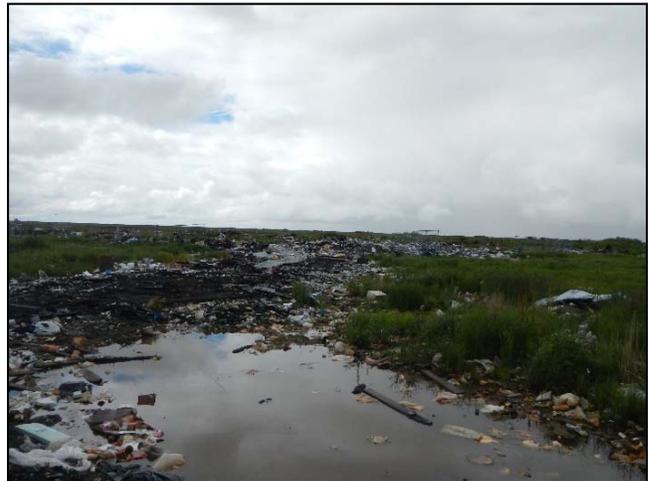
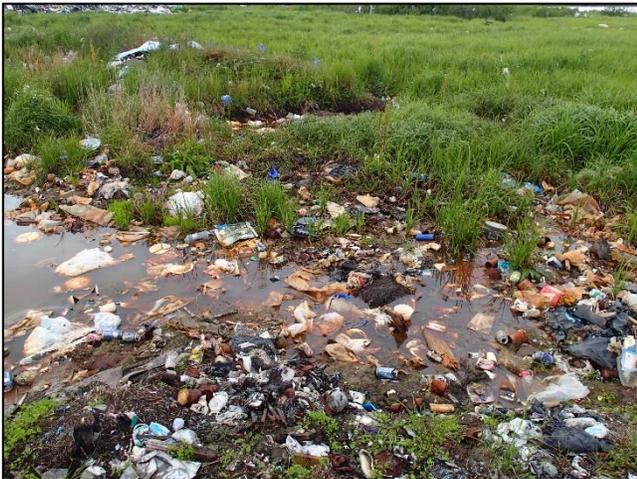
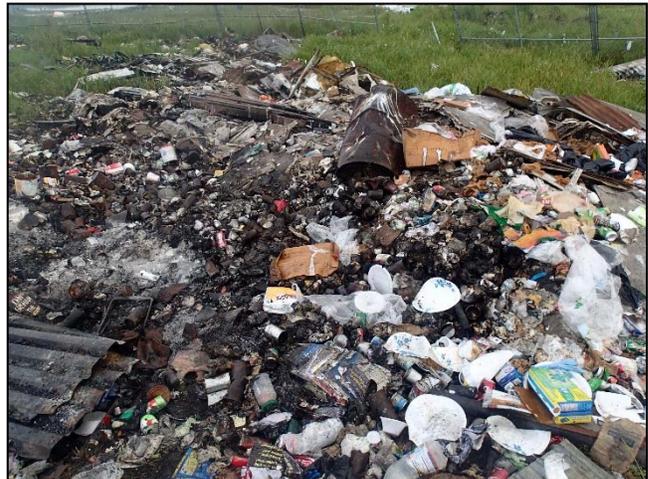
- **Landfill, 62.519308/-164.858959 (Active)** – This unpermitted landfill is located more than half a mile south of the community, accessed from a boardwalk. It is operated by the City of Nunam Iqua and accepts municipal waste. The landfill does not accept honeybucket waste. There are separate areas for metals, white goods and construction and demolition debris located outside the landfill and a lead-acid battery collection station located in the village. The site is partially fenced with a makeshift, metal roofing road that runs through the middle of the landfill connecting the front and rear entrances. Open burning is conducted which has led to the boardwalk being repeatedly burned. Waste is spread throughout the site. There is evidence of leachate from standing water in the landfill. The City does not have heavy equipment to manage the site. The landfill is near sea level, between multiple tundra ponds and experiences annual flooding. There currently is not a permanent landfill operator, but a local crew is hired for litter pickup from unauthorized dumping and flooding.

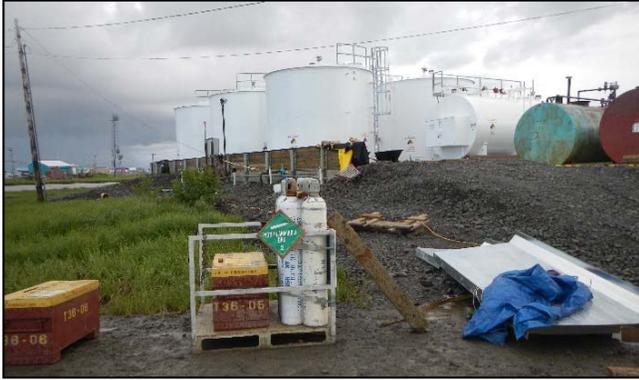
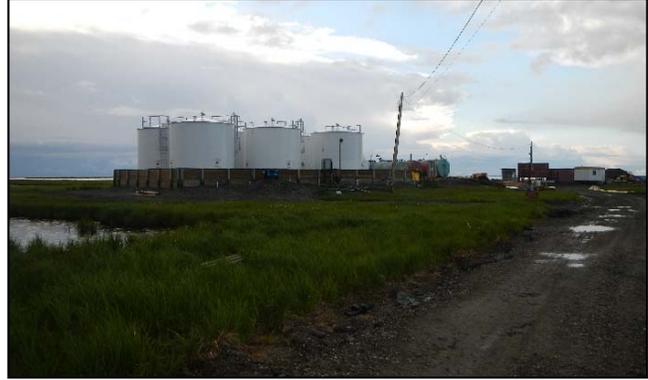
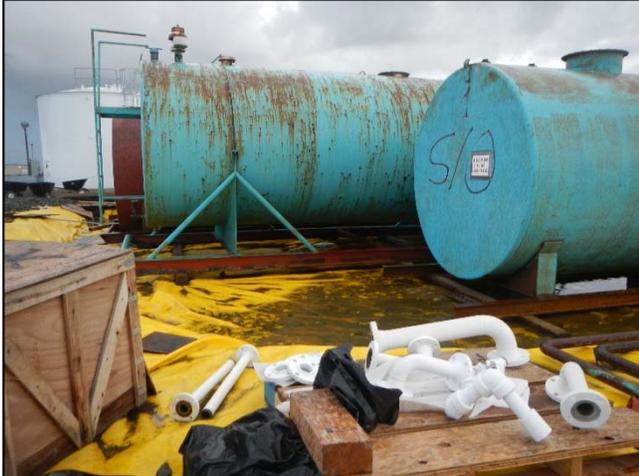
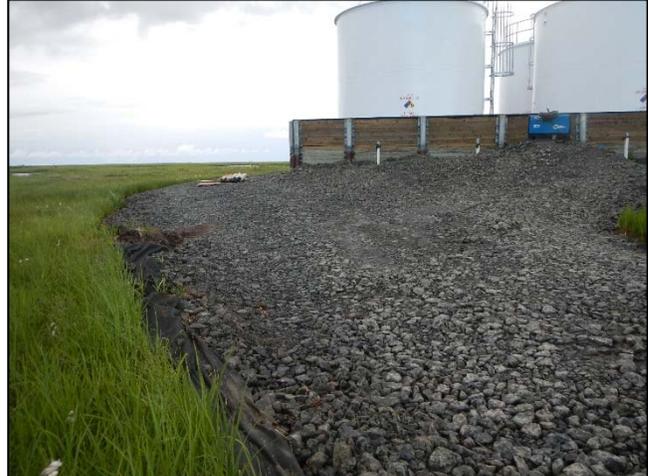
- **City Tank Farm, 62.532582/-164.850867 (Active)** – This site is located at the north end of town between the barge landing and Swan Lake. The tank farm has been in this location since 1997, but it was being upgraded in 2013-2014 through a Denali Commission project. It is owned and operated by the City of Nunam Iqua. This site contains six 40,000 gallon tanks and one 10,000 gallon tank. They are within secondary containment of metal lined wooden walls on three sides of the tank farm. The fourth wall appeared to still be under construction during the 2014 site visit. Four horizontal fuel tanks remain on site, but it was unknown if they were still in use. Residents reported that the shoreline north of Swan Lake has been eroding at about five feet per year. It is located 450 feet from Kwemeluk Pass, the nearest source of erosion.

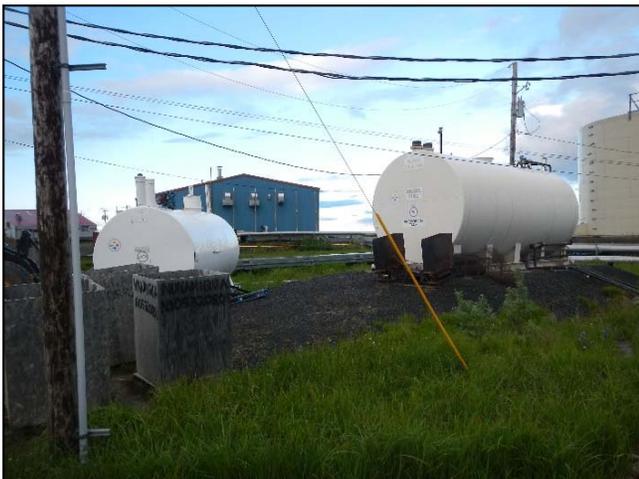
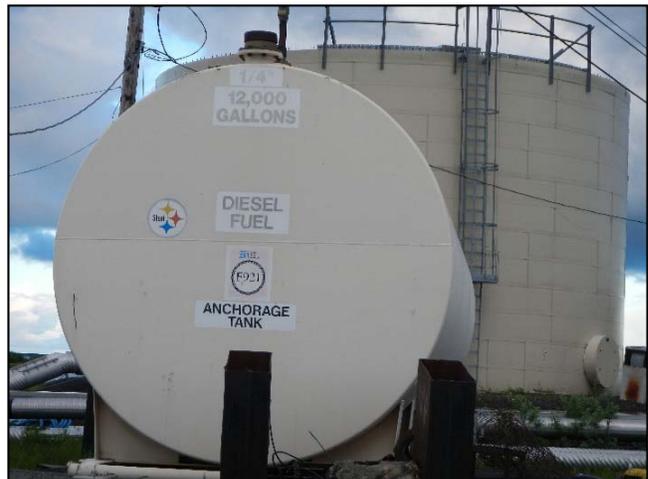
- **Power Plant Tanks, 62.530840/-164.850159 (Active)** – This site contains two diesel fuel tanks: 12,000 and 5,000 gallons each. The tanks are double-walled. The tanks are next to the power plant and they are about 250 feet from the north shore of Swan Lake. They are built on an earthen pad several feet above the surrounding area. They were constructed in 2002 through a Denali Commission project. The tanks are located 1,000 feet from the nearest source of erosion, Kwemeluk Pass, which is reported to eroding at five feet per year.

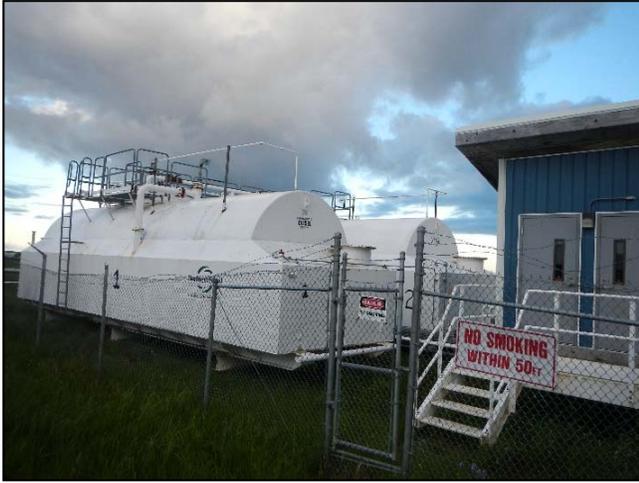
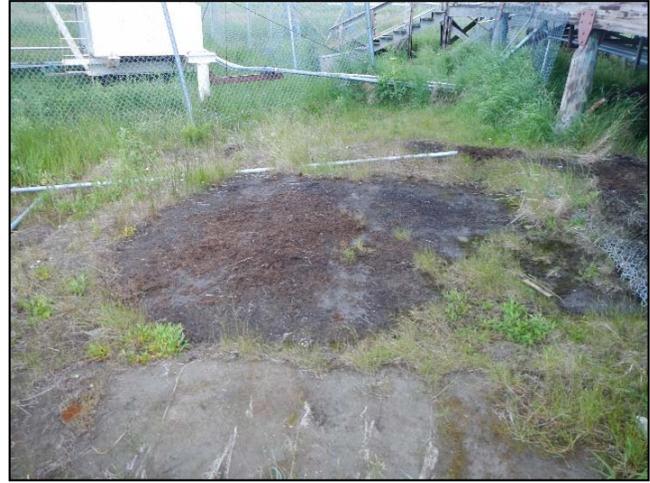
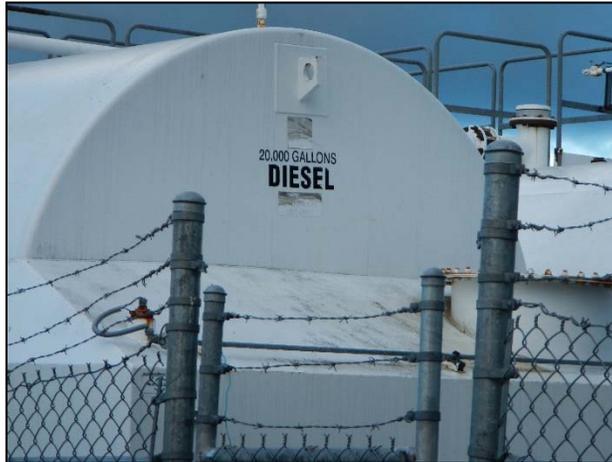
- **Fuel Storage Tanks, 62.531498/-164.847354 (Active)** – This site contains two fully fenced, double-walled, 20,000 gallon tanks. These tanks are owned by the Lower Yukon School District. Tanks have been in this location since the 1990's, but the current tanks were put in place in the early 2000's. Some stained soil was noticed from where a tank was previously removed. The tanks are 600 feet from the Kwemeluk Pass which is the nearest source of erosion.

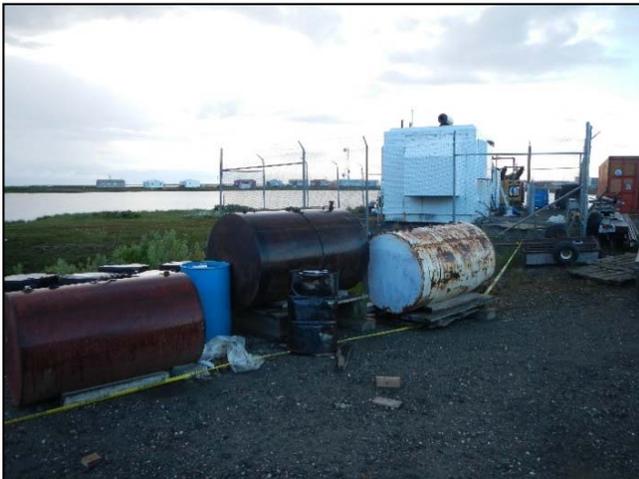
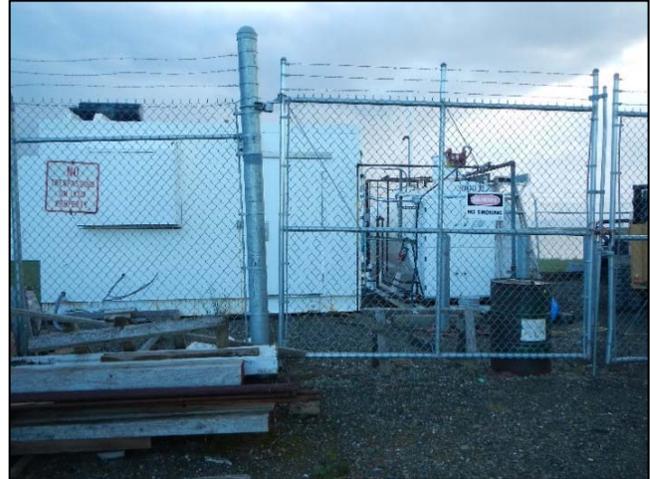
- **School Day Tank, 62.526738/-164.851093 (Active)** – This site is on the southern side of Swan Lake. It is owned and operated by the Lower Yukon School District. The school power plant and day tank were built in 2008. The power plant and day tank are within a locked, fenced area. The day tank is 3,000 gallon, double-walled, diesel tank. There are a few other empty tanks of the same size nearby, but they are outside the fence. It is 2,400 feet from the Kwemeluk Pass, which is the nearest source of erosion.
