Alaska Department of Environmental Conservation (ADEC) Solid Waste Program (Trisha Bower and Kym Bronson) conducted a Coastal Impact Assistance Program (CIAP), Waste Erosion Assessment and Review (WEAR) site visit for the Village of Kaktovik, August 28th, 2014. Tom Nicolos, the North Slope Borough Airports and Landfills Manager, helped coordinate our visit. The following narrative is a brief description of our findings during the August inspection.

WEAR Sites

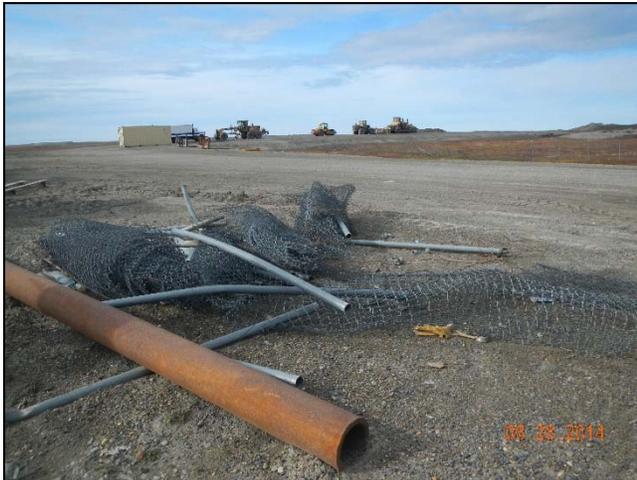
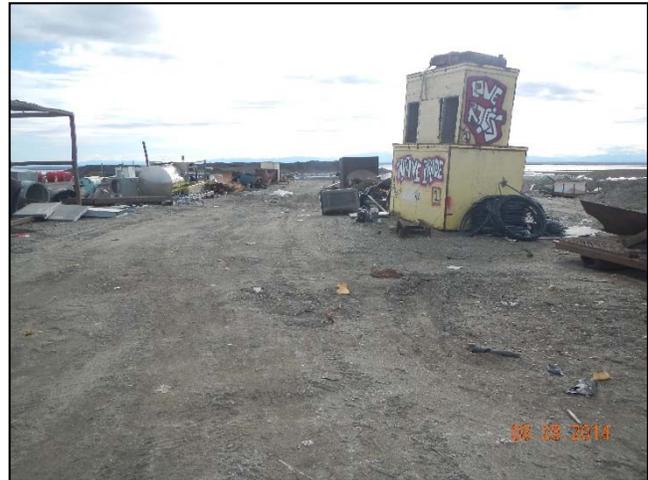
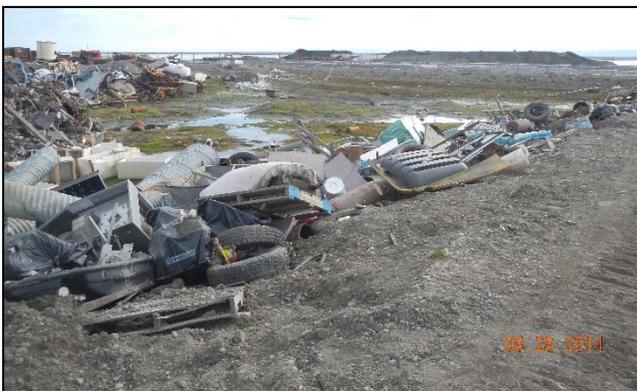
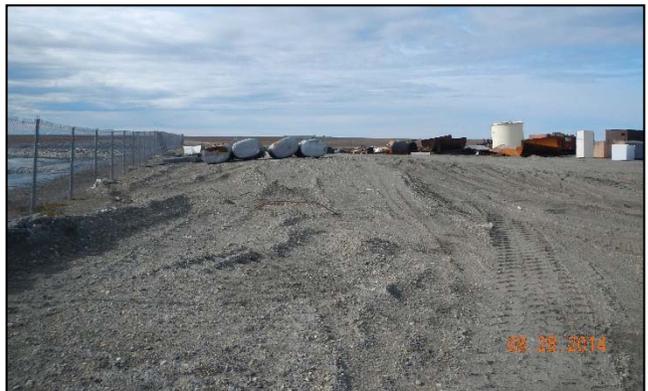
- **Landfill, 70.111198/-143.634774 (Active)** — This 8 acre site includes a permitted landfill and two sewage lagoons. Both are operated by the North Slope Borough (NSB) Public Works Department and are in the process of being decommissioned and incorporated into the new airstrip apron. The landfill was contracted to be closed by 2014, but it is unlikely that the contractor is going to meet this deadline due to delays with completing the new landfill. The landfill accepts municipal waste and construction and demolition debris. The NSB allows only waste from Kaktovik residents to be placed in the landfill. Waste from special projects may be allowed if the project submits an application to the NSB, and it is approved by NSB and ADEC. ADEC approval is also required in the NSB application process for polluted soil and other special wastes. The landfill has been in operation since the 1980s. This facility is located approximately 1,150 feet from the Kaktovik Lagoon and approximately 8,000 feet from the Beaufort Sea.

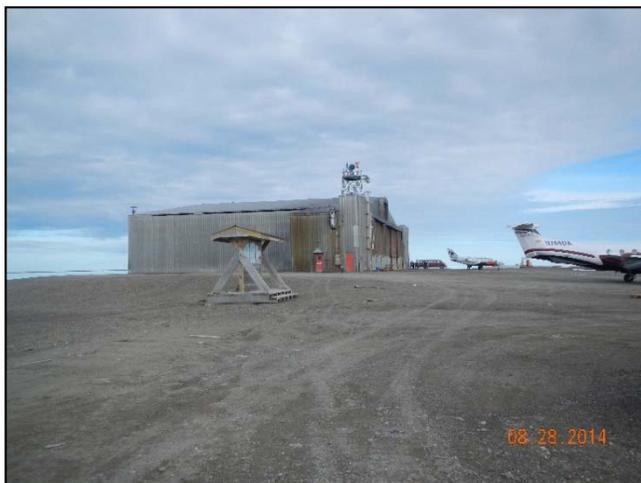
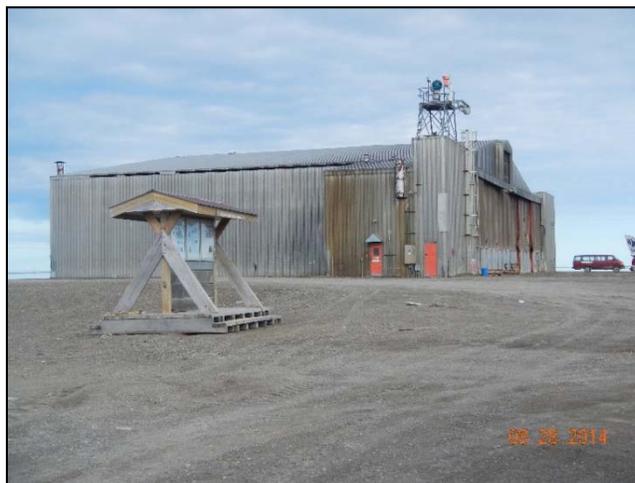
- **Barter Island LRRS Hanger, 70.135543/-143.589814 (Active)** – This is a half-acre, active known Contaminated Site (File ID 350.38.008) due to petroleum and PCB contamination. The hanger building is owned by the US Air Force and is currently being used for dry storage of assorted equipment, vehicles, and supplies. It is located on the north side of the current runway, which is northeast of the community. Various cleanup activities have occurred over the years: 3 cubic yards of PCB contaminated soil were removed in 2006; the floor in the West Mechanical Room was remediated for PCBs, and some concrete flooring was removed and shipped out of the community for disposal in 2008. This site is a compliance site for the Barter Island Long Range Radar Station (LRRS). This site is approximately 200 feet from the Beaufort Sea.

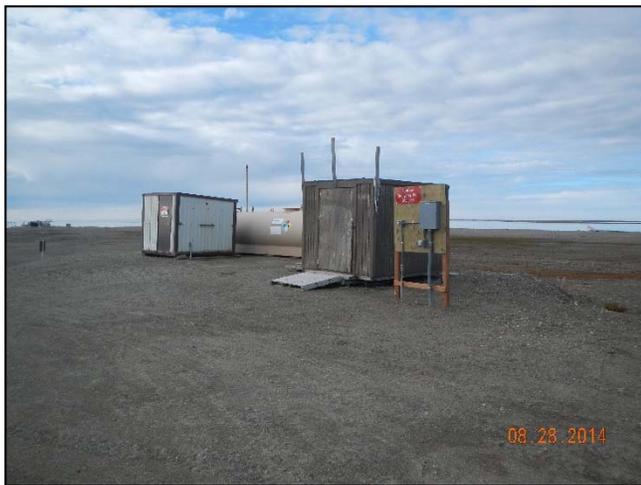
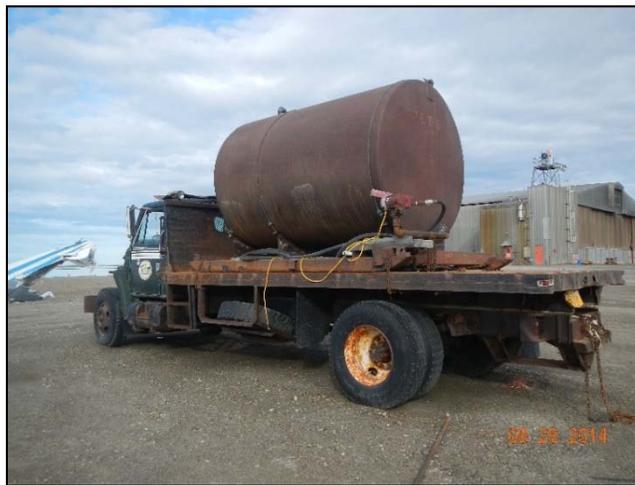
- **Barter Island LRRS Refueling Area, 70.135791/-143.591294 (Active)** – This is a known Contaminated Site (File ID 350.38.009) due to petroleum contamination. The site is owned and cleanup is being managed by the US Air Force. It previously contained numerous ASTs, drums, connexes, and sheds. The southside of the Refueling area is currently used as a third-party fuel storage area and an aircraft fueling and maintenance area. The area is under long-term monitoring. This site is approximately 225 feet from the Beaufort Sea.

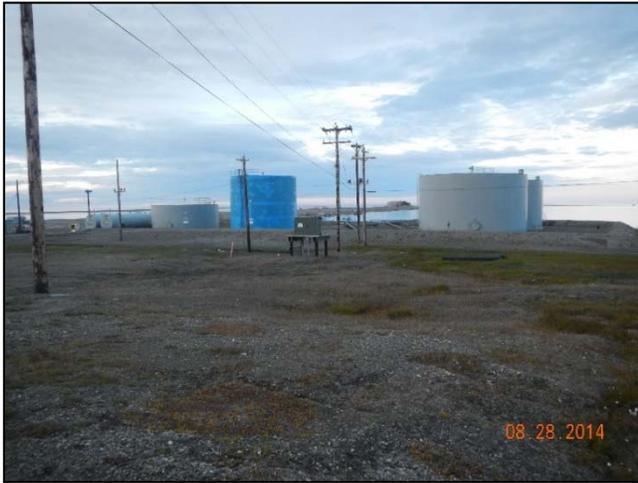
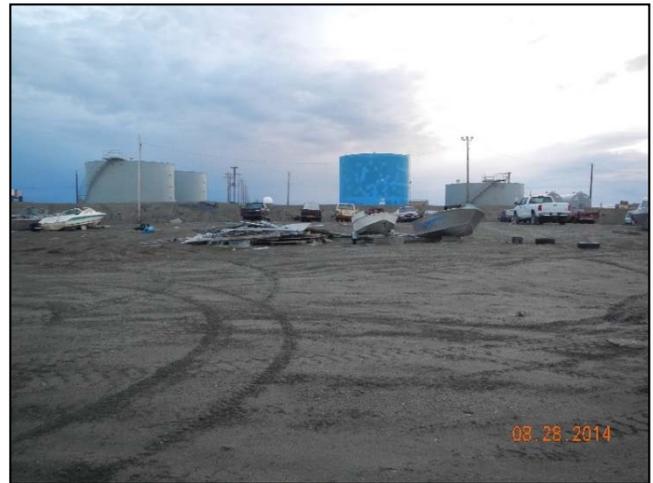
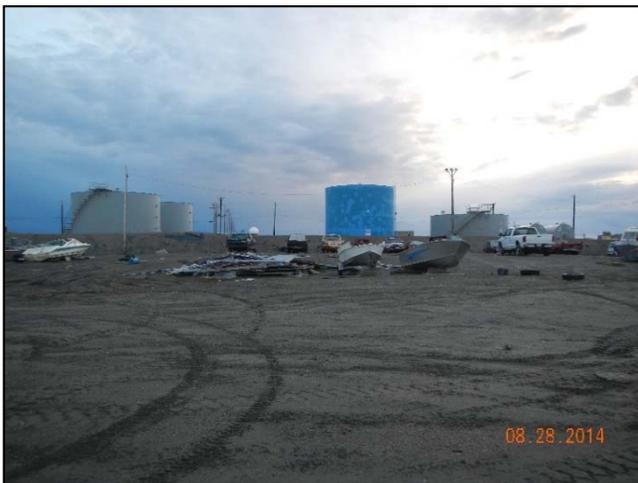
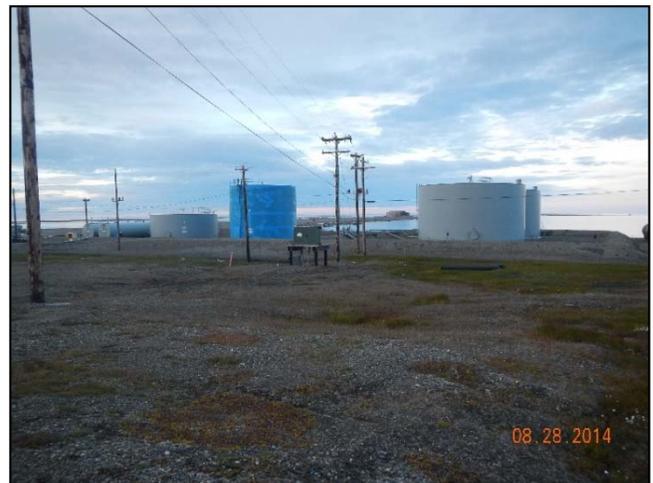
- **Community Tank Farm, 70.132158/-143.618185 (Active)** – The community tank farm is a 1.5 acre site that is regulated by the ADEC Terminals and Tank Farm Section. It is owned and operated by the North Slope Borough (NSB) and has a total capacity of 1,078,014 gallons of fuel. The site contains four vertical tanks and two horizontal tanks within fenced, secondary containment. It is also a Contaminated Site (File ID 350.38.005) due to petroleum contamination found in 1993. It contains of a fuel header and pipeline connected to the fuel tanks. Gravel covers most of the area around the facility with a small amount of tundra and surface water along the perimeter. The tank farm was upgraded in 1994. This site is approximately 725 feet from the Beaufort Sea and 260 feet from Kaktovik Lagoon.
