Alaska Department of Environmental Conservation (ADEC) Solid Waste Program (Doug Huntman and Rebecca Colvin) conducted a Coastal Impact Assistance Program (CIAP), Waste Erosion Assessment and Review (WEAR) site visit for the Village of Russian Mission on August 27^h, 2012. Agnes Housler, City Administrator, helped coordinate our visit. The following narrative is a brief description of our findings during the August inspection.

WEAR Sites

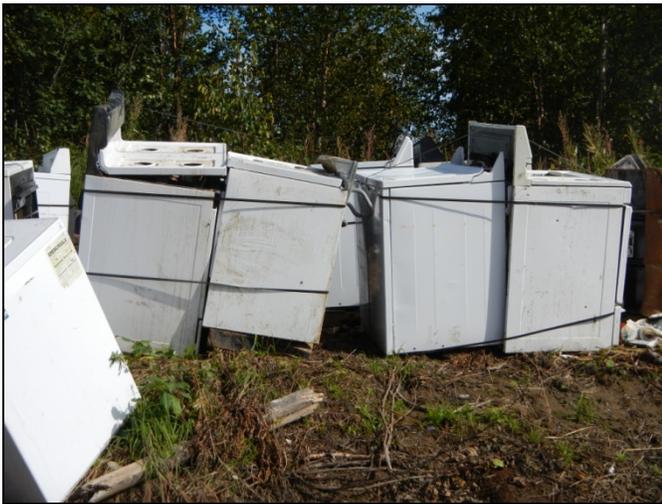
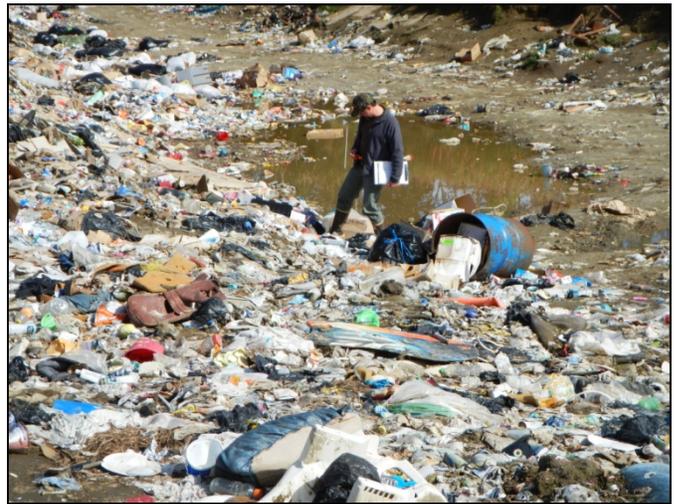
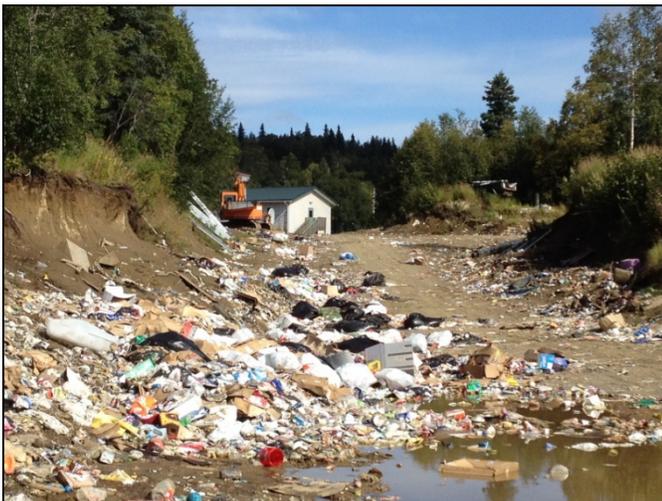
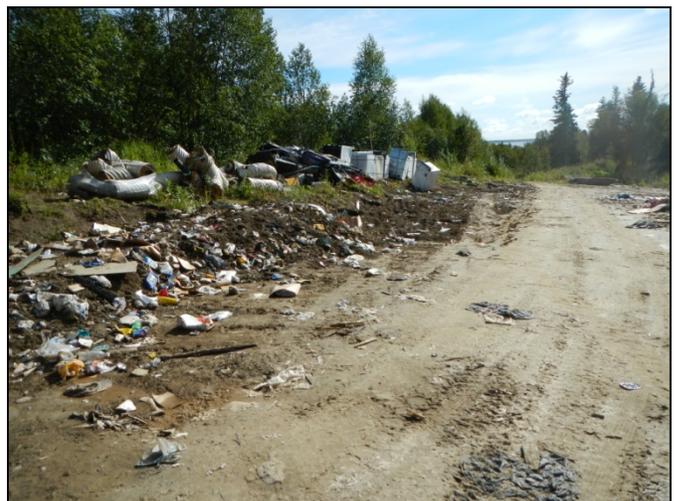
- **Landfill, 61.783578/-161.331248 (Active)** – This site is a self-haul landfill. The site is approximately 5 acres with waste spread out throughout the site. Site is split into two sections: household waste and a metals/backhaul area. It is located on land owned by the Russian Mission Native Corporation and the Greek Orthodox Church. The village does a good job separating household hazardous waste and prohibited waste from the site. This site is high on a hill outside the flood plain and is over 2,400 feet from the Yukon River.

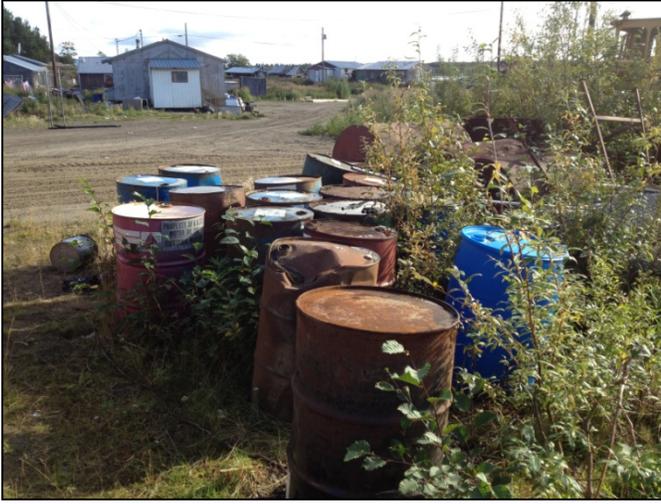
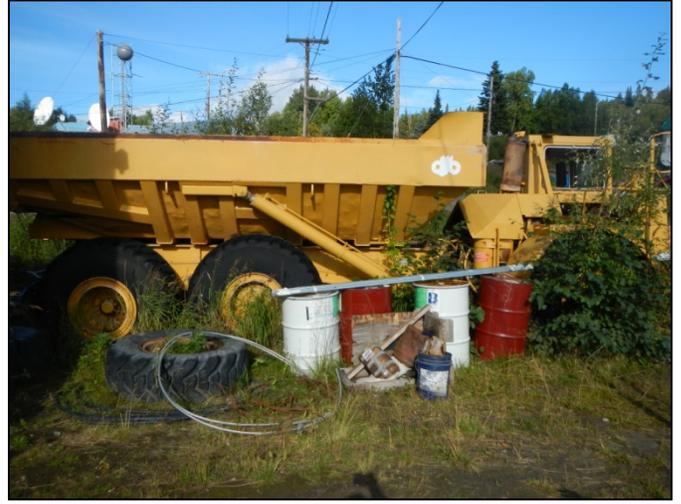
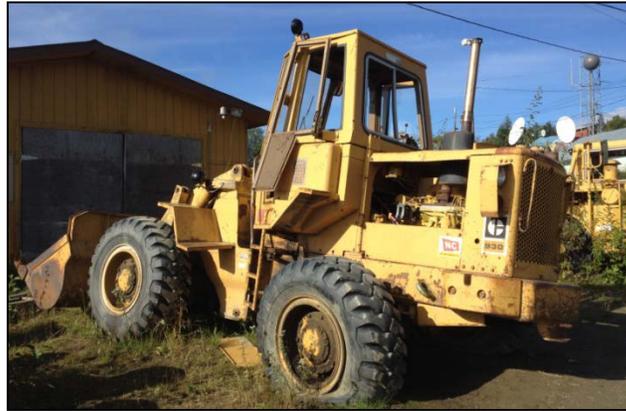
- **Boneyard, 61.784178/-161.321513 (Active)** – This site is located in front of the Hazardous Waste/Recycling collection center near the middle of town. Vehicles on the site consist of an old loader, a mining truck and an old dozer. Batteries and fluids were not removed from them. The site was formerly the City shop, so soil could potentially be contaminated with fuel and solvents. Site is located over 700 feet from the Yukon River.

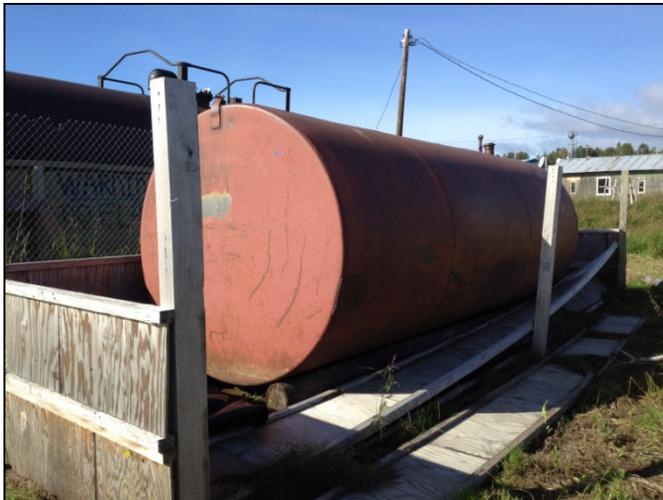
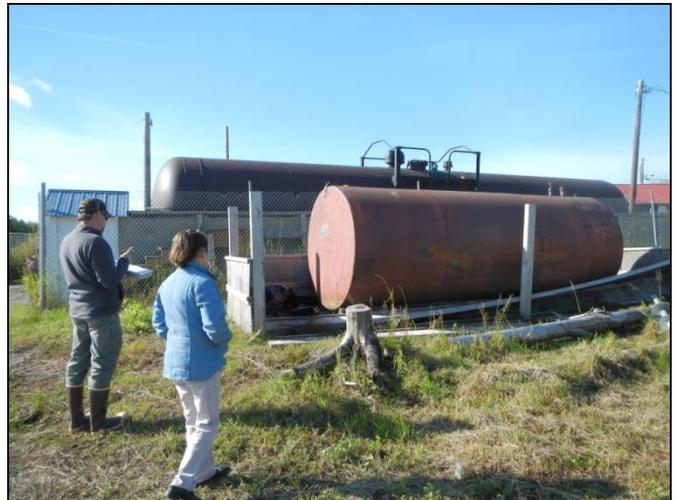
- **DOT 5,000 Tank, 61.784430/-161.318613 (Active)** – This site is in use by the Department of Transportation (DOT) and consists of a 5,000 gallon horizontal tank used for gasoline storage. The site has a secondary containment area that was in disrepair and it was unfenced. It is on silty soil approximately 150 feet from the Yukon River. Local residents reported the river bank to be eroding at approximately 2 feet per year.

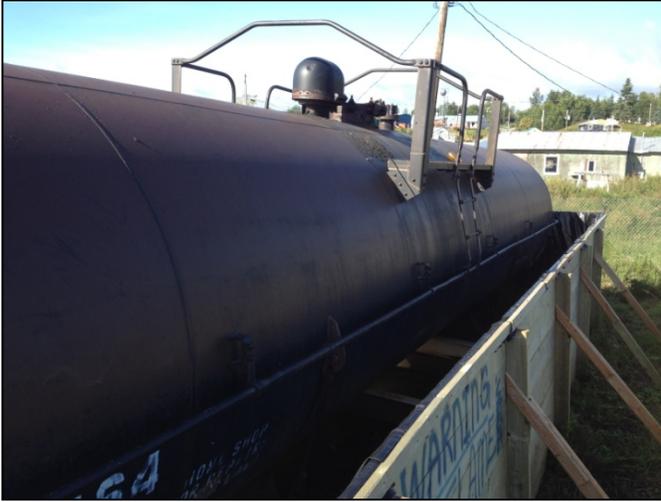
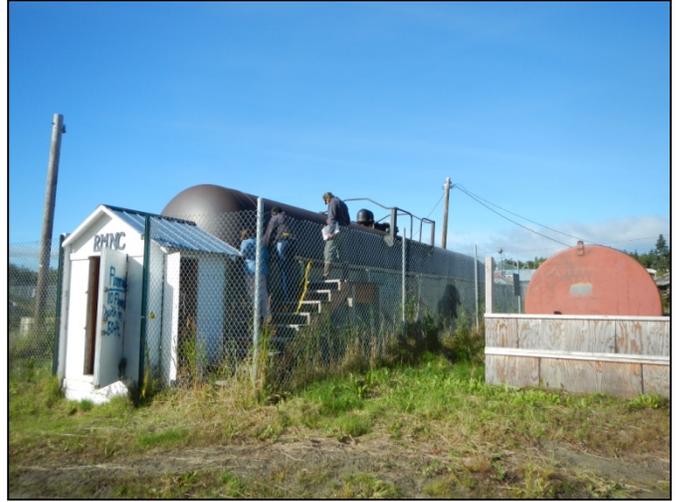
- **Native Corporation 20,000 Tank, 61.784446/-161.318555 (Active)** – This tank is an old railway tank car converted into a gasoline storage tank. It holds 20,000 gallons and is owned by the Russian Mission Native Corporation. The tank was in a locked, fenced area that had secondary containment. It is located adjacent to the DOT storage tank, approximately 150 feet from the Yukon River.

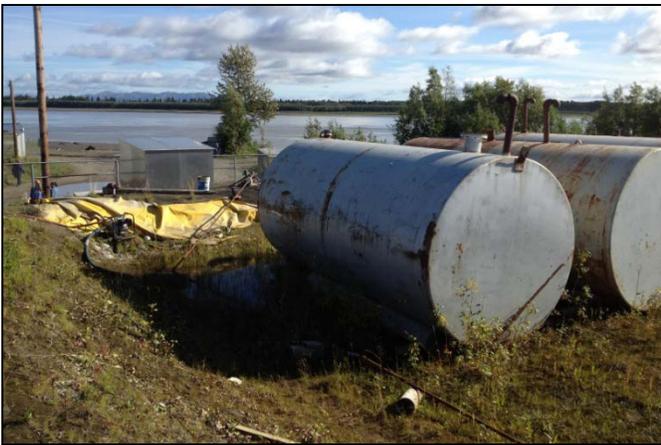
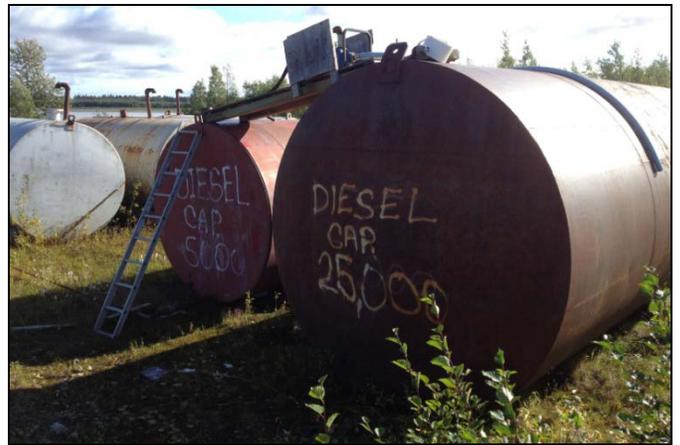
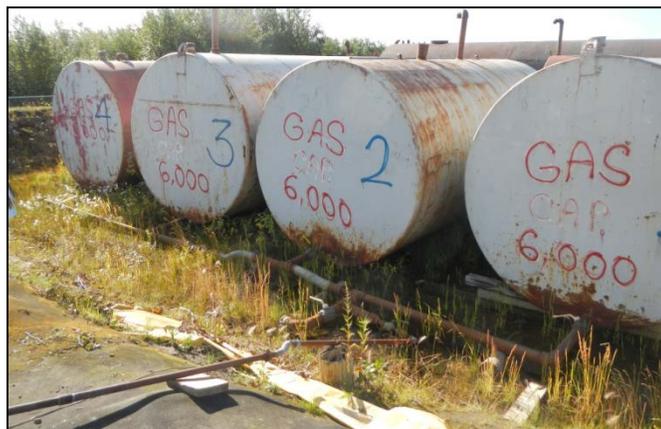
- **Native Corporation Tank Farm, 61.784048/-161.318847 (Active)** – This tank farm is owned by the Russian Mission Native Corporation. There were a total of six horizontal tanks: 25,000 gallon diesel tank, 5,000 gallon diesel tank, 10,000 gallon gasoline tank, and 3-6,000 gallon gasoline tanks. Some tanks are inactive. The tank farm was raised about 10 feet on an earthen berm with a liner system for secondary containment. Vegetation was growing on the secondary containment and appeared distressed. It is located approximately 250 feet from the Yukon River.

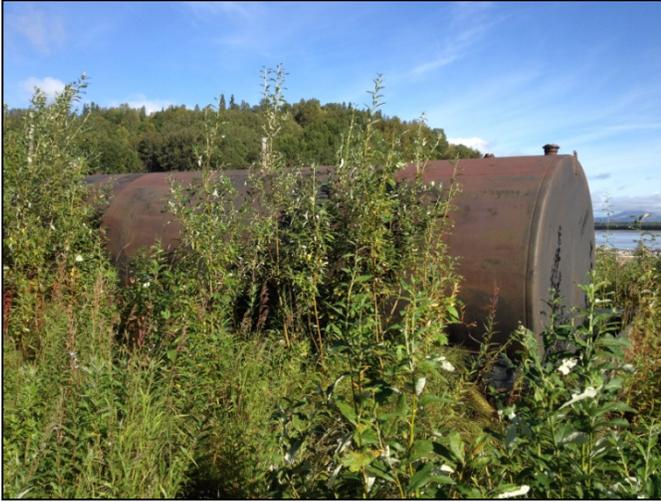
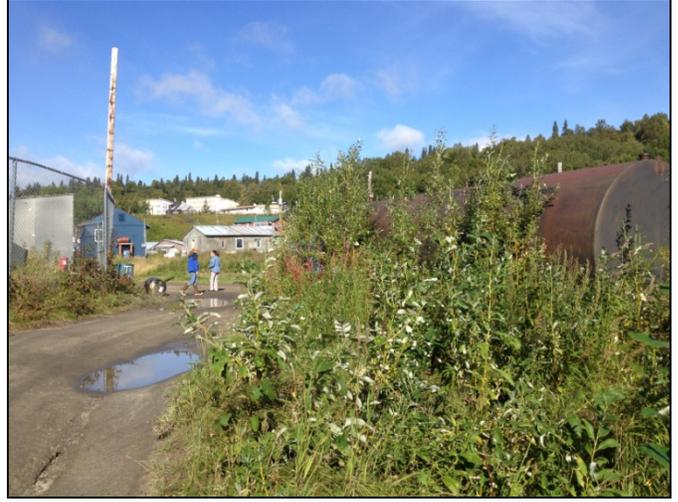
- **Native Store 10,000 Tank, 61.784229/-161.318517 (Abandoned)** – This 10,000 gallon horizontal tank is no longer in use. A 1998 Denali Commission report listed it as owned by ANICA. Tank was used for gasoline storage. The unfenced site was overgrown with alders, making assessment of the soil difficult. It is approximately 15 feet from the Native Corporation tank farm fence. It is about 100 feet from Yukon River and prone to flooding.

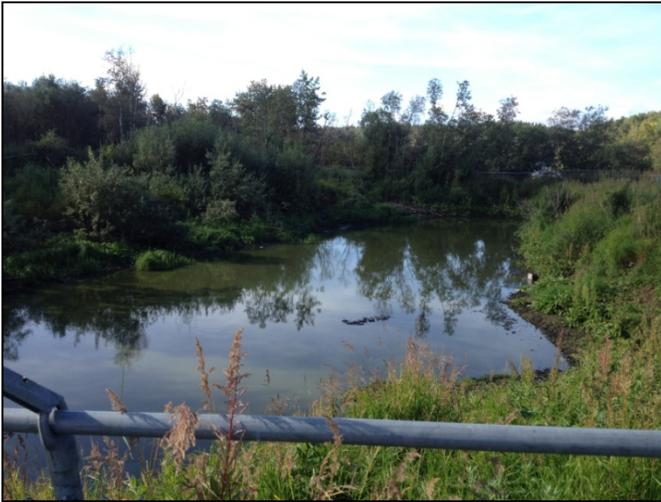
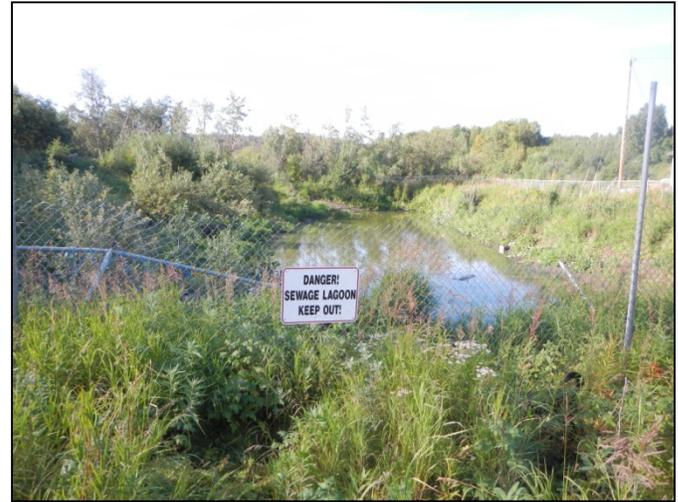
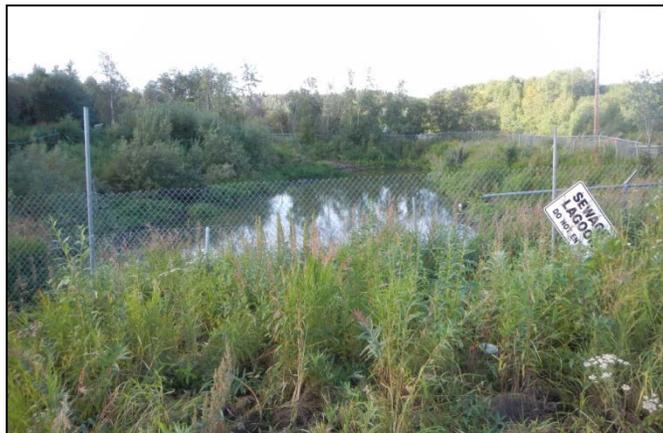
- **Sewage Lagoon, 61.783963/-161.320934 (Inactive)** – This site has been inactive since the early 1990's. It has not been de-watered or covered as required by the Solid Waste Program to close a sewage lagoon. The fence is down in some places as are the signs. It is next to the main road in town near the airport and houses. It is located a little over 600 feet to eroding bank of the Yukon River.

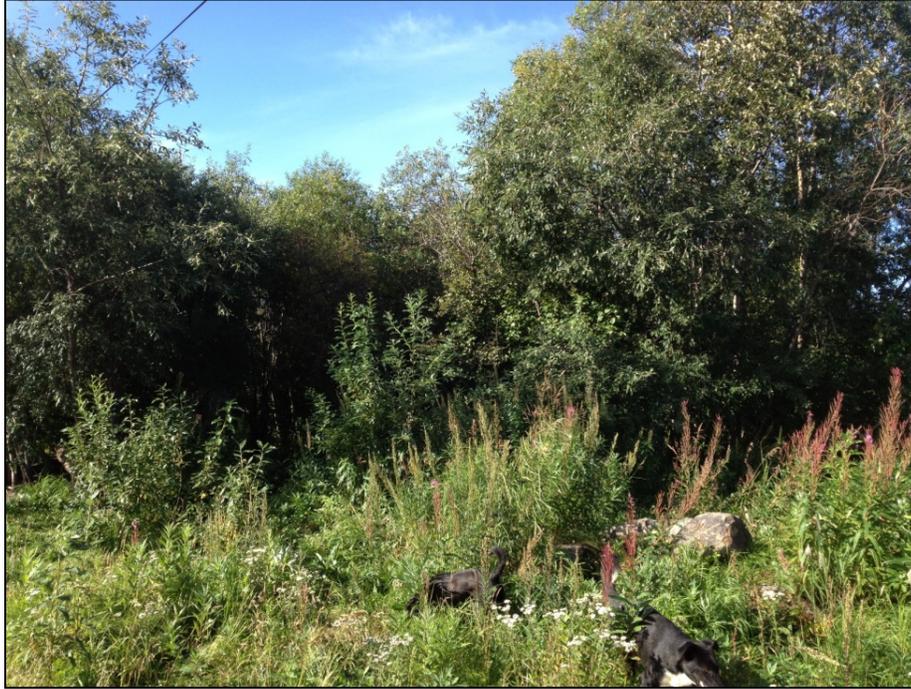
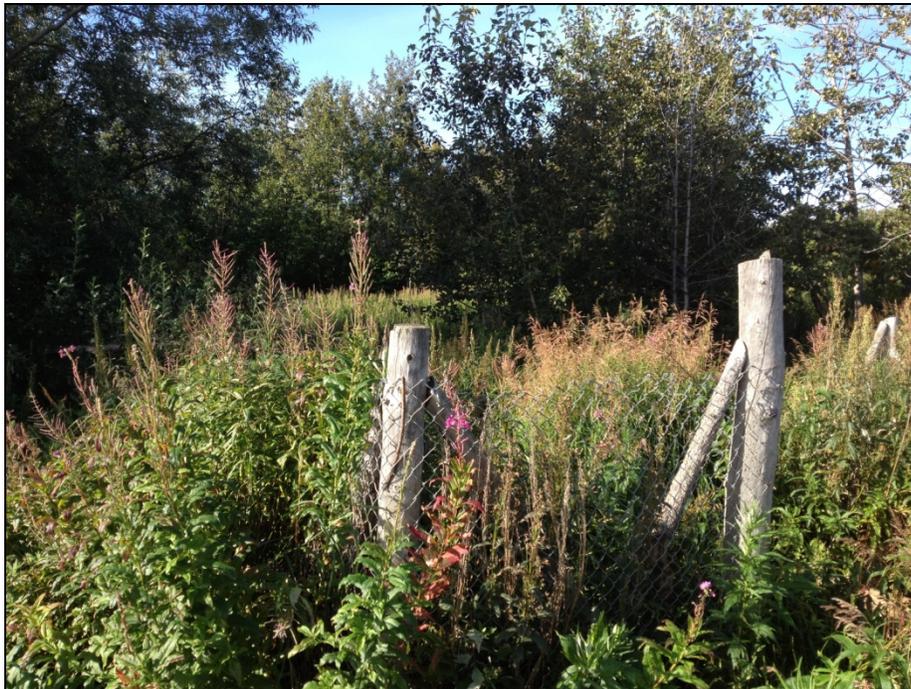
- **1970s Landfill, 61.783187/-161.320309 (Retired)** – This former landfill was in use until the 1970's. It is in a flood plain near houses and the airport apron. The site is covered and re-vegetated with large trees and no sign of waste. Part of the old landfill is now a dog lot. It is approximately 560 feet from the Yukon River.
