Alaska Department of Environmental Conservation (ADEC) Solid Waste Program and Contaminated Sites Program (Doug Huntman and Grant Lidren conducted a Coastal Impact Assessment Program (CIAP), Waste Erosion Assessment and Review (WEAR) site visit for the Village of Saint Mary's and Pitkas Point on September 21<sup>st</sup>, 2012. The following narrative is a brief description of our findings during the September inspection.

**WEAR Sites**

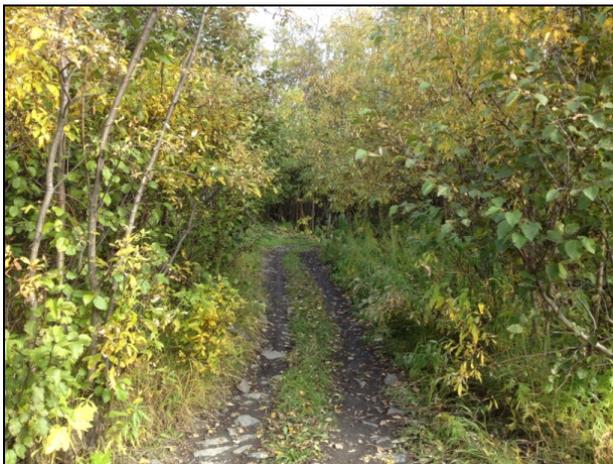
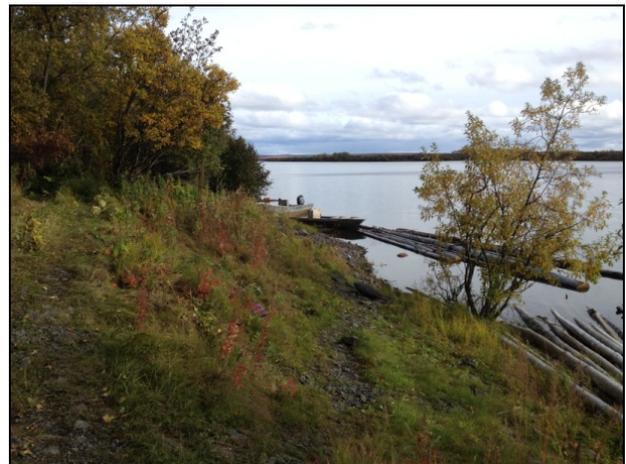
- **1970s Landfill, 62.051480/-163.171045 (Retired)** – This historic landfill site was reported to be along the Andreafsky River in Saint Mary's. It was listed as a solid waste disposal site per the Division of Community and Regional Affairs community maps. The site was overgrown with birch trees that were estimated to be 20 years old. We could find no sign of the landfill through the trees. There was observed litter on the beach, but it did not appear to be from the retired landfill. The site is susceptible to erosion and flooding.

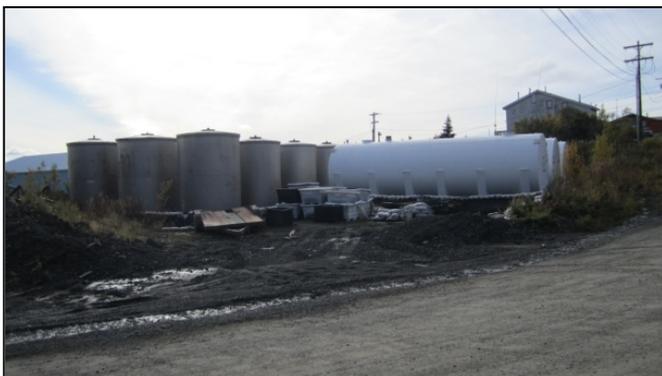
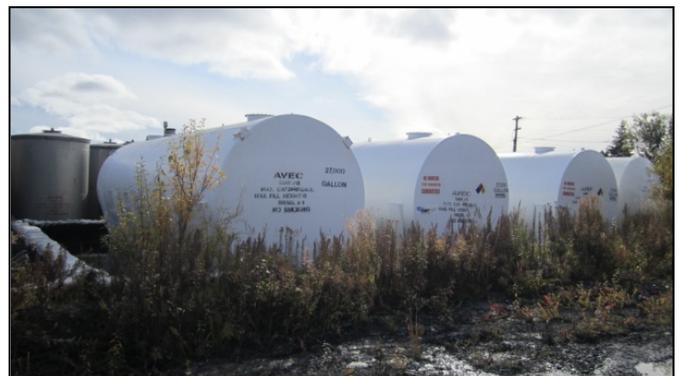
- **AVEC Tank Farm, 62.052106/-163.172408 (Active)** – This unfenced, tank farm contained 12 vertical and 4 horizontal fuel tanks owned and operated by AVEC in Saint Mary's. Secondary containment consisted of gravel filled bags forming berms within the site. It appeared work was being done to reinforce the berm during the visit. The site is located approximately 200 feet from the small boat harbor on the Andreafsky River, which is susceptible to flooding.

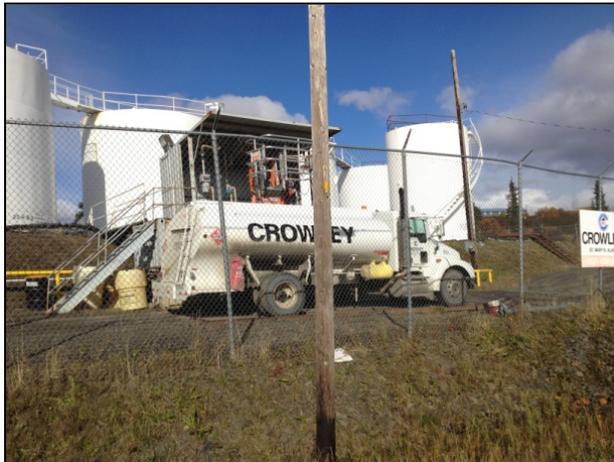
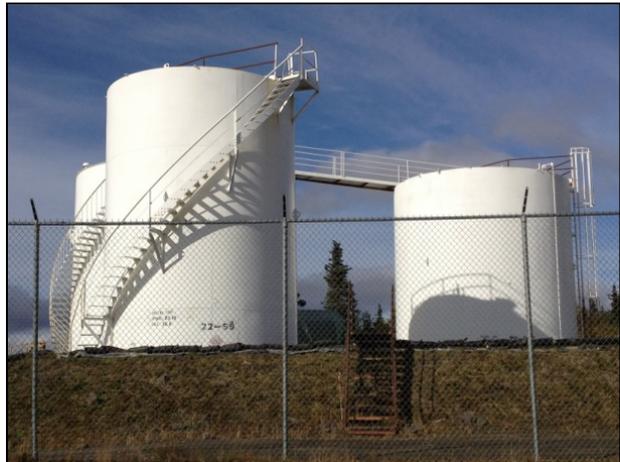
- **Crowley Tank Farm, 62.048463/-163.188463 (Active)** – This fully fenced tank farm is managed by Crowley and is located in Saint Mary’s. It consists of 5 vertical fuel tanks and multiple horizontal tanks. The site was well maintained and had secondary containment. The fence was in good condition and had a locking gate. It is located 520 feet from the Andrefsky River.

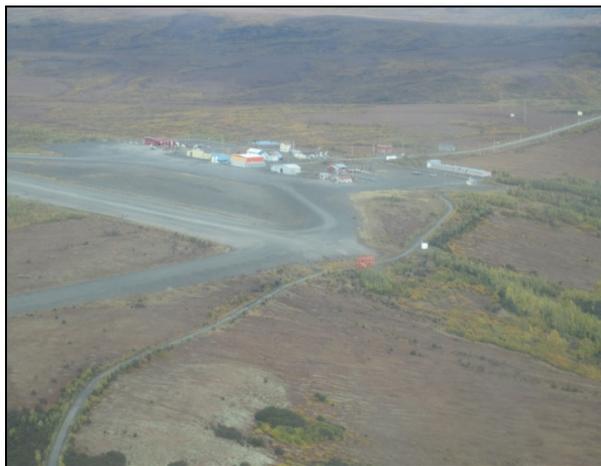
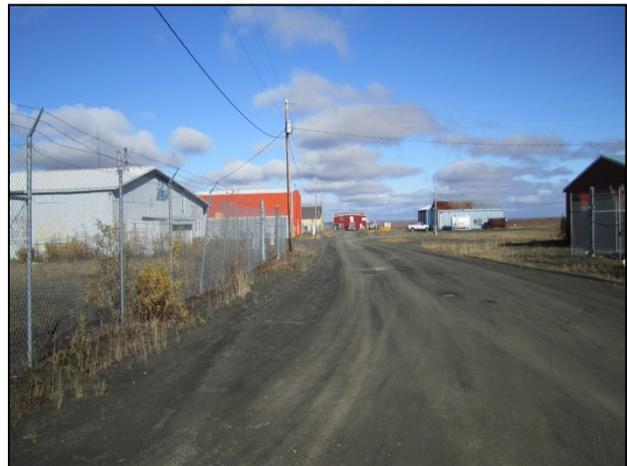
- **MarkAir – Saint Mary’s Airport, 62.057417/-163.295695 (Active)** – This is an active petroleum Contaminated Site (File ID 2444.38.004) at the Saint Mary’s airport. Potential spill sources include on-site fuel supply systems, heating oil, and aviation gasoline. In 1996, soil samples collected contained benzene and diesel range organics (DRO) above ADEC migration to groundwater cleanup levels. Additionally, soil samples collected at a 1,000 gallon above ground storage tank located at the ADOT Airport Lease lot building contained DRO above ADEC maximum allowable concentrations. A water sample collected from an onsite drinking water well did not contain detectable concentrations of contaminants. As of this site visit in 2012, all the former tanks and dispensers had been removed. DWW housing at the former MarkAir Terminal Facility was Located. No obvious signs of contamination were evident.

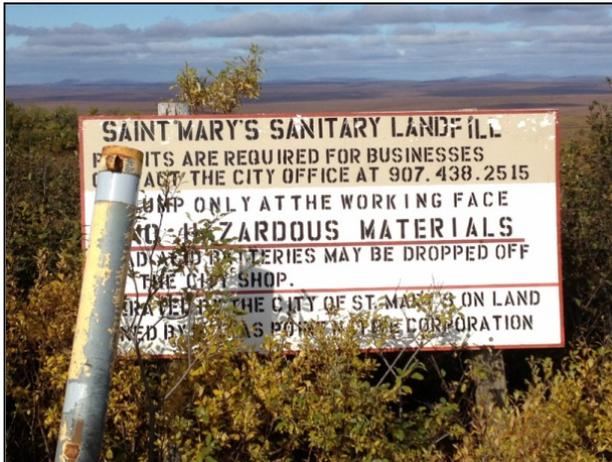
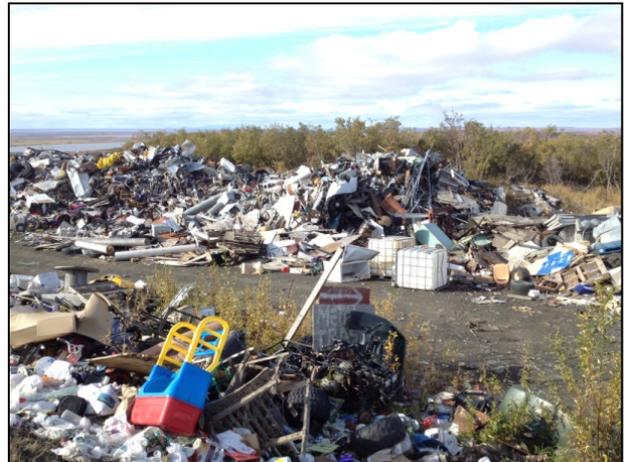
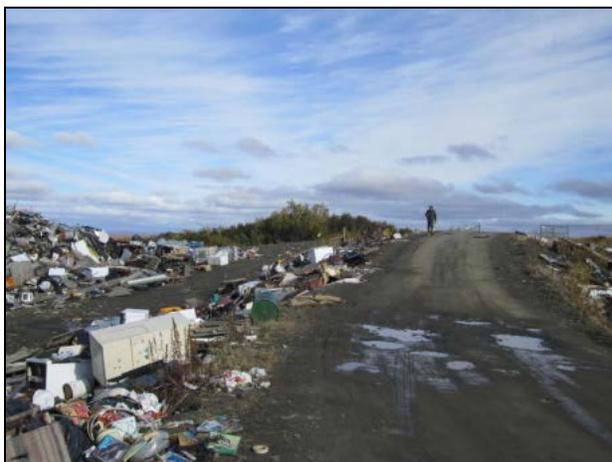
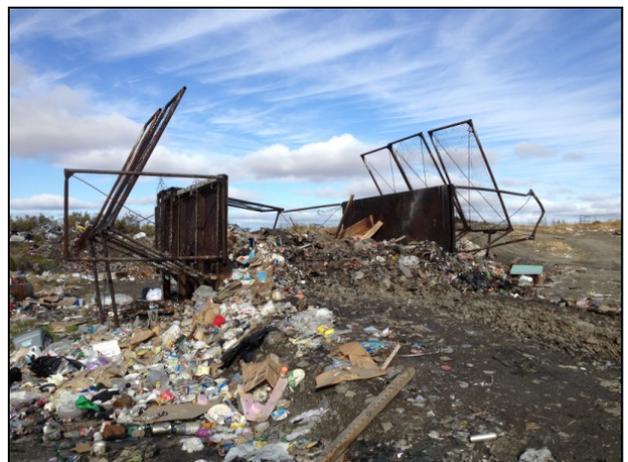
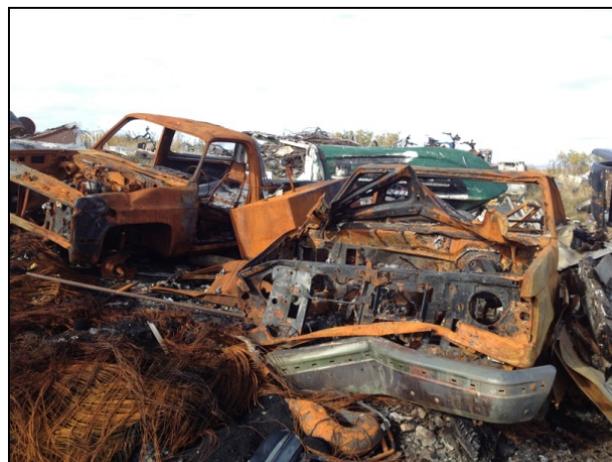
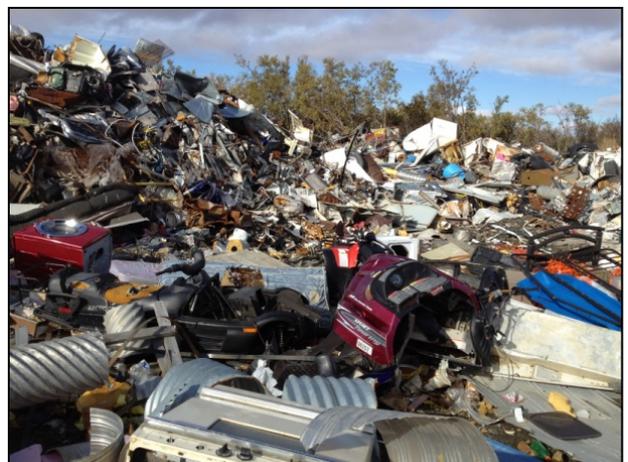
- **Landfill, 62.053977/-163.264957 (Active)** – The landfill is roughly 5 acres in size and is located on the road system between Saint Mary’s and Pitkas Point. It is 2 miles from Saint Mary’s and 1.5 miles from Pitkas Point. The landfill is used by both villages. Saint Mary’s utilizes a collection program, although residents are also able to self-haul to the site. Pitkas Point residents also self-haul waste. The site is managed on an “as-needed” basis with waste burning the primary method for volume reduction of waste. The main concerns with the site are: waste exposed to the elements, open burning of waste, poorly managed construction and demolition cell, and animal/subsistence waste mixed with municipal waste. It is located on high ground approximately 8,000 feet from the Yukon River.
