1.0 INTRODUCTION, PURPOSE, AND SCOPE

A United States Air Force site remediation project took place during the 2004 summer field season at the North River RRS located just outside of Unalakleet, Alaska. This on-site field project ran from mid June to mid September 2004.

NORTH RIVER RRS, ALASKA		
2004		
GENERAL SITE LAYOUT		
PROJECT DATE:	SCALE:	DRAWING DATE:
2004	No Scale	DEC 04
DRAWN BY:	FIELD DATE:	FIGURE No.:
JCB	JUN-AUG 04	3

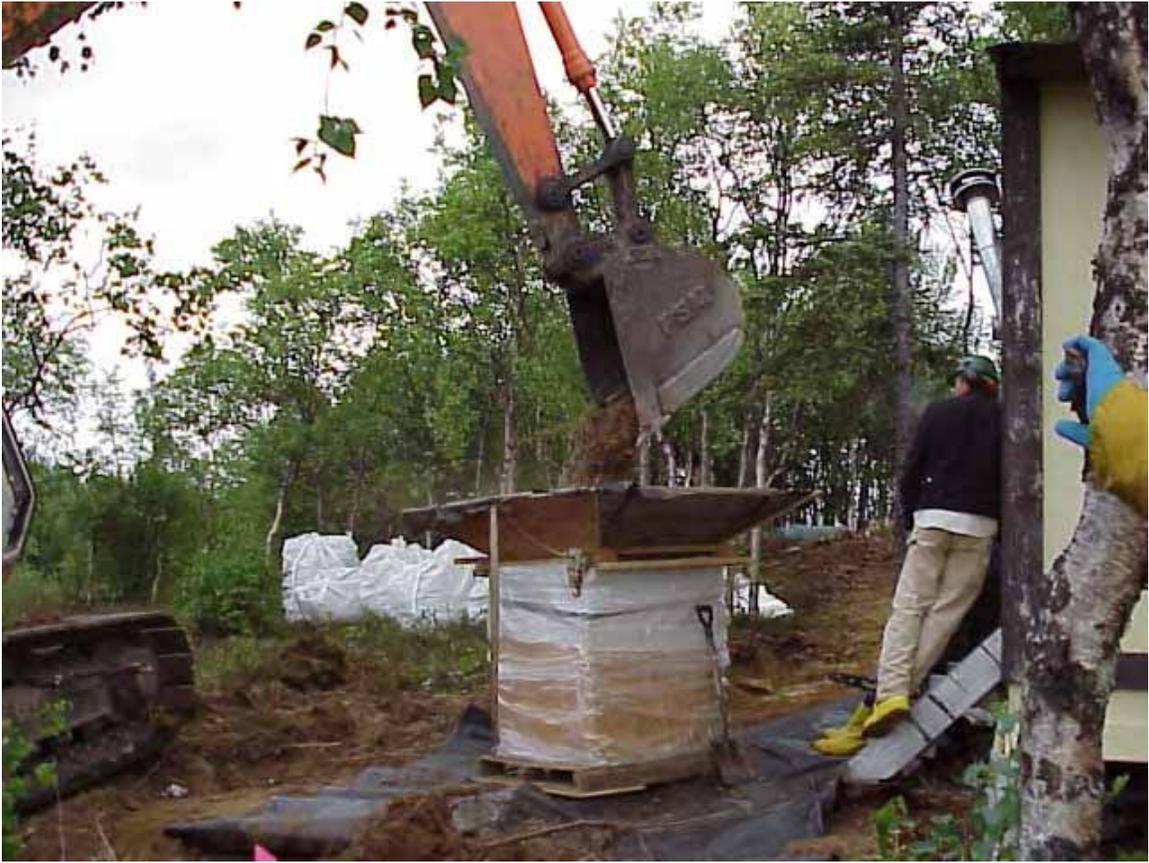
Filling Soil Sacks at the Cabin

Excavation along the Road to Cabin proceeded quickly; Contamination here consisted of wheel-tracked ruts in the soil, with the west rut soils having a heavier PCB coating (80 ppm, low being 1.7 ppm) than the East rut (52 ppm, with a low value of 0.3 ppm). Excavation here consisted of scalping soil top layers from underneath track ruts to a depth of 4" – 6" to clear the rut surfaces of PCB contamination. Width of excavation varied, from just under 10' wide along the roadway, but at the Turnaround Area the excavation was widened to about 35' wide (Sheets 12 and 12A). Field screening located a small spot which needed to be reexcavated (original excavated value was given as 2.8 ppm by field sample 72704, reexcavated to <0.11 ppm as field sample 72801) on Figure 13, and cleared by samples 125 and 126 on Figure 13A.

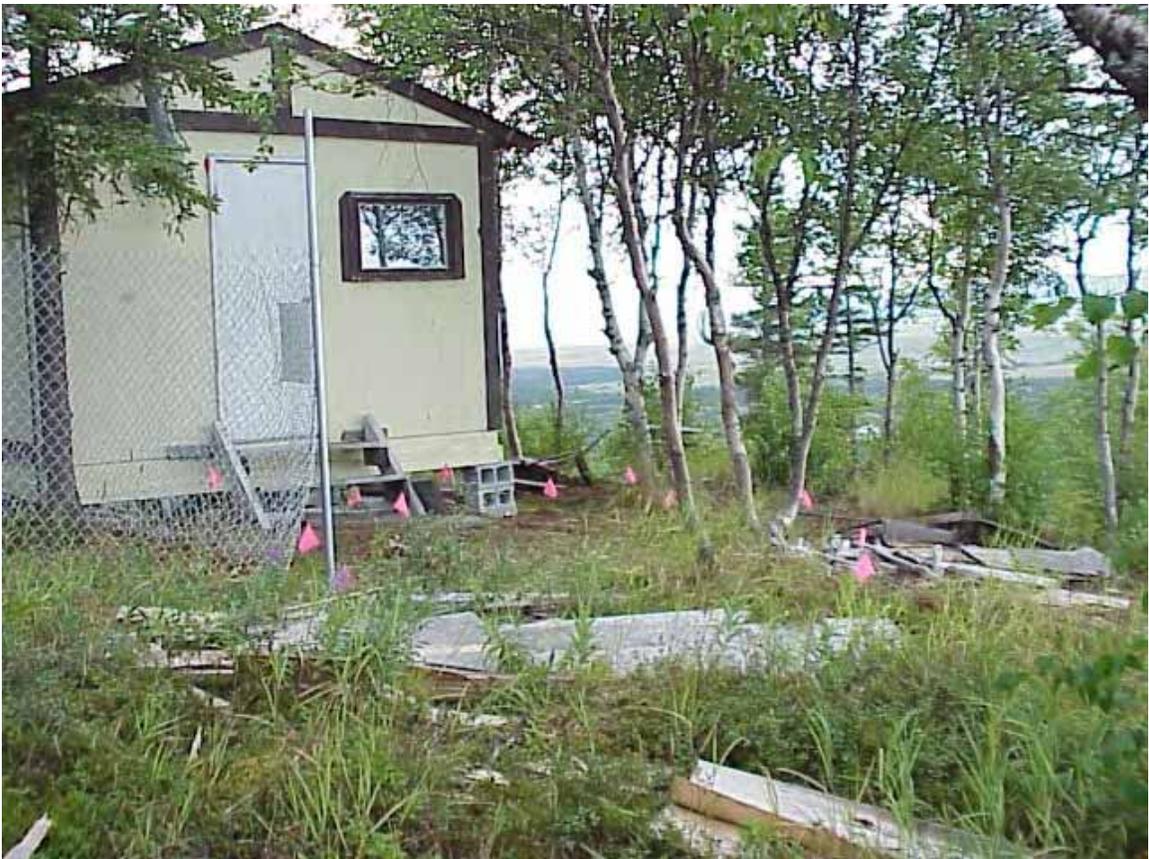
Sampling Points at Cabin

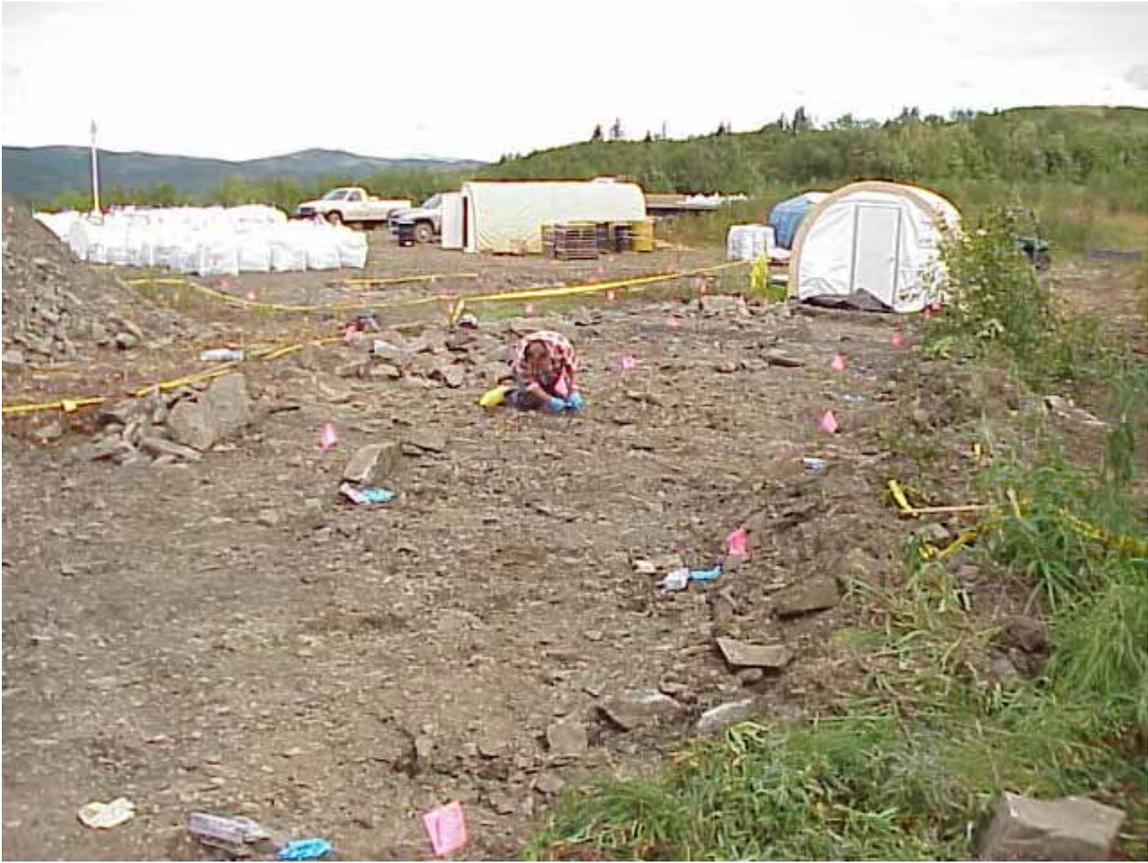
Collecting Soil Samples at the Contamination Reduction (Southernmost) Finger

Upon discovery of this north and east trending contamination plume, samples were collected on a daily basis to delineate the plume. Samples were taken at intervals 10 feet apart, so that each day an additional 10 feet of plume was excavated. The 10 feet sample spacing essentially results in one sample per 100 square feet. In actuality, the total square footage was 4300 ft², and about 111 field chromatography samples taken, for a field sampling density of one field sample for every 39 ft².

Portions of the easternmost finger (CRZ) had analyses that failed twice, resulting in an overall excavation of as much as three times. At the northern end of this excavation, field samples 80602 and 80603 failed the ADEC limit of 1.0 ppm PCB. Reexcavation here permitted samples 82010, 11, and 12 to be recollected. These samples passed the ADEC standard, permitting collection of confirmation samples 239 and 240, which also passed. The southernmost redig located at sample 241 will be reexcavated during future completion of the project. In addition, the small diamond shaped area from which samples 71906 and 73109 were taken needs to have a confirmation sample collected and analyzed.

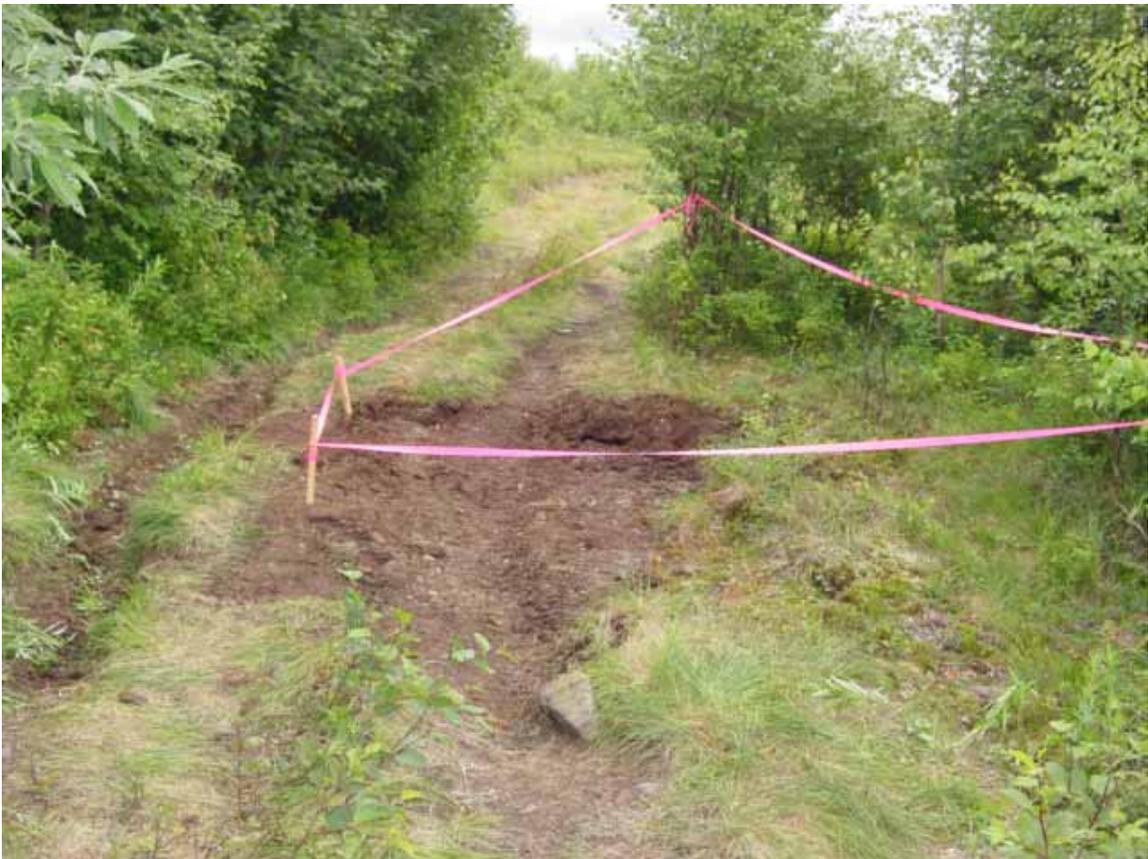
The Original Hot Spot, 2003, on the Trail to the Cabin

The Hot Spot was the site of the original PCB spill that was responsible for contamination of Area C. It had been excavated in to a depth of about 1-½ feet and a circular width of nearly 20 feet. This excavation was accomplished in 2003, but not all of the contaminated material was removed at that time: PCB containing soil remained at the bottom of the hole and at the end of the 2003 work season immediately prior to crew departure the hole bottom was covered with a Hypalon liner and then backfilled with clean crushed rock.

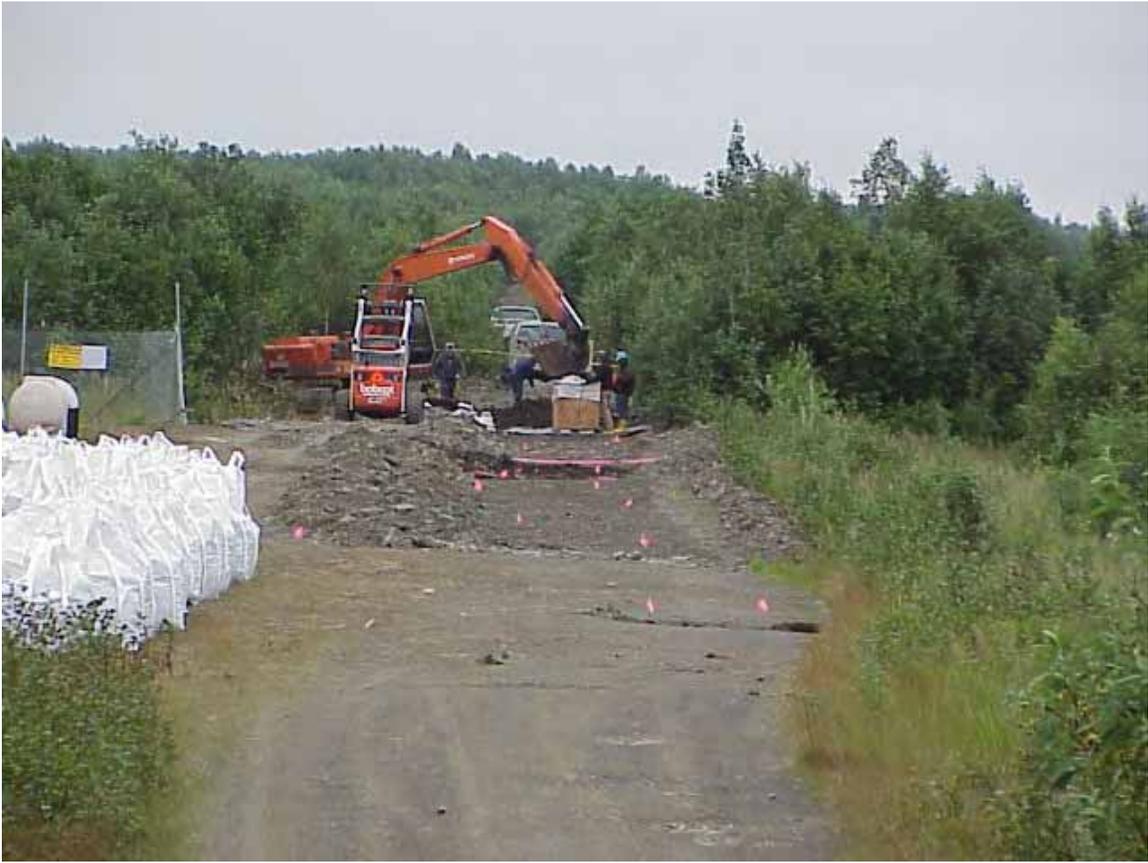
Excavating the Main Road

Initial excavation was done on the lined and bermed road to the White Alice site, which had had PCBs tracked on to it from the Hot Spot. This excavated portion of the main road is shown as a northeast-southwest trending road segment outlined in red on Figure 3. To prevent further migration of PCB, in late 2003 the roadway was protected with a liner, upon which a thin layer of crushed stone was placed. The clean backfill which had previously been placed in the Fall of 2003 was scrapped off of the Hypalon liner. The liner was then hauled up and placed in a soil bag for disposal, along with the rest of the excavated PCB contaminated soil. The edges of the road as well as the top surface were then scraped down about 4 inches (see Contamination Theory, Section 6.0), and this material was then also bagged for shipment off site for disposal. The average width of the road excavation was about 10 feet.

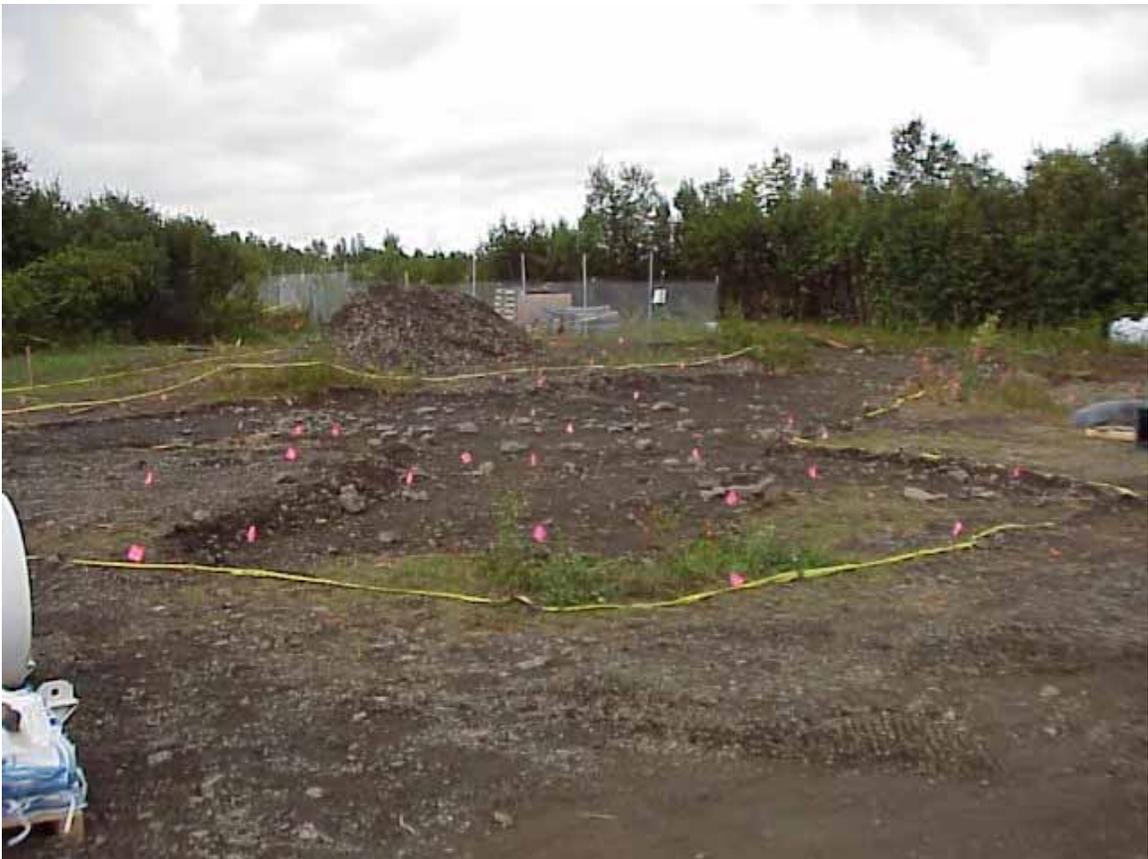
Rockpile dig at the Middle Finger

This area of soil containing more than 1.0 ppm PCB was apparently created when ATVs crossed the Hot Spot and turned nearly due north to travel to the White Alice Site, first going past an alder hedge and then turning north and east. The area of this former alder hedge lies in Figure 9, just east of the easternmost of the Rock Pile Digs.

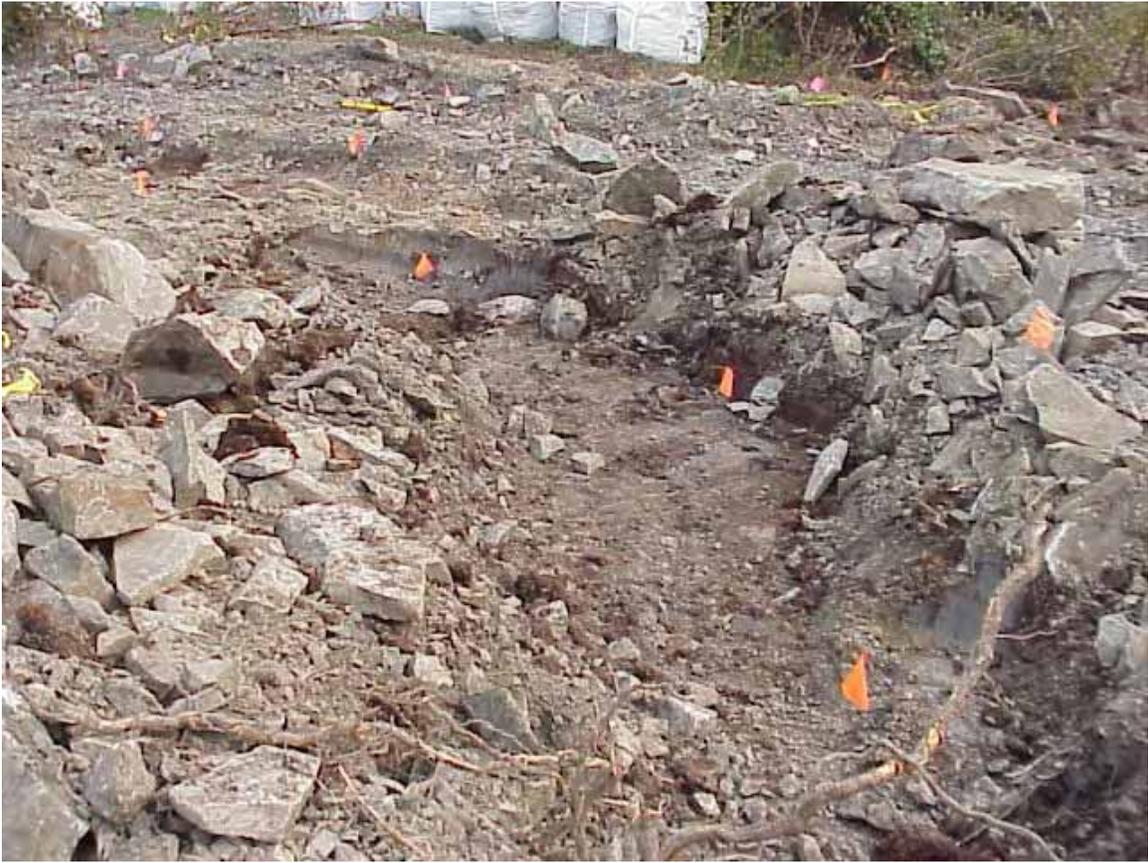
Reredig at the Contamination Reduction Zone

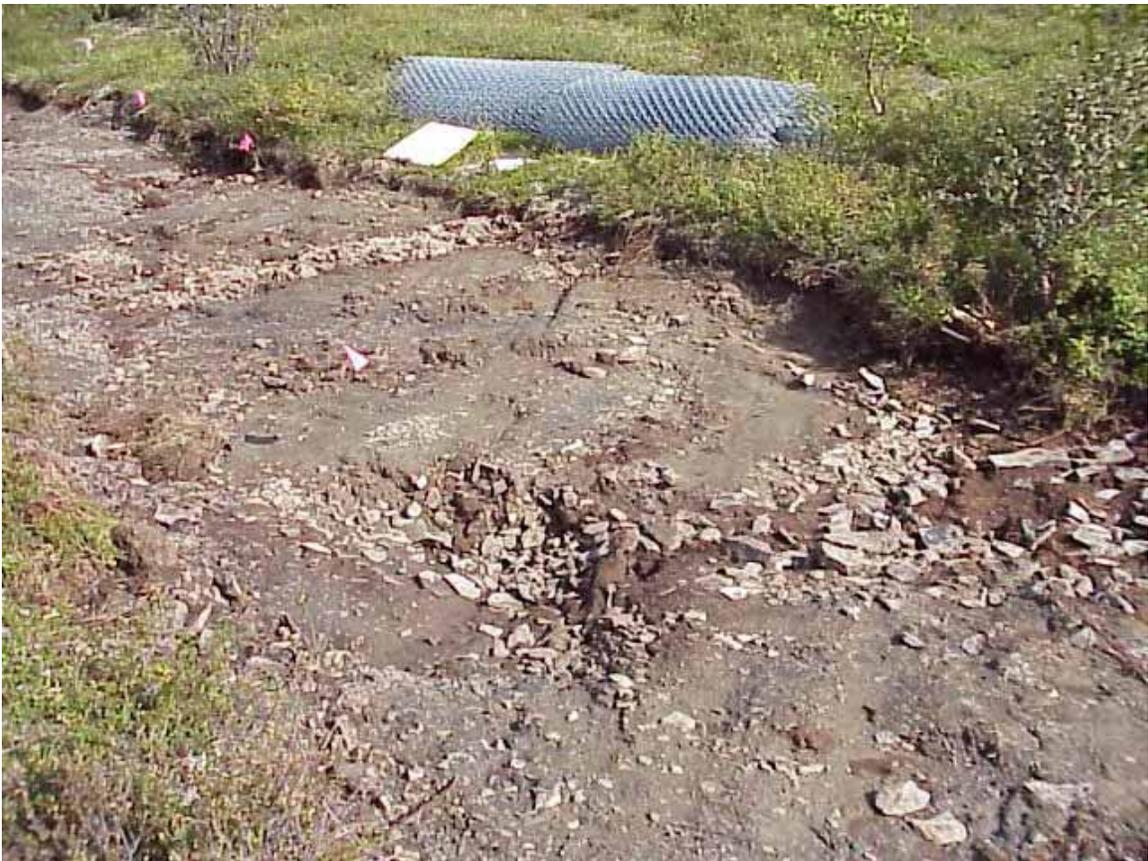
Redig at Trail to Cabin

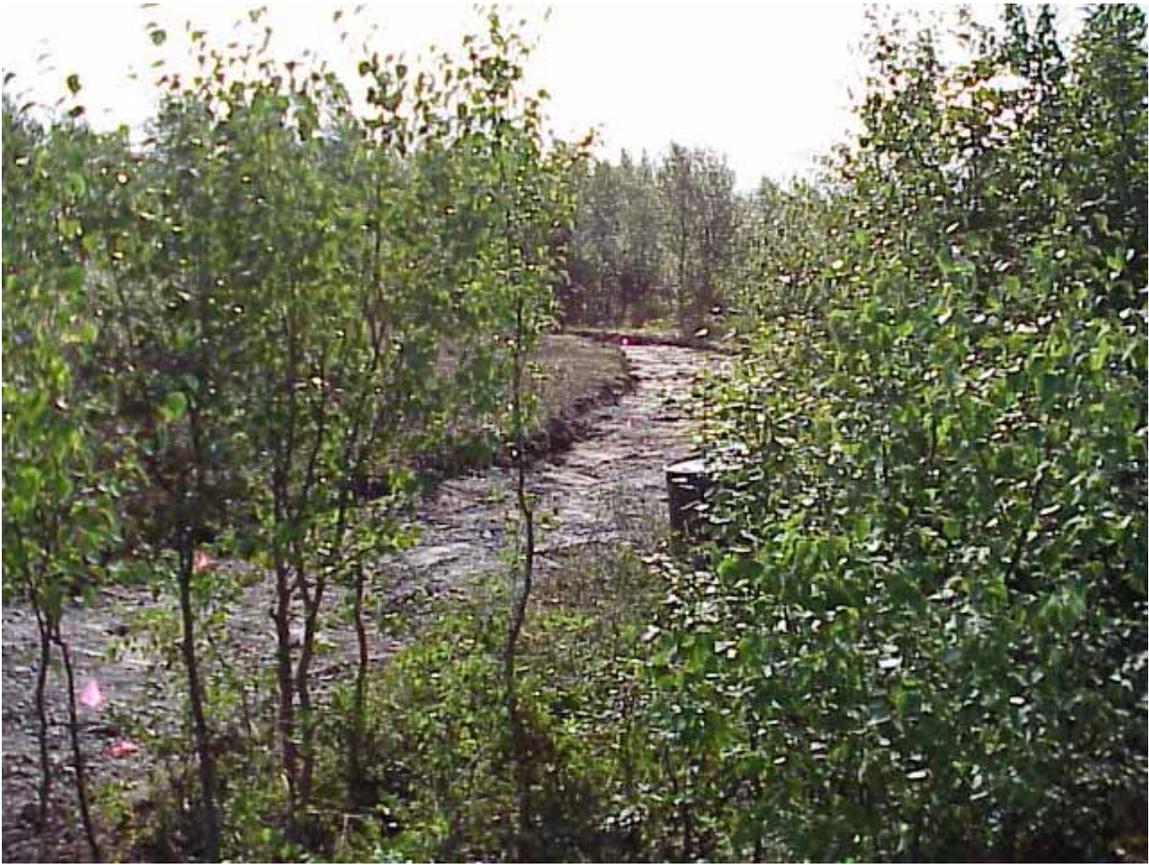
Excavated Trail, View Toward Cabin

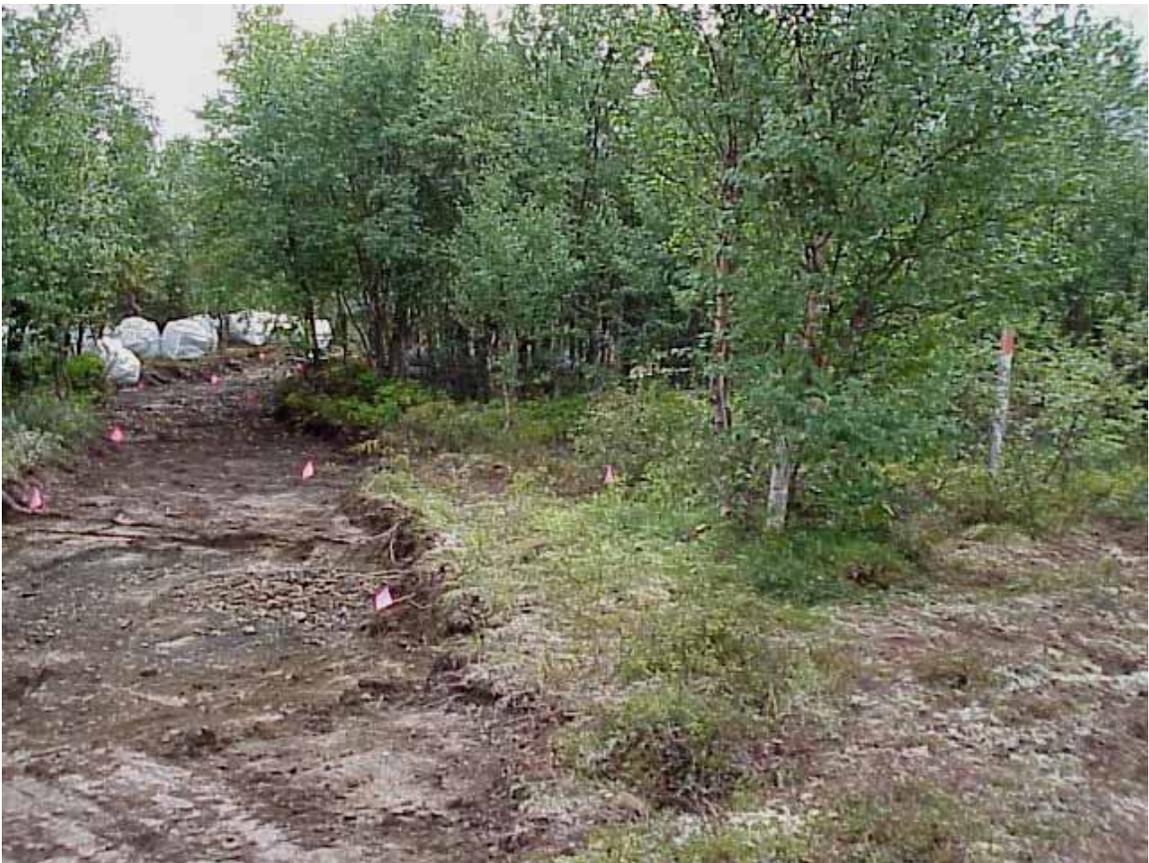
Excavated Trail, View Toward Cabin

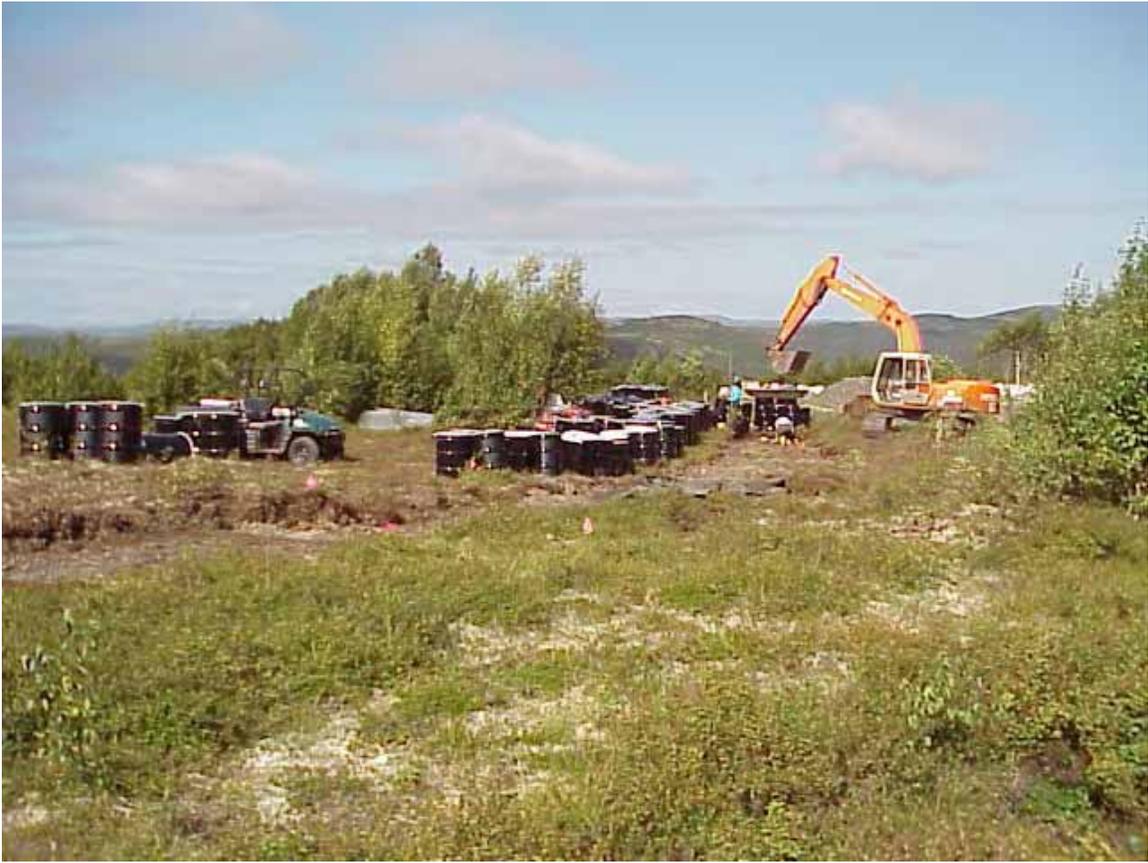
Trail Excavation and Drum Filling

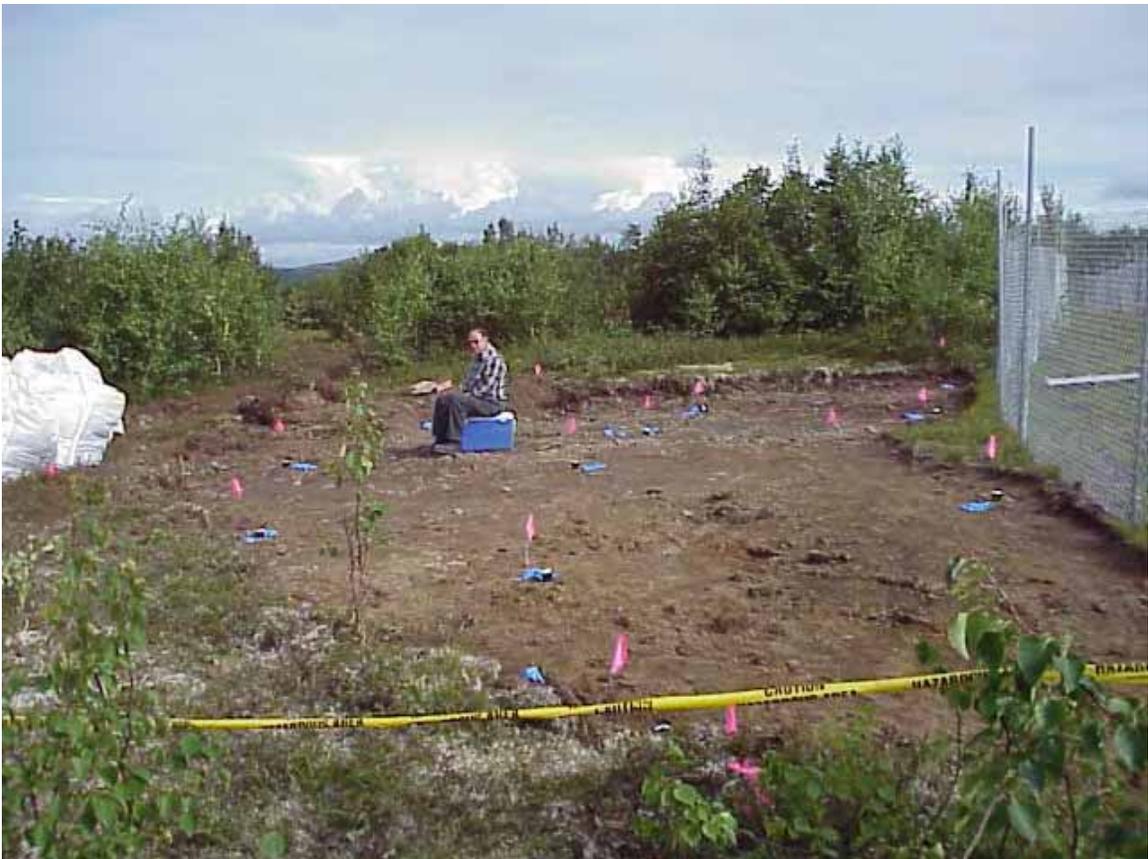
Sampling Soil Excavation at the Turnaround Area, Trail to Cabin

The Turn – Around area is shown in Figure 12, and consists of an enlarged apron along the western side of the Trail to the Cabin, 250 feet northwest of the cabin. The name was given because the location and shape of this apron suggests this area may have been used as a turnaround for ATVs or ATV trailers (it is the first brush free area north of the cabin). Confirmation samples were collected here (after scalping the top 4 inches of soil and tundra peat off of the top of the trail and the turnaround section) between the 23^d and 28th of July. Again, samples were taken at 10 foot intervals. Samples collected at the Turnaround area were taken from only the topmost layer of peat, to reflect the manner of contamination and ensure the hottest samples were taken. Contamination removal here consisted of removing only the peat which overlaid the underlying clay, and no secondary excavation was required after the limits of contamination were reached.

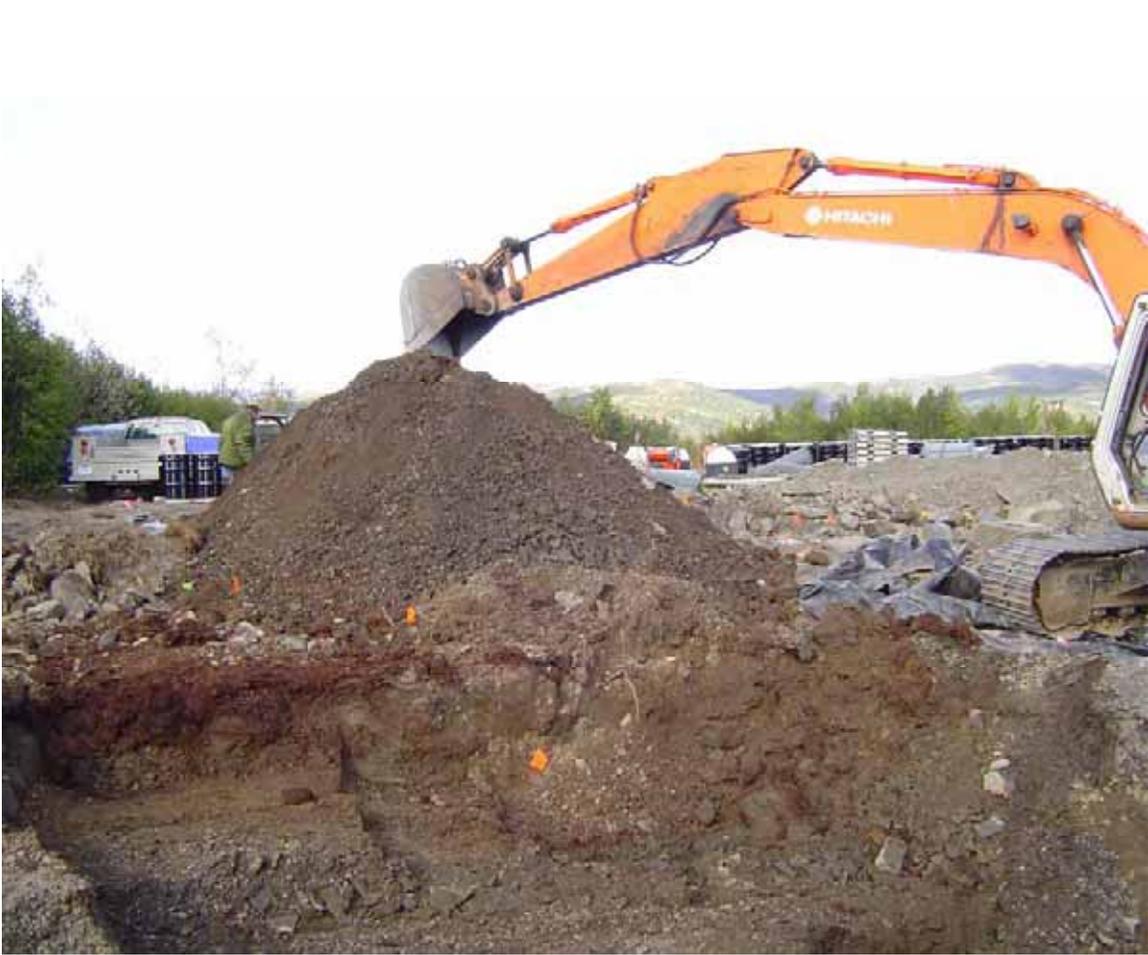
Excavating at the Hot Spot

Excavation here proceeded with a slight widening of the original 2003 hole, but additional deepening occurred to a depth of 6 feet at the northeastern corner. In contrast, sampling indicated the opposite (southwest) corner was relatively clean at a depth of two feet.

Nonetheless, most of the material removed from the Hot Spot contained high levels of PCB, and was shipped off site in open top drums, until these were consumed and the remaining excavated material was placed directly over the hot, unexcavated portion of the roadway. This northeastern corner of the Hot Spot is underlain by in-place weathered greywacke, so that further excavation here will be limited, since the bottom of the hole here is very close to bedrock. However, it may be possible to dig one - or two - feet deeper at this deep end, and this may indeed be deep enough for clearance, since analytical data shows that in at least one instance, removal of two feet of material from the bottom of the hole resulted in lowering of PCB concentrations from 14,646 ppm (Field Sample 82209) to 36.7 ppm (Lab Sample 283). Samples 275 and 272 on the northwestern corner and western side of the Hot Spot excavation are still nearly 6000 ppm, but the current excavated depth (four feet) should permit easy clearance by excavation of two or three feet more. These are the hottest points remaining in the Hot Spot. Ten out of 24 sample points at the bottom of this excavation are less than 100 ppm PCB, so that a minimum amount of redigging may be enough to complete the cleanup. In contrast, the southwestern corner of the Hot Spot did not need to be dug to so great a depth, and the floor was left at a depth of two feet. The alternate two diagonal corners were dug to intervening elevations.

In the southwestern corner of the 2004 Hot Spot excavation high concentrations of trichlorobenzene were located and identified by the unique odor. Samples 289 and 290 were collected at the southwestern corner and analyzed by EPA method 8260. Trichlorobenzene values were high at 1551 ppm. Because trichlorobenzene has a vapor pressure and is capable of evaporation (unlike PCB), it is apparent that this compound has been moving laterally through

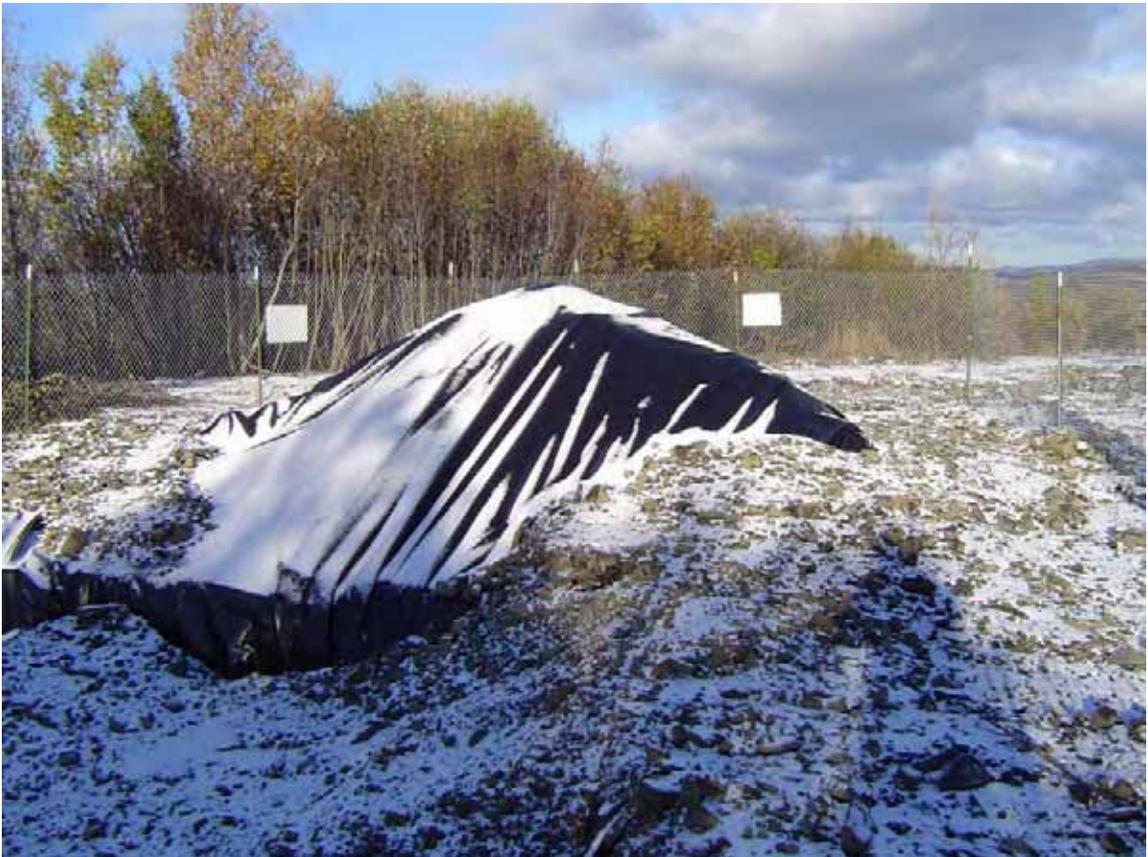
End of project, mid September, showing Hot Spot, fencing, and excavated materials.

Because of time and material constraints, the project was abandoned in mid September. The Hot Spot excavation was again relined with Hypalon, and some clean crushed rock was put into the hole to hold this liner down. There also remains about 50 yd³ of excavated soil and rock sitting on the unexcavated portion of the Road to the Cabin that must also be drummed for shipping.

Before leaving the site, Areas A and the Hot Spot at Area C were fenced in with a 6 foot high chain link fence. Cleaned, excavated areas were backfilled with clean gravel and brought to surface grade at Area C.
