CIAP WEAR Trip Report
Cold Bay (population 85)
August 12, 2013

Alaska Department of Environmental Conservation (ADEC) Solid Waste Program (Doug Huntman and Jamie Gorman) conducted a Coastal Impact Assistance Program (CIAP), Waste Erosion Assessment and Review (WEAR) site visit for the Village of Cold Bay on August 12th, 2013. The following narrative is a brief description of our findings during the August inspection.

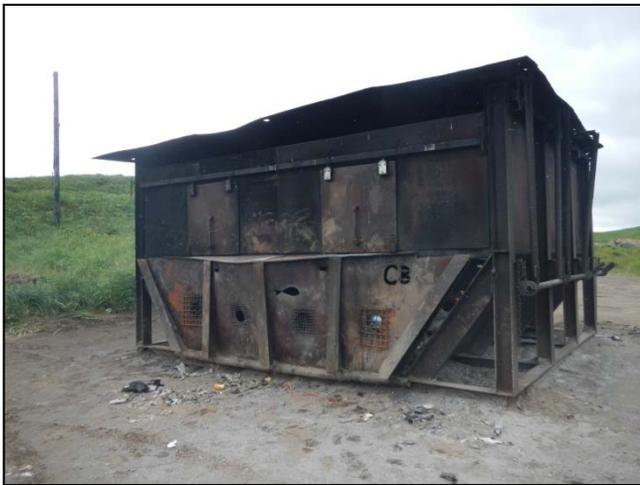
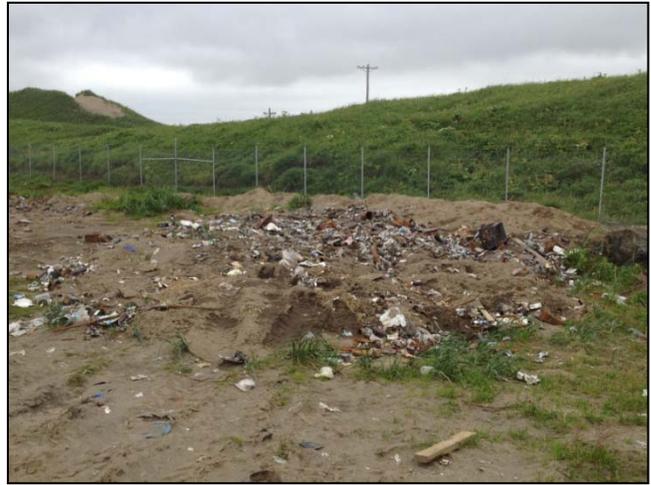
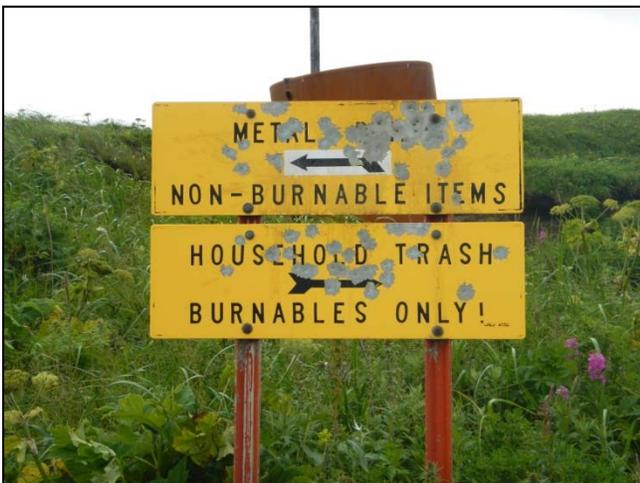
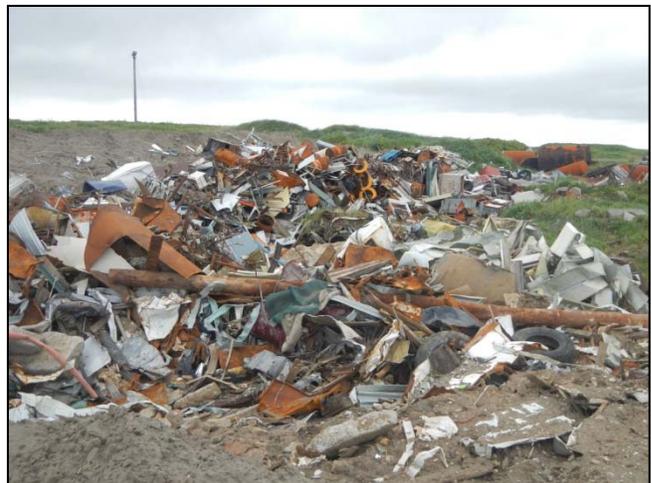
- **Landfill, 55.219787/-162.727943 (Active)** – This unpermitted Class III Landfill uses a Summit burn box to incinerate burnable waste. Non-burnables are separated and disposed of at an adjacent site. Both a waste collection program and self-haul methods are used for community solid waste disposal at the landfill. Limited signage is in place to direct self-haulers where to dispose of household burnable waste and other non-burnable waste items. The landfill has been in operation since the early 1980's and employs a landfill operator. The area containing the burn box, including where the ash is disposed, is fully fenced; however, the cell where non-burnables are placed is unfenced. There is no screening system for hazardous or prohibited wastes prior to disposal and the salvage/metals area located outside of the landfill fencing is large and unconsolidated. The landfill is located north of town, 875 feet east of the Cold Bay Airport N/S runway and 300 feet west from the water body of Cold Bay.
