CIAP WEAR Trip Report  
Iliamna (population 111)  
July 25, 2013

Alaska Department of Environmental Conservation (ADEC) Solid Waste Program (Kit Persson and Jamie Gorman) conducted a Coastal Impact Assistance Program (CIAP), Waste Erosion Assessment and Review (WEAR) site visit for the Village of Iliamna on July 25<sup>th</sup>, 2013. The following narrative is a brief description of our findings during the July inspection.

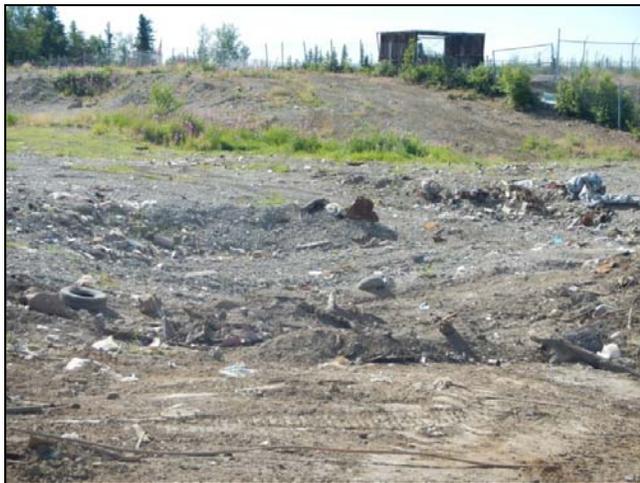
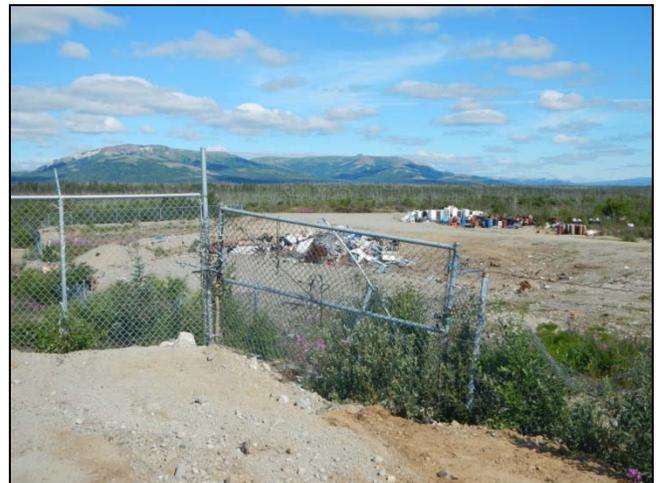
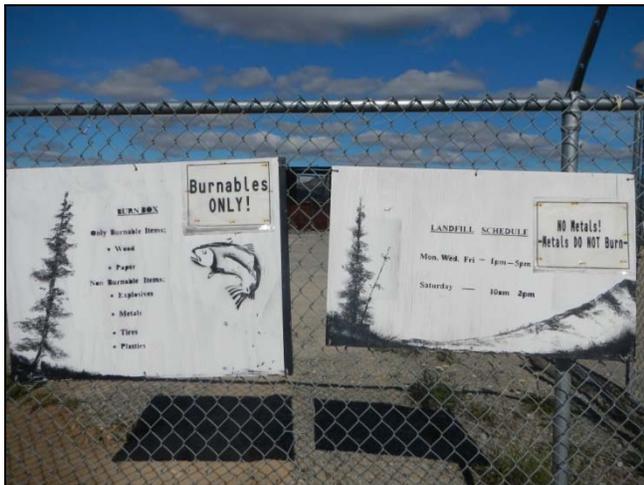
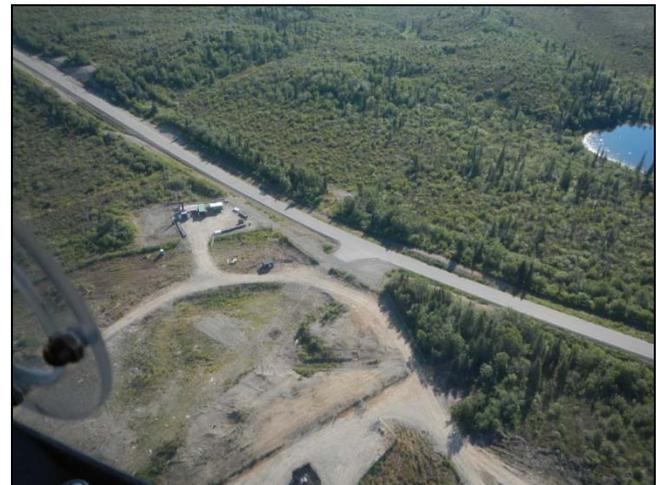
- **Landfill, 59.783836/-154.901292 (Active)** – This permitted landfill is a self-haul facility that burns most of its waste in a Summit burn unit. It has been in operation since at least 1986. There is adequate fencing throughout the site and non-burnable waste is compacted and covered. Also, there are well-defined collection areas for recyclables near the landfill’s entrance. The Iliamna Landfill employs a landfill operator but would benefit from improved management of burning and special wastes. The landfill is located approximately 3.3 miles from Lake Iliamna.

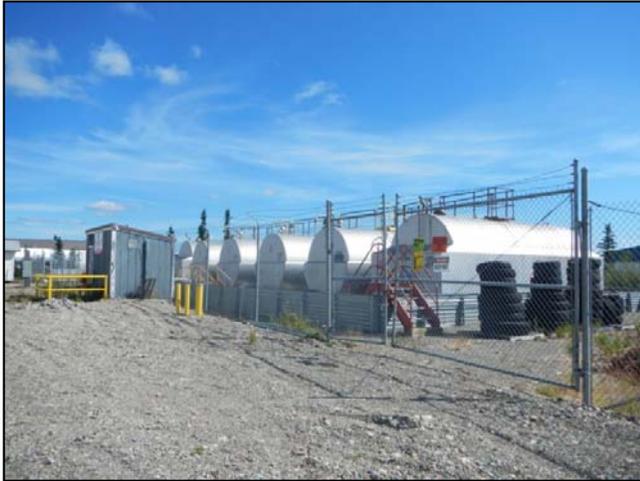
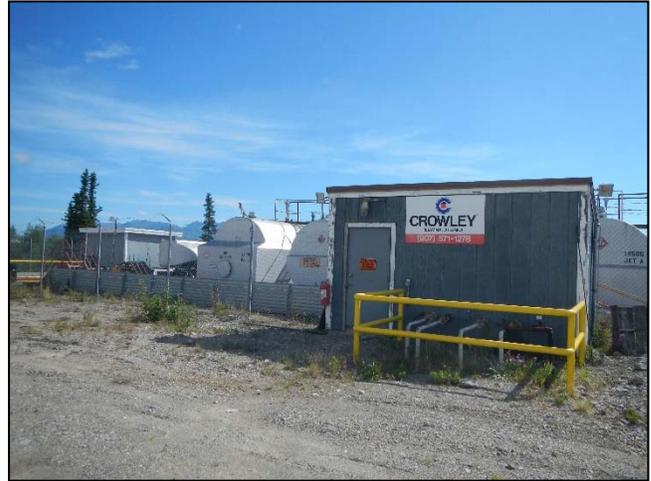
- **Airport Crowley Tank Farm, 59.754428/-154.906141 (Active)** – This Crowley tank farm, which is located across the street from the Iliamna Airport, is an active Contaminated Site (File ID 2560.38.012). A spill of 1,507 gallons of aviation gas occurred at the site in late 2009. 65 cubic yards of contaminated soil were excavated and landfarmed to remediate the soil beginning in 2011. After remediation, the soil was transported to and disposed of at the Newhalen Landfill in June 2013. This site is still being monitoring by the Contaminated Sites Program as not all contaminated soil was excavated. The tank farm is about 0.15 acres in size and holds six tanks, which have a total capacity of 258,000 gallons in a fenced and locked area.

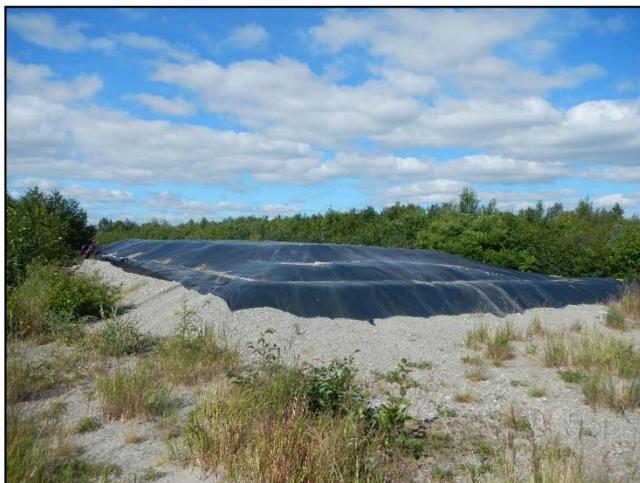
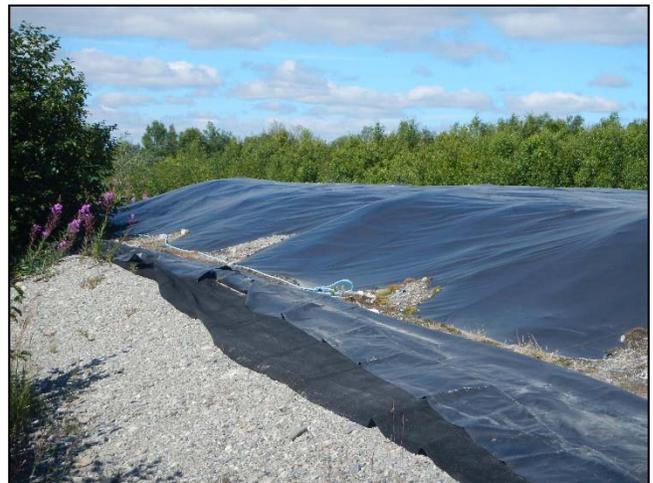
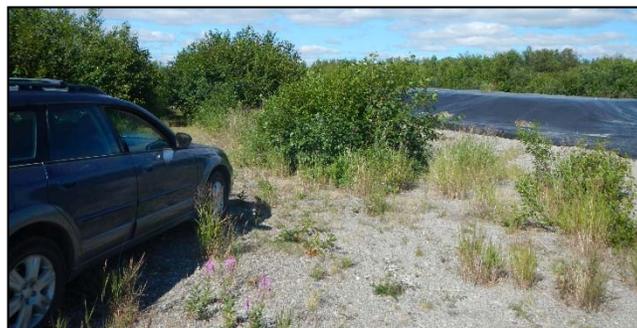
- **FAA Living Quarters Landfarm, 59.761161/-154.828806 (Active)** – This site is part of an active Contaminated Site (File ID 2560.38.001). The landfarm is remediating contaminated soil linked to above ground fuel tanks that used to exist in the area. The site is sandy and the landfarm itself consists of a raised rectangular platform of soil that is covered by a geotextile sheet. The landfarm is within Iliamna Airport Tract II, near the Old FAA Landfill, and covers an area of approximately 0.08 acres. The site is 170 feet south of Lake Superior.

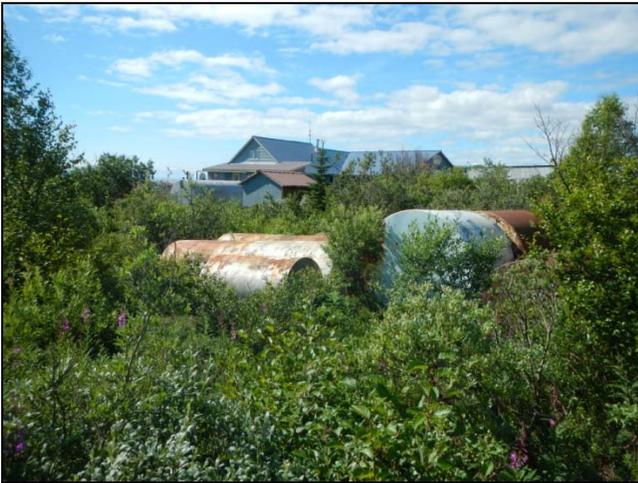
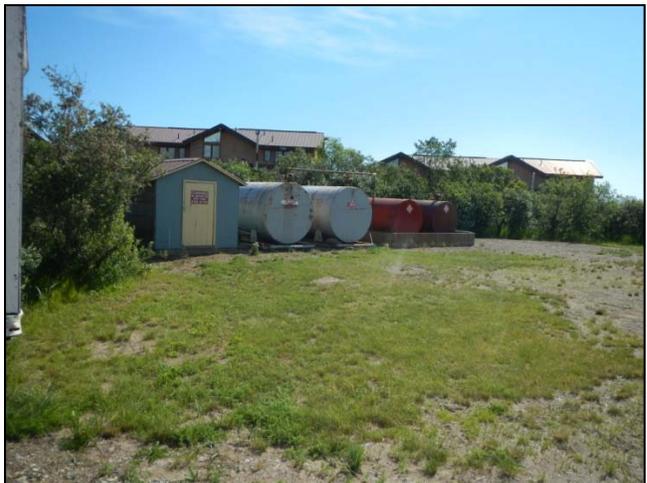
- **Trading Store Tanks, 59.752344/-154.828716 (Active)** – This cluster of fuel tanks is in the Roadhouse Bay Subdivision and sits adjacent to the Iliamna Trading Store. Four tanks, which were reported to belong to Iliamna Trading, were sitting on a cleared section of land. A secondary containment berm constructed of lumber encircled the perimeter of the two smaller tanks. Also, several tanks were seen in the dense vegetation a few yards north of the maintained tanks. This site is 220 feet north of Iliamna Lake.

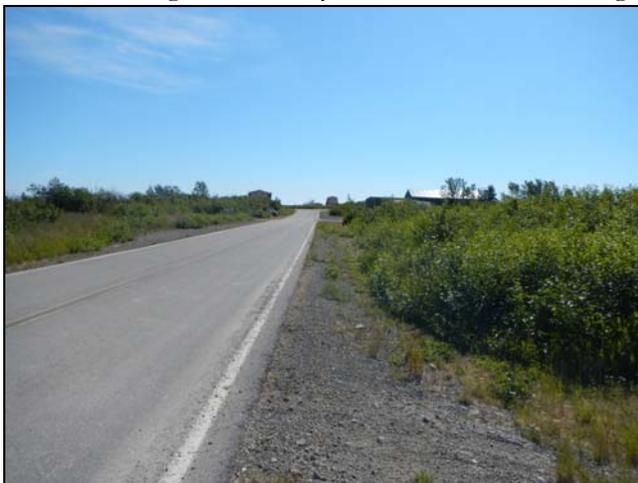
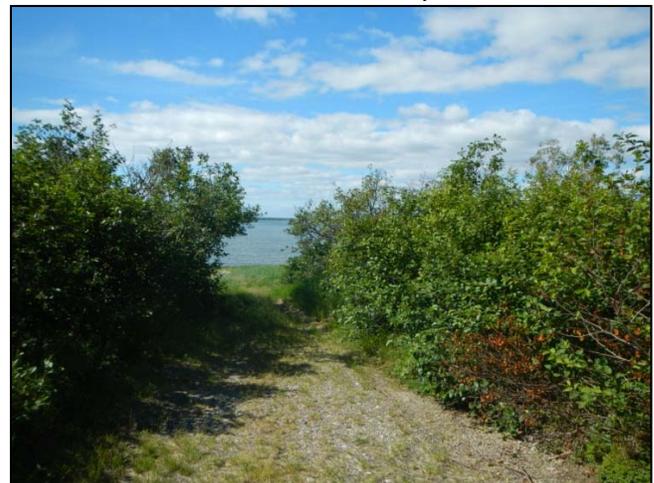
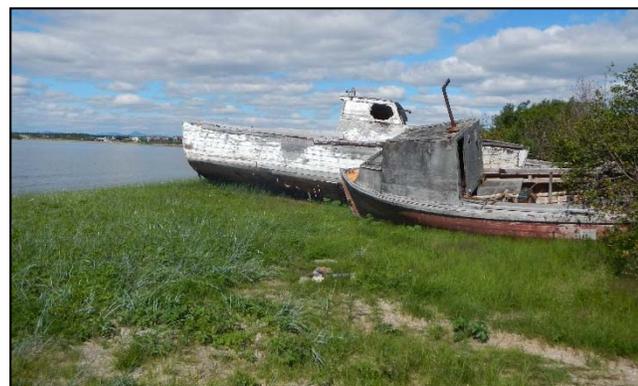
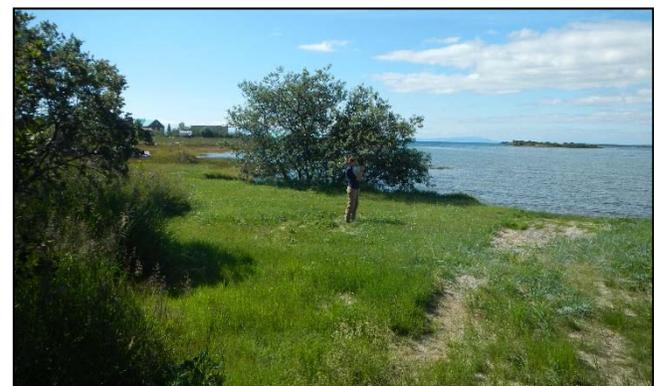
- **Former US Post Office, 59.751424/-154.815653 (Active)** – The former Iliamna US Post Office was located on Iliaska Drive at this site. In November of 1999, it was reported that drums of used oil were shot and subsequently leaked. This caused the site to become an active Contaminated Site (File ID 2560.38.007). During inspection, the area appeared to be well vegetated aside from a cut in the bushes to provide access to the lake from the road. The site is no longer owned by USPS and is located right on the shoreline of Roadhouse Bay.

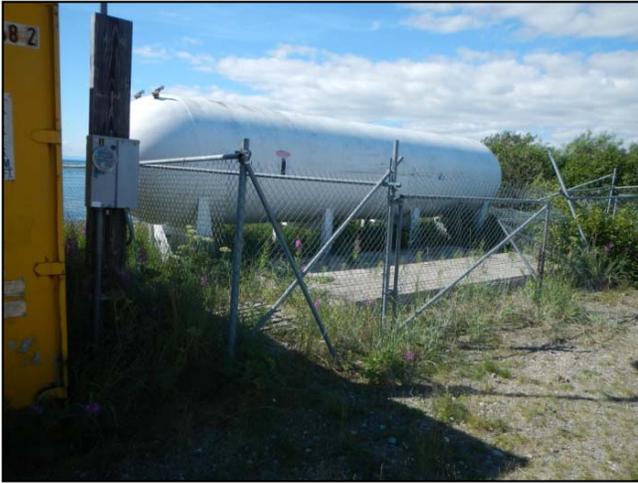
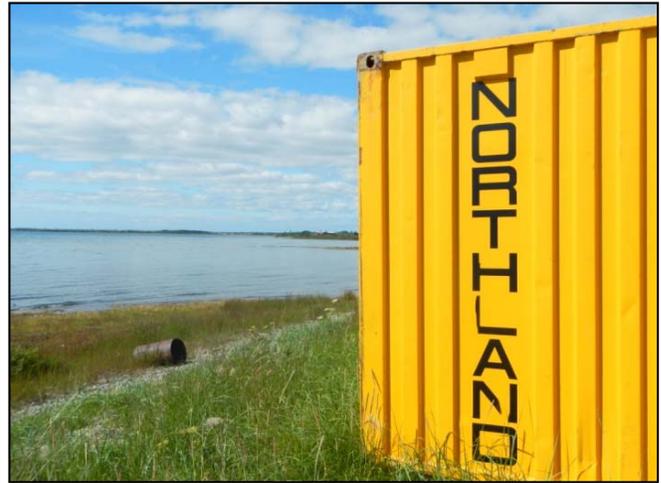
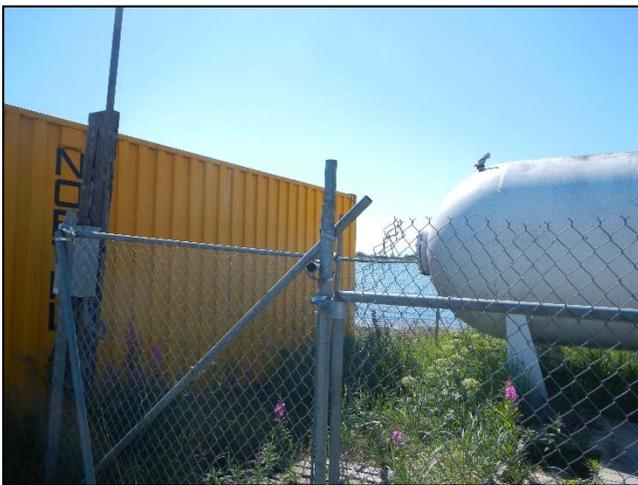
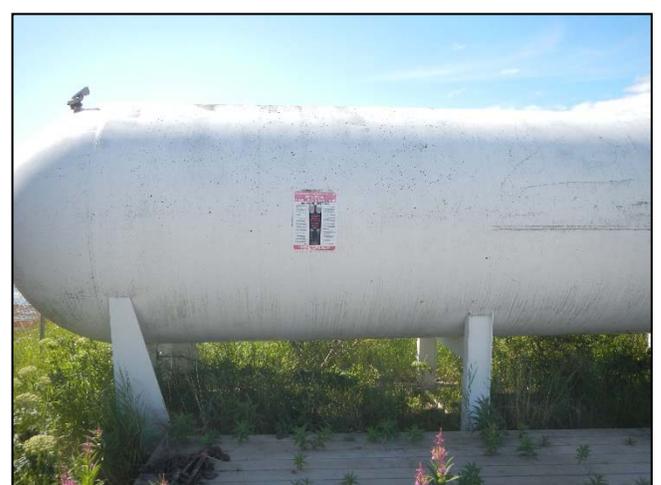
- **Propane Storage Tank, 59.752726/-154.820800 (Active)** – This site consists of a large propane tank of unknown capacity and a yellow Connex located across the road from the southern tip of Triangle Lake. The site is reportedly owned by a Bristol Bay contractor and was also reported to no longer be in operation. The fence surrounding the tank was in disrepair. It is 35 feet from Roadhouse Bay.

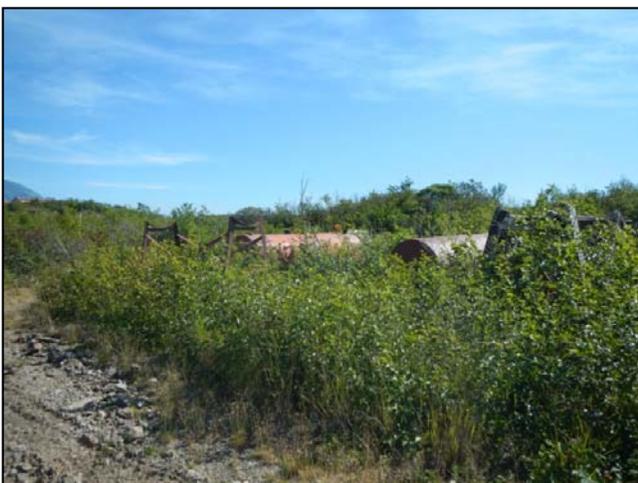
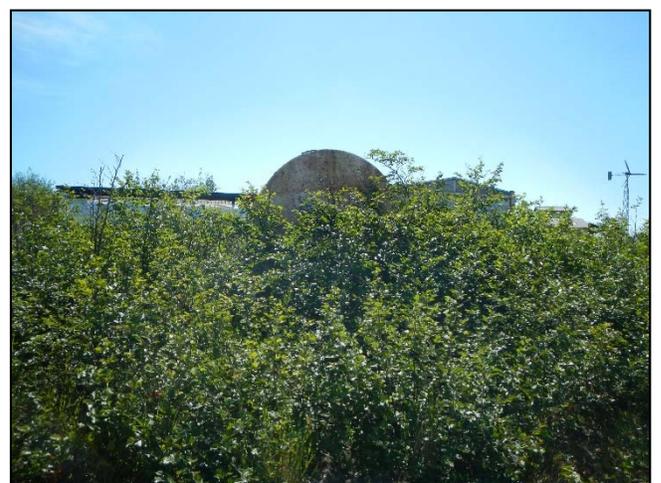
- **Abandoned Fuel Tanks, 59.749782/-154.812959 (Abandoned)** – These tanks, with unknown size and contents, reside in the Iliaska Subdivision in front of Lots 30 and 31. The tanks were completely surrounded by dense vegetation and are 245 feet from Iliamna Lake.

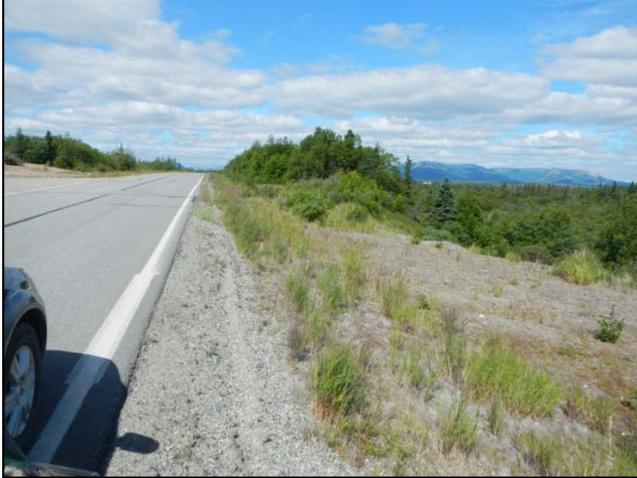
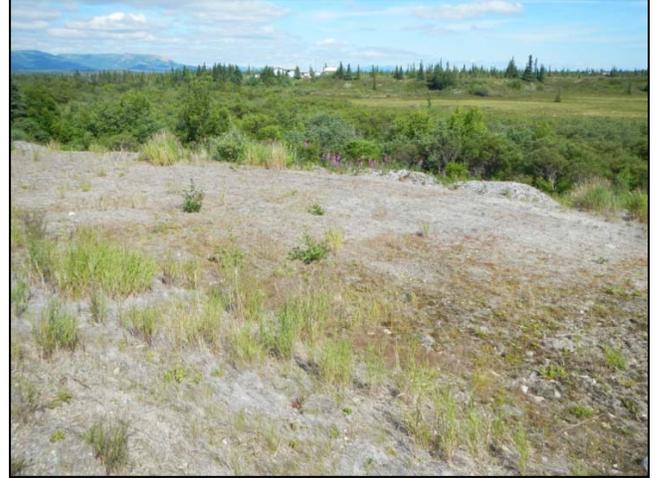
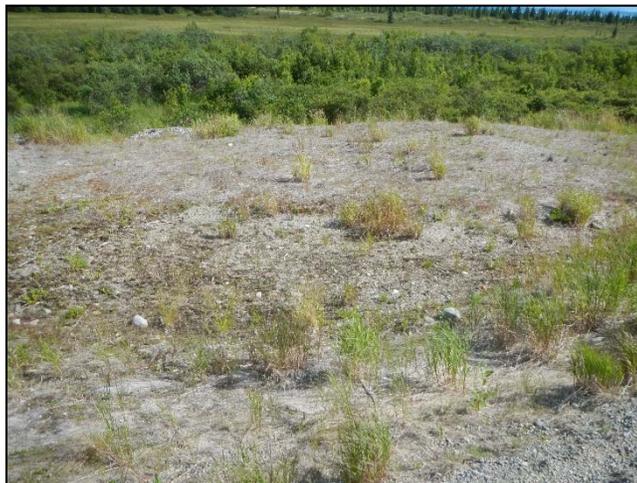
- **AFB Drum Cache 2, 59.752445/-154.843221 (Removed)** – This closed Contaminated Site (File ID 2560.38.005) used to contain 300 surface drums and an undetermined number of buried drums. The site is one of two Air Force Base (AFB) drum dumps in Iliamna; the other is located on the NE corner of the N-S runway. The drums were removed and the site cleaned up in 2006 and declared closed in 2007. The site showed no signs of drums, but it had minimal vegetative regrowth in the last 6 years. The site sits alongside Iliamna Airport Road, less than 200 feet west of Roadhouse Creek.
