Alaska Department of Environmental Conservation (ADEC) Solid Waste Program (Doug Huntman and Jacob Timmons) conducted a Coastal Impact Assistance Program (CIAP), Waste Erosion Assessment and Review (WEAR) site visit for Platinum on July 10th, 2014. The following narrative is a brief description of our findings during the July inspection.

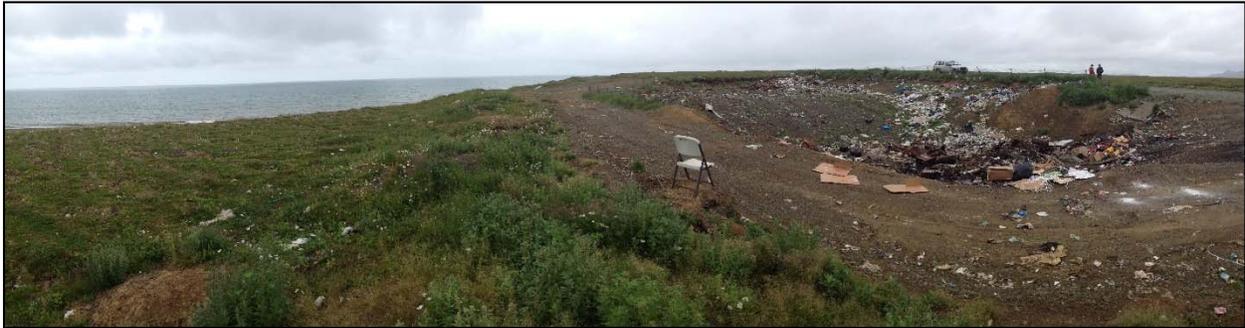
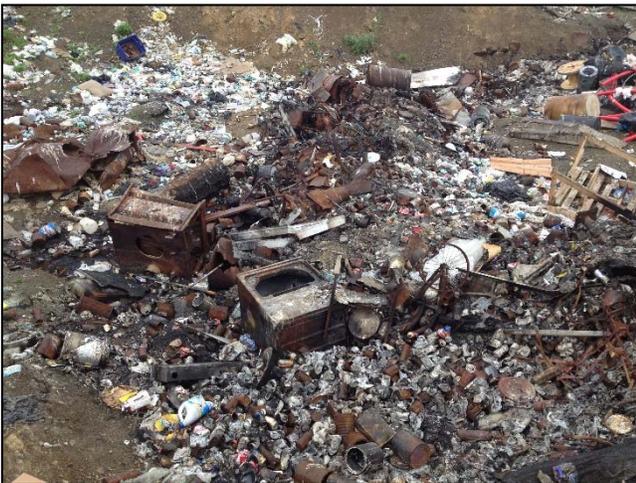
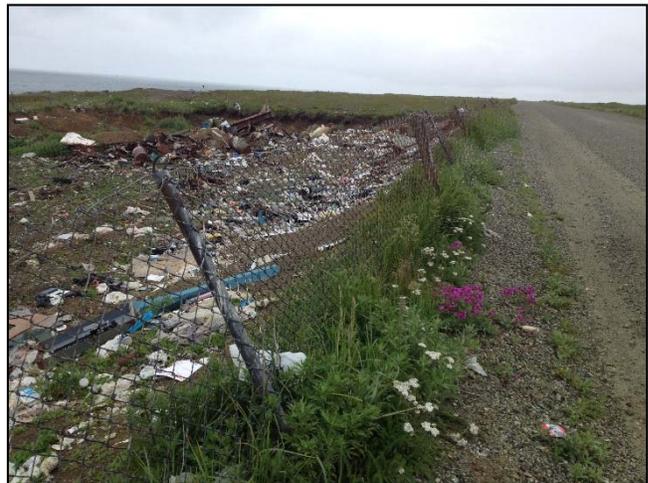
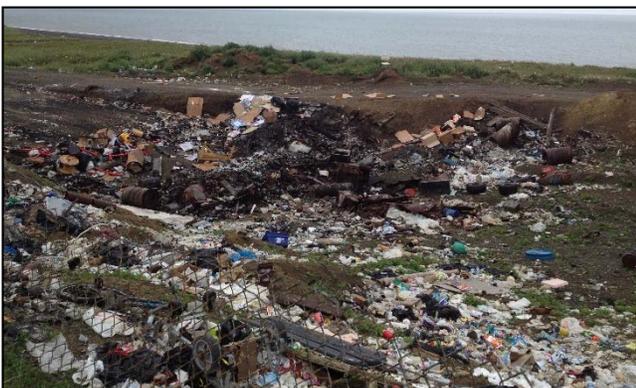
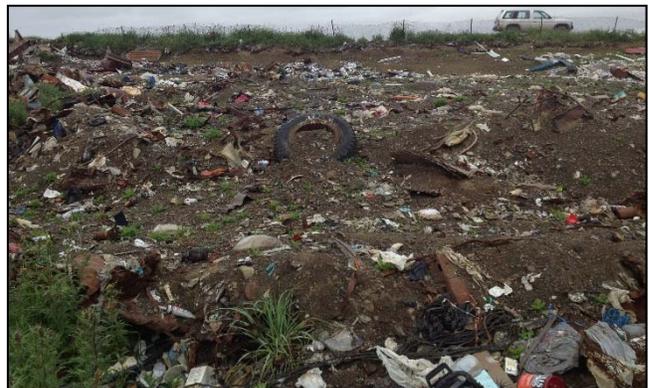
- **Landfill, 58.988681/-161.797836 (Active)** – This half-acre, unpermitted landfill is located 1.5 miles southeast of town. It has been in operation since around 1992 and is managed on an “as needed” basis by the City of Platinum. The site is mostly fenced, but it is accessible to the public as there is no gate. There is no collection program and residents self-haul waste. The most serious issues identified include: waste spread throughout the site, open burning, and no sorting of wastes at the landfill. Additionally, the site is located close to an eroding water body, Kuskokwim Bay, only 80 feet away. This site is also effected by storm surges.

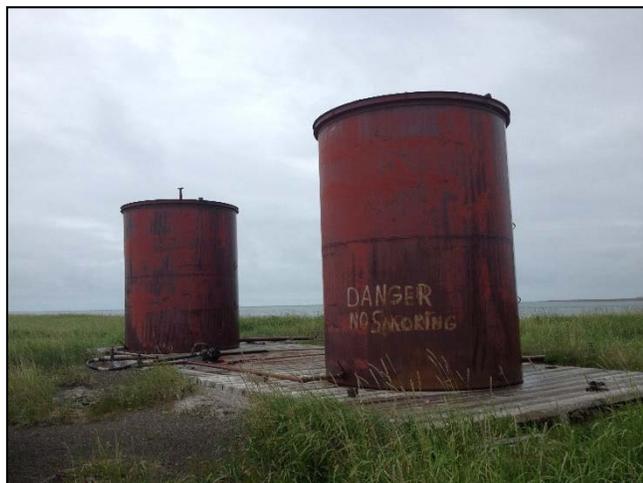
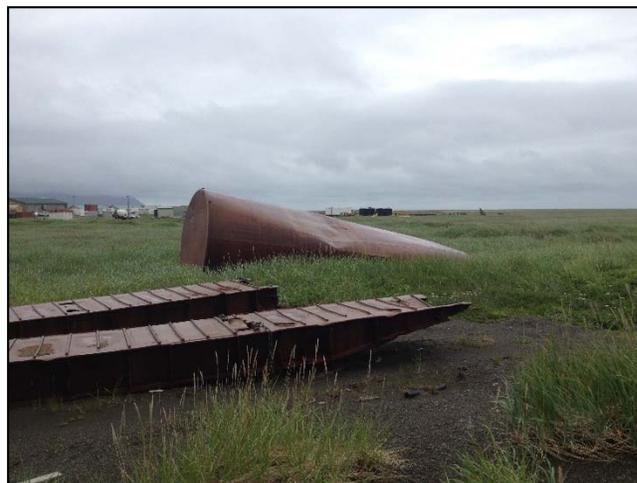
- **North Point Tanks, 59.049605/-161.822302 (Abandoned)** – This site, located at Platinum’s northern point, consists of three rusted, vertical tanks on wooden timbers that sit on top of a buried liner. The tanks have been abandoned, are no longer in use and are reportedly owned by Arviq Inc. Use at this site reportedly began around in 1984 and ended sometime after 2001. One tank has been moved off the timbers and has collapsed on itself. The nearest source of erosion, Kuskokwim Bay, is 50 feet away.

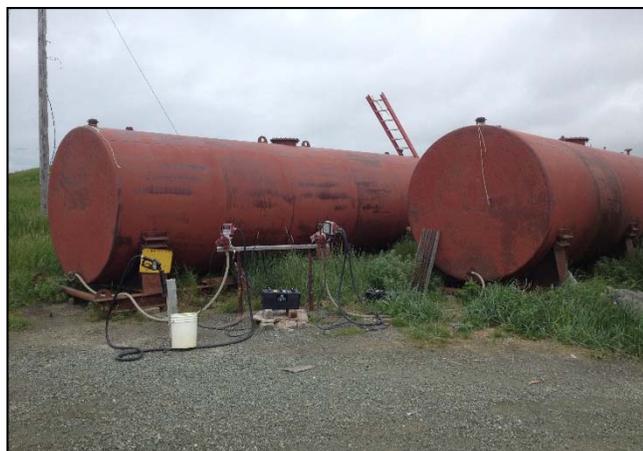
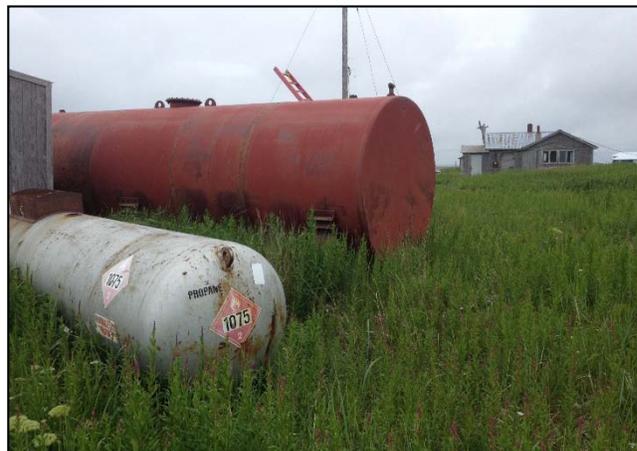
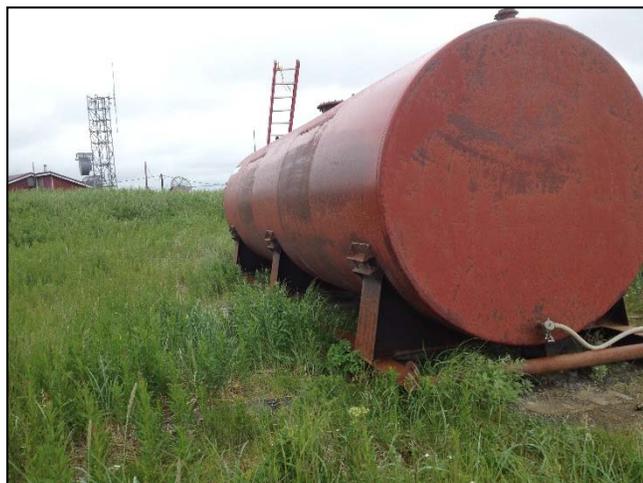
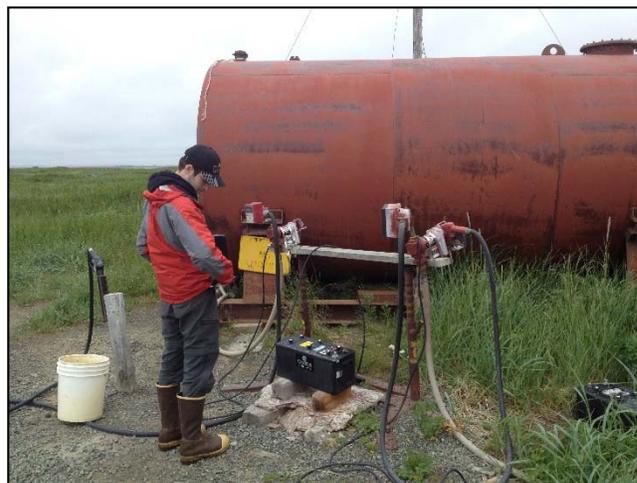
- **Arviq Inc. Tank Farm, 59.013573/-161.820229 (Active)** – This site is centrally located in town, near the Arviq Store. It is used for fuel storage and is the fueling station for Platinum community members. This site has been in use since 1987 and currently consists of two 10,000 gallon tanks (one gas, one stove oil), seven liquid gas tanks, and one 4,000 gallon propane tank without secondary containment. There is no liner or secondary containment visible. It is 240 feet from Smalls Slough.

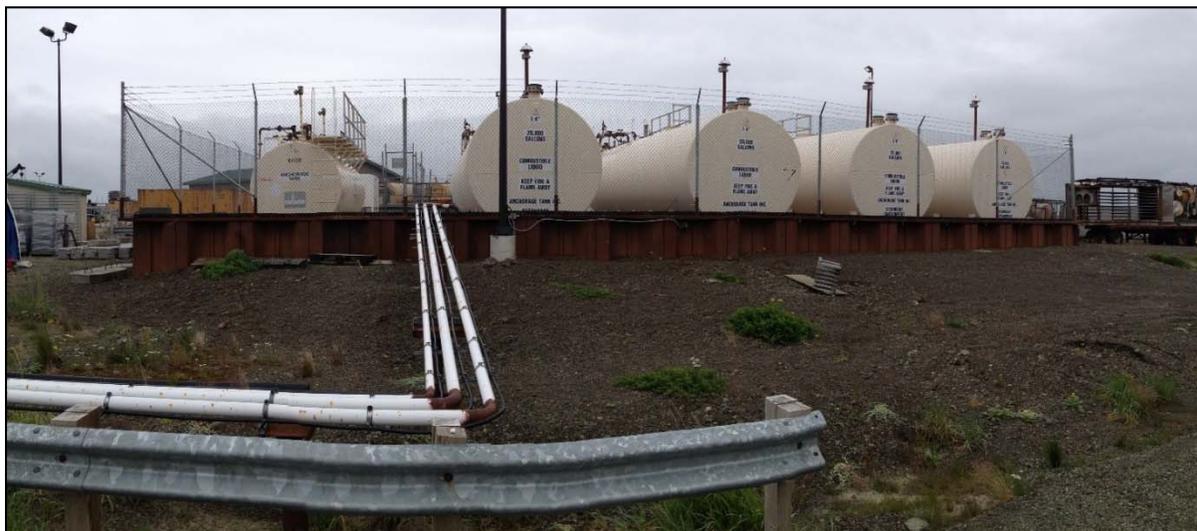
- **CVRF Tank Farm, 59.047643/-161.819916 (Active)** – This site is a Coastal Villages Region Fund (CVRF) tank farm containing eight 20,000 gallon tanks within secondary containment and one 4,000 gallon diesel tank. The tank farm was constructed in 2009. The tanks are within a secondary containment area housed in a fenced, corrugated steel wall. This site can be found in the industrial area about 2.5 miles north of the community. The nearest source of erosion, Goodnews Bay, is 240 feet away.

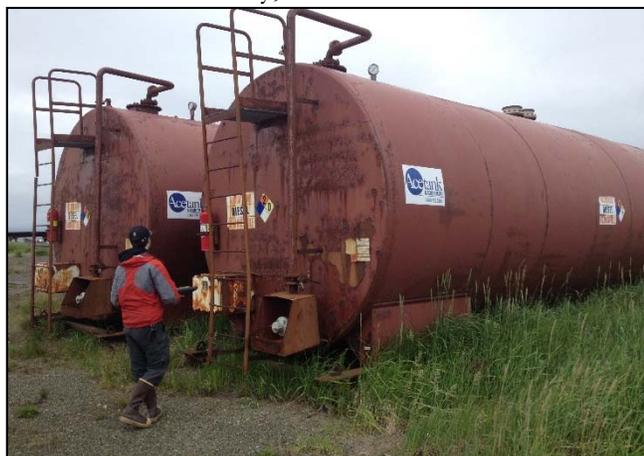
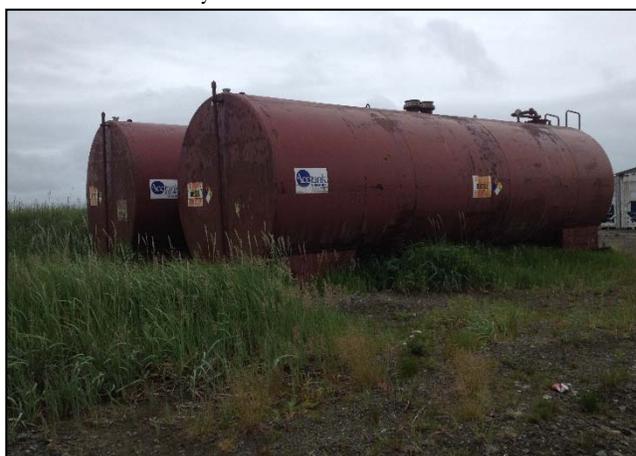
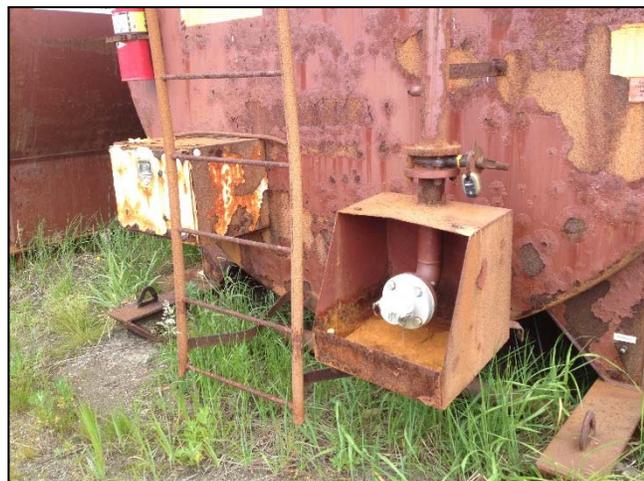
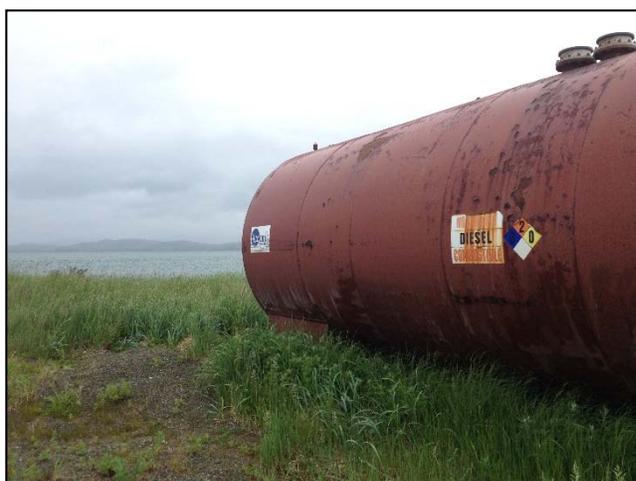
- **Hanson Intermediate Tanks, 59.046225/-161.818637 (Active)** – This site includes two approximately 30,000 gallon diesel tanks used for temporary fuel storage. The tanks are not connected to any piping. It is located in an industrial area about 2.5 miles north of the community of Platinum. This site began use in 2004 and is owned by Hanson Industries. Goodnews Bay, the nearest source of erosion, lies 100 feet away.

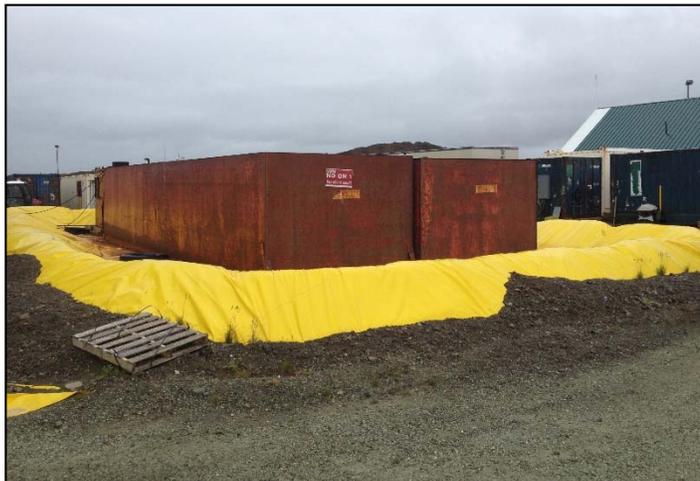
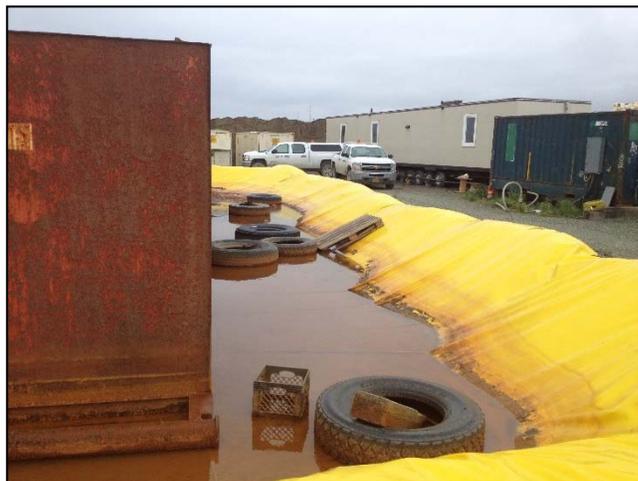
- **Knik Fuel Tanks, 59.047853/-161.819356 (Active)** – This site, owned by Knik Construction Company Incorporated, is located in the industrial area about 2.5 miles north of the community of Platinum. It consists of two rectangular cuboid tanks, approximately 20,000 gallons each, within a yellow liner for secondary containment. This tank farm has been in use since 2009. The nearest source of erosion, Goodnews Bay, is 160 feet away.

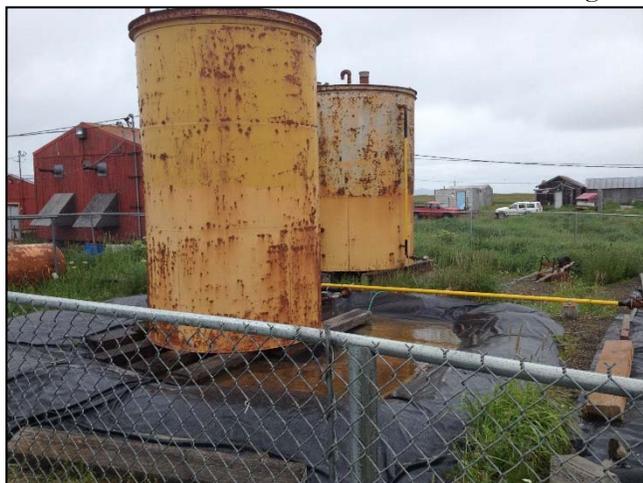
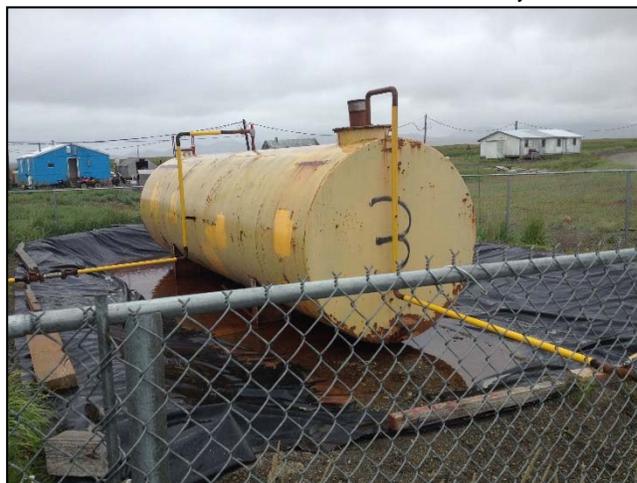
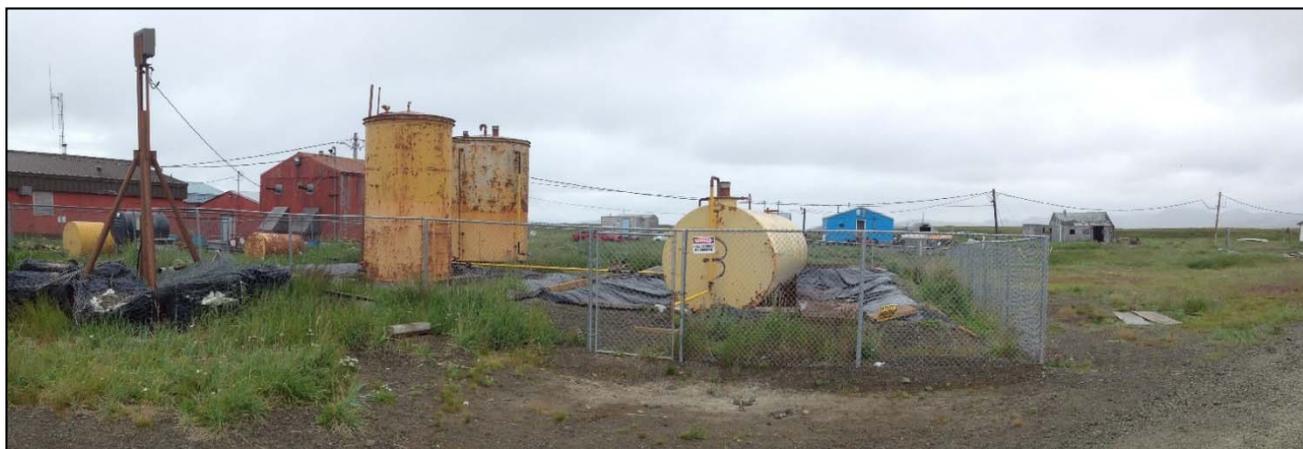
- **School Tank Farm, 59.011574/-161.81716 (Active)** – This site is located adjacent to the school in the middle of town and is owned by the Lower Kuskokwim School District. The site includes three tanks with an approximate total capacity of 30,000 gallons. The two vertical tanks are supported on timbers. One vertical and one horizontal tank sit on individual liners within separate earthen berms, but the second vertical tank has no liner or earthen berm. The school's tank farm has been in use since the 1980s. All three tanks were connected, in use and contained within a locked, fenced area. Smalls Slough, the nearest source of erosion, is 240 feet away.

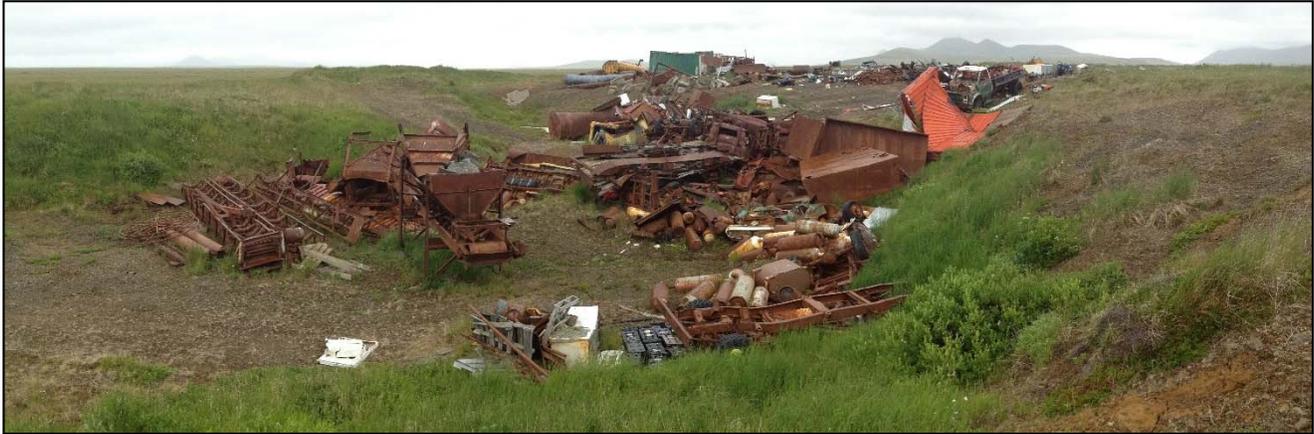
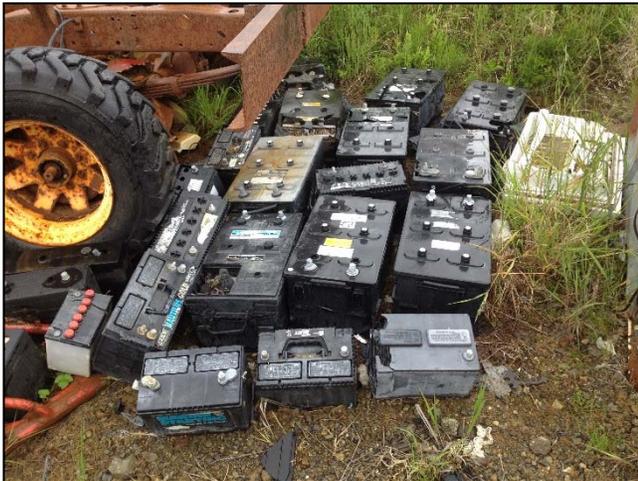
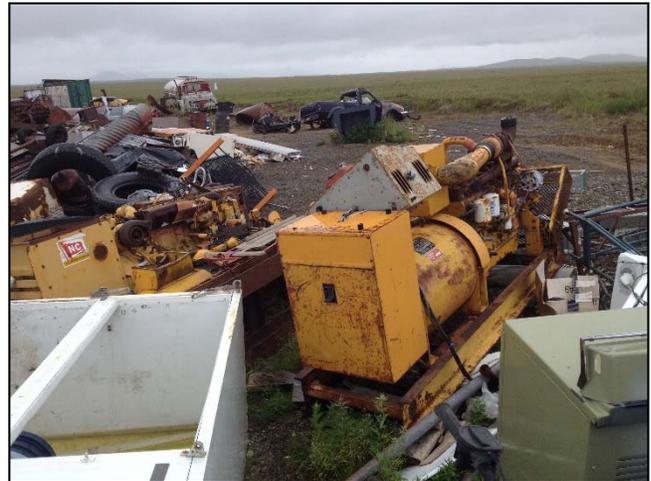
- **Boneyard, 58.987247/-161.777947 (Active)** – This 1 acre site is located 2.5 miles south of town, approximately 1 mile past the landfill via road. The scrapyards include lead acid batteries, propane tanks, 55 gallon drums with unknown contents, vehicles, generators, used oil filters, and mixed metals. Reportedly, this area has been in use as a scrapyards since 2004. The nearest source of erosion, Kuskokwim Bay, lies 3,600 feet away.

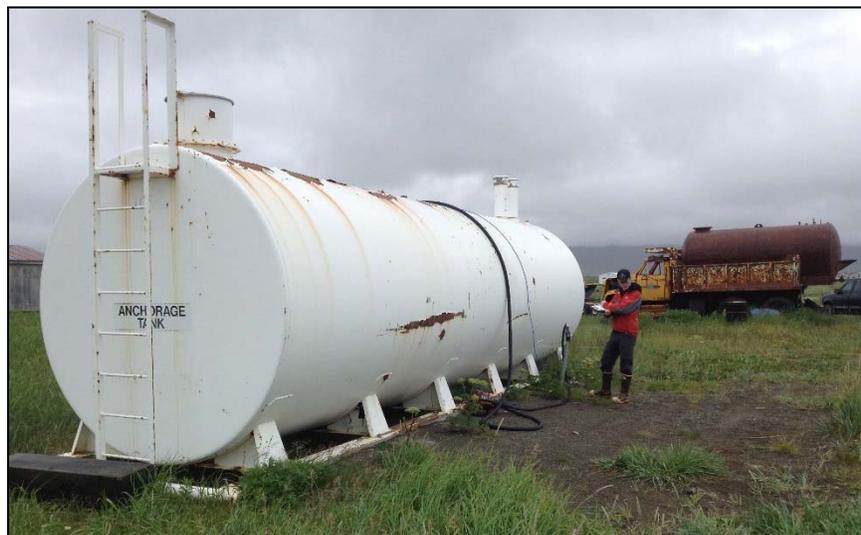
- **Tribe Tank, 59.012061/-161.818996 (Active)** – This site consists of a single, white 10,000 gallon, double-walled tank that is owned by Platinum Traditional Village. It can be found near the middle of town, about 250 feet west of the school. It has been in this location since around 2002. Smalls Slough, the nearest source of erosion, is 390 feet away.

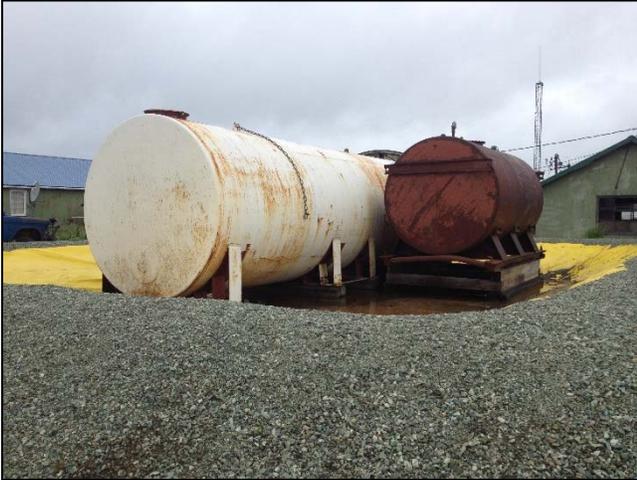
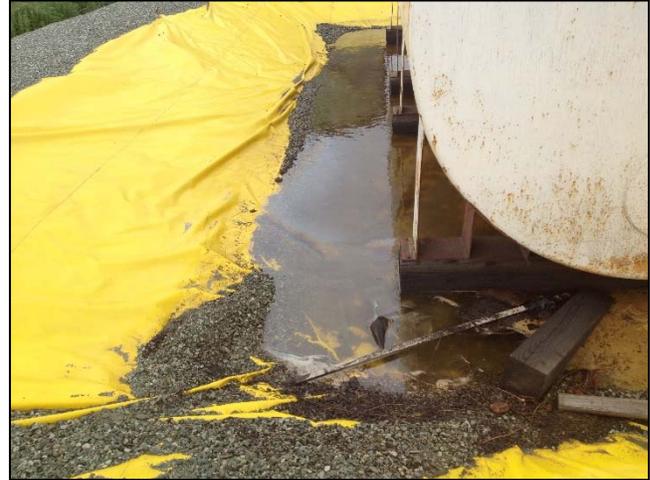
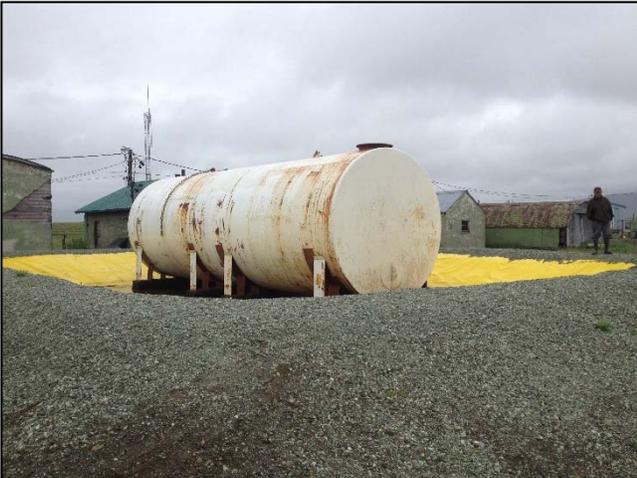
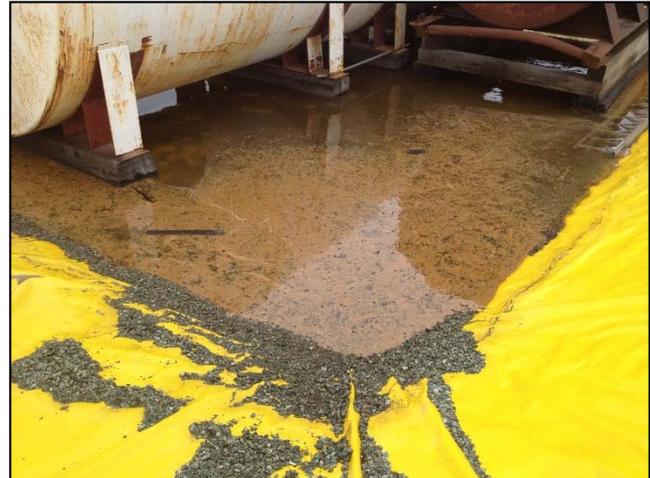
- **Utilities Tank Farm, 59.012384/-161.818812 (Active)** – This site, constructed in 2012, includes two tanks with a total capacity of 44,000 gallons. It is owned by Platinum Commercial Company LLC. The tanks supply fuel that powers the utilities. The site is surrounded by a gravel berm with a yellow liner. The tanks are supported by timbers resting on the liner. The nearest source of erosion, Smalls Slough, lies 360 feet away.
