**ALASKA DEPARTMENT OF ENVIRONMENTAL CONSERVATION**  
Division of Spill Prevention and Response  
Prevention and Emergency Response Program  
**SITUATION REPORT**

## **Dalton Highway Truck Rollover MP 309.5 Diesel Release**

**SITREP # 6**

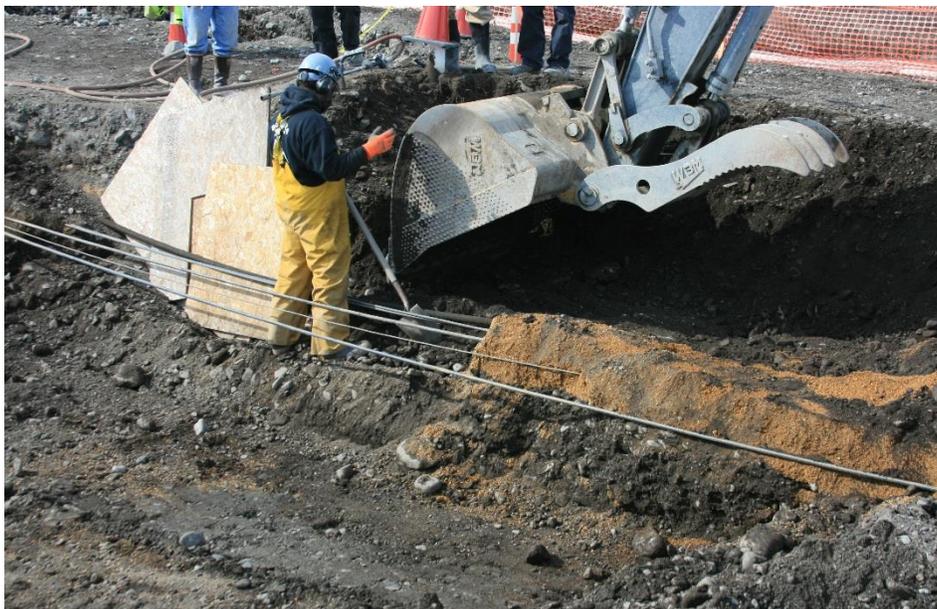
Responder working with excavator adjacent to TAPS utility lines, May 14, 2014. (Photo/ADEC)

Today, the Hamilton crew continues to remove soil from the delineated area to a target depth of 5 feet. Soil sampling at that depth will determine whether excavation needs to extend deeper or beyond the current demarcation. To minimize potential for damaging the utility lines, workers first expose short segments of the lines using a vacuum truck, then use an air knife (a high-pressure compressed air wand) and hand tools to help an excavator remove soil adjacent to and beneath the lines.

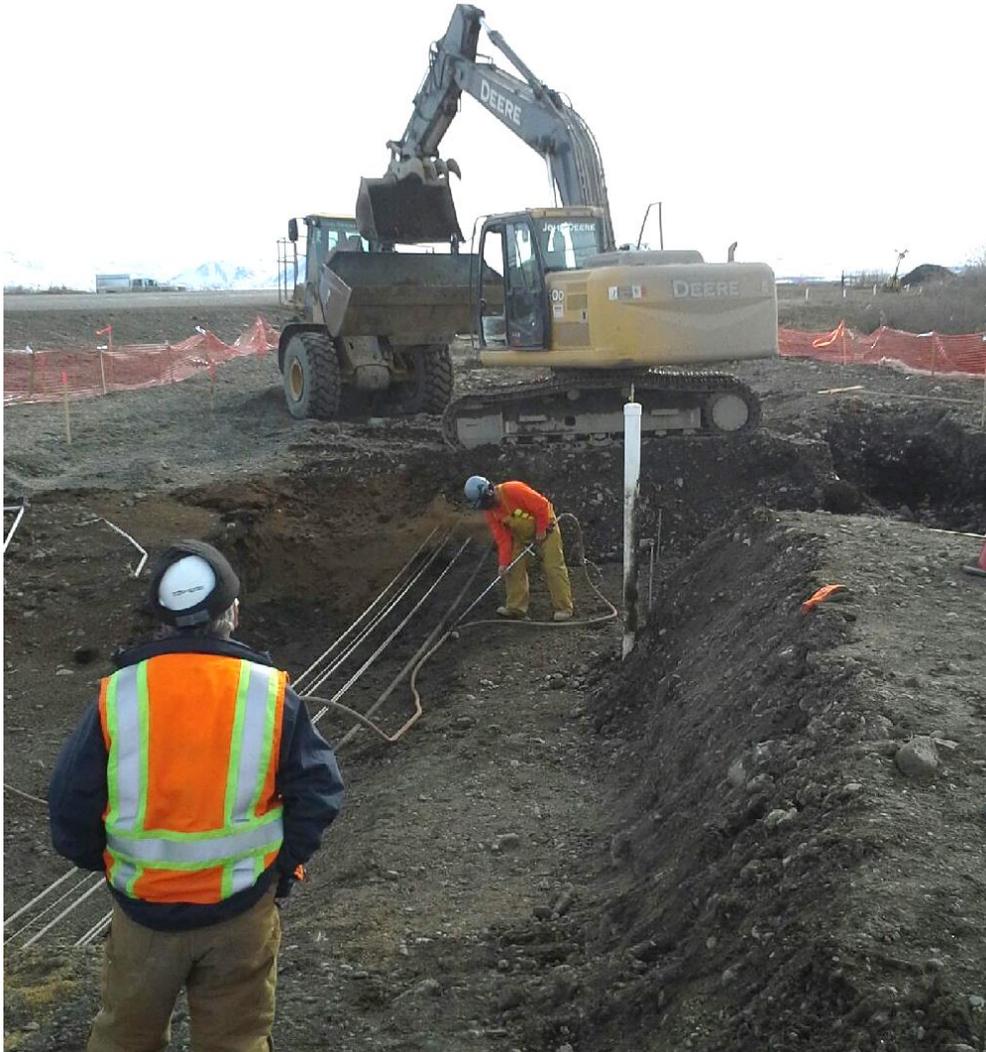
Responder using an air knife to break up soil beneath TAPS utility lines, May 15, 2014. (Photo/ADEC)
